# Maldon District Heritage at Risk Register 2022

January 2022

## Introduction

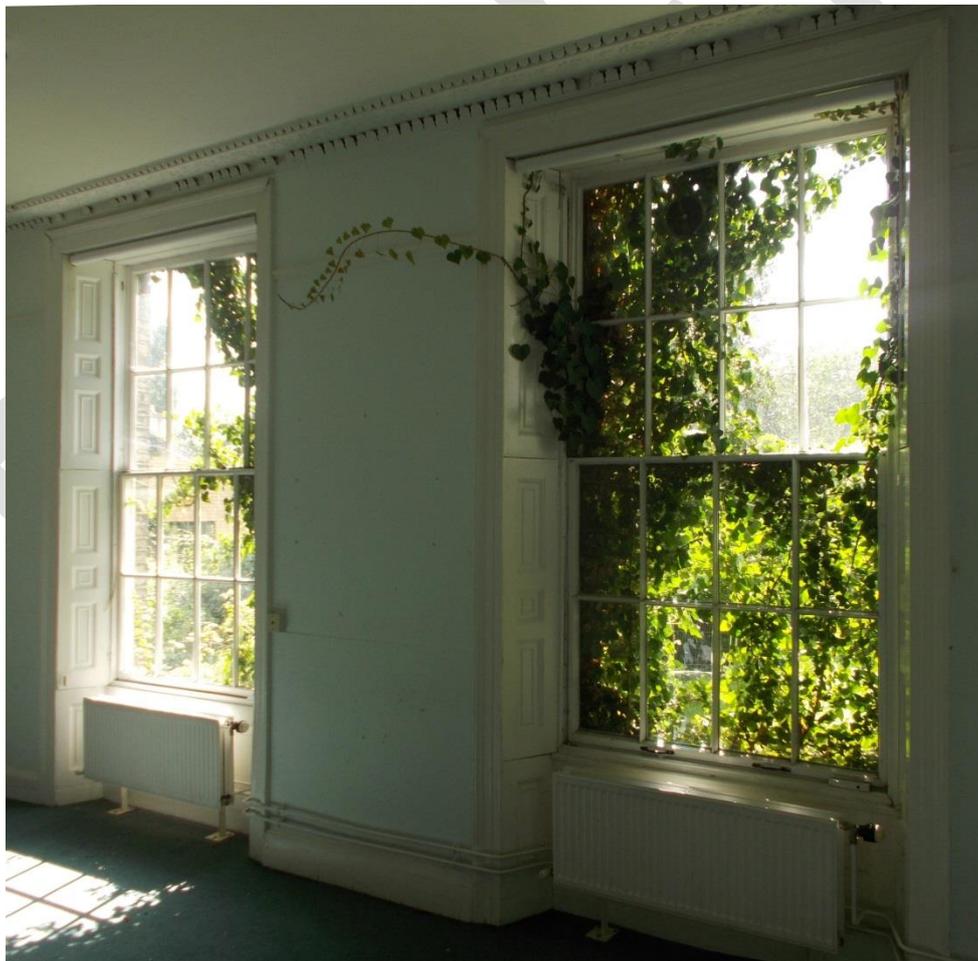
*Ivy invading Friary East, Maldon (grade II listed) in August 2017. The ivy has since been removed. Listed building consent was granted in April 2021 for conversion to apartments but has not yet commenced*

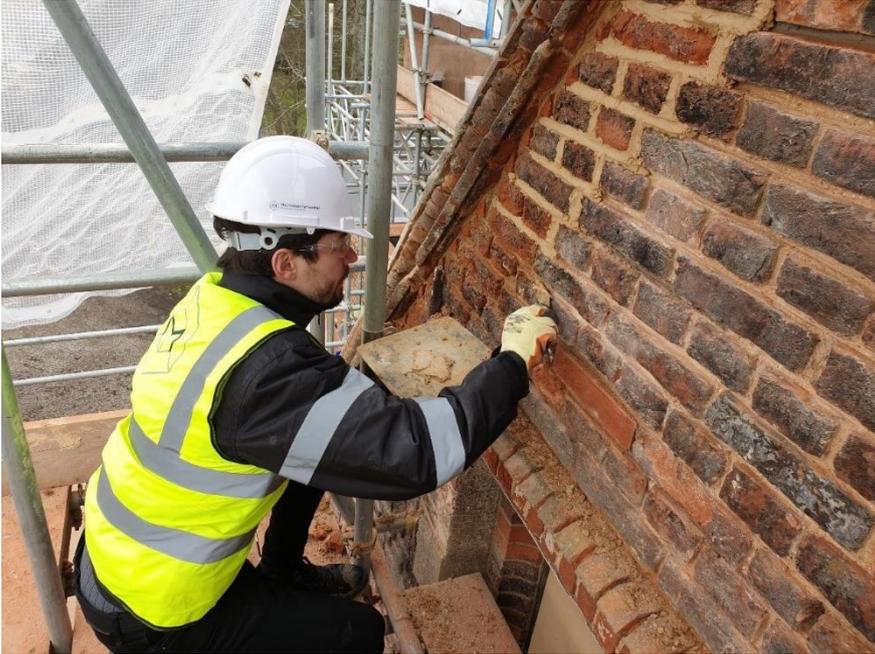
*Cristian Petrescu of The Morton Partnership doing some lime pointing at Creeksea Place, Burnham-on Crouch in 2021*

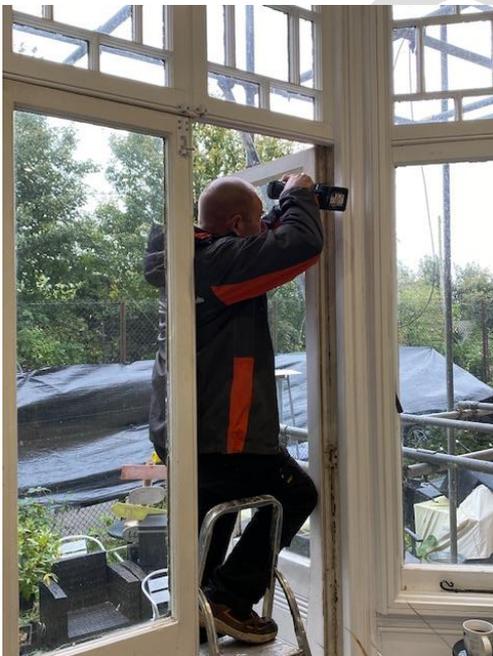
*Joiner Shaun Chapman repairing windows and doors at The Convent, Maldon, November 2021*

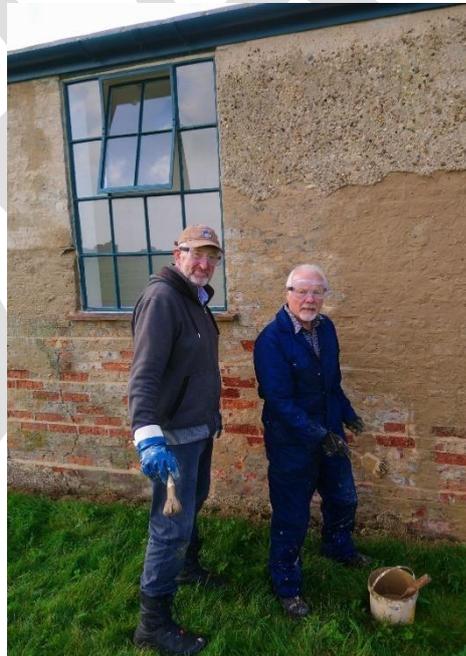
*Volunteers applying a lime 'slurry' coat to Building 30 at Stow Maries Aerodrome, October 2021*

*Building 30 at Stow Maries Aerodrome in November 2021. The building has been repaired in stages over the past decade, with grant support from Leader and Historic England, and is now used as offices for the trust which manages the site. The application of a protective lime-based slurry coat in October 2021 represented the final stage in the building's refurbishment and it can now be removed from the register.*

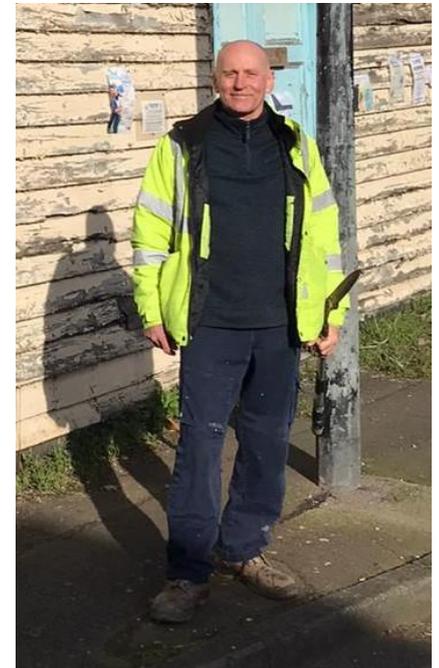
*Rofer Rob Deering, who repaired the leaking valley of the redundant URC Chapel in Heybridge Basin free-of-charge in February 2020*

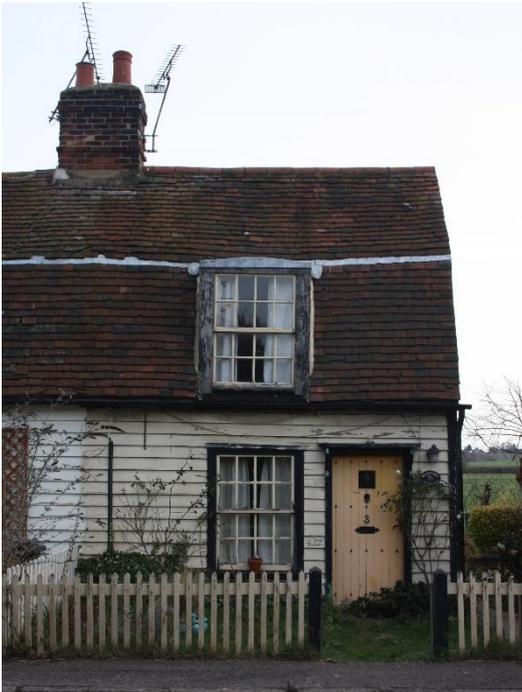
*No. 3 Black Lion Cottages, Althorne (grade II listed). Photo taken January 2019 prior to refurbishment.*

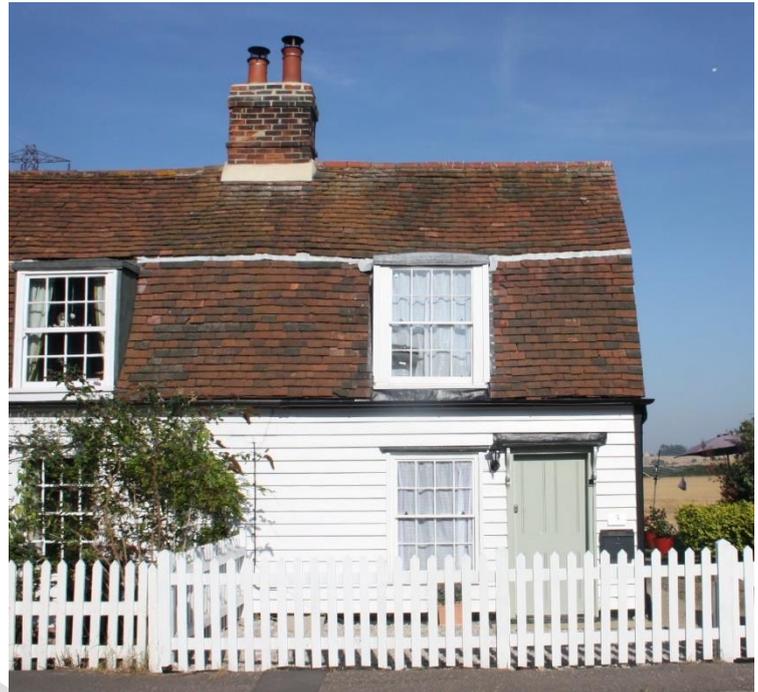
*No. 3 Black Lion Cottages in September 2021 following refurbishment. The repair works were highly commended in the 2021 Maldon Conservation and Design Awards*

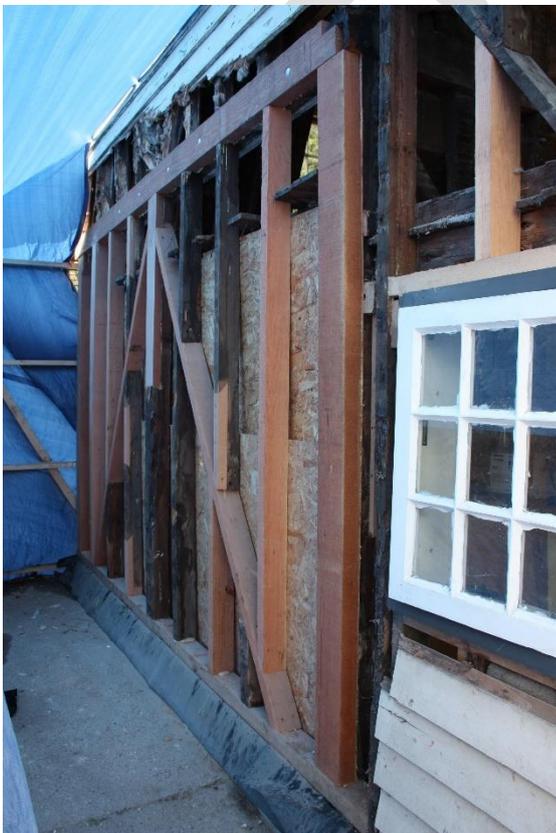
*The gable end of No. 3 Black Lion Cottages undergoing repair*

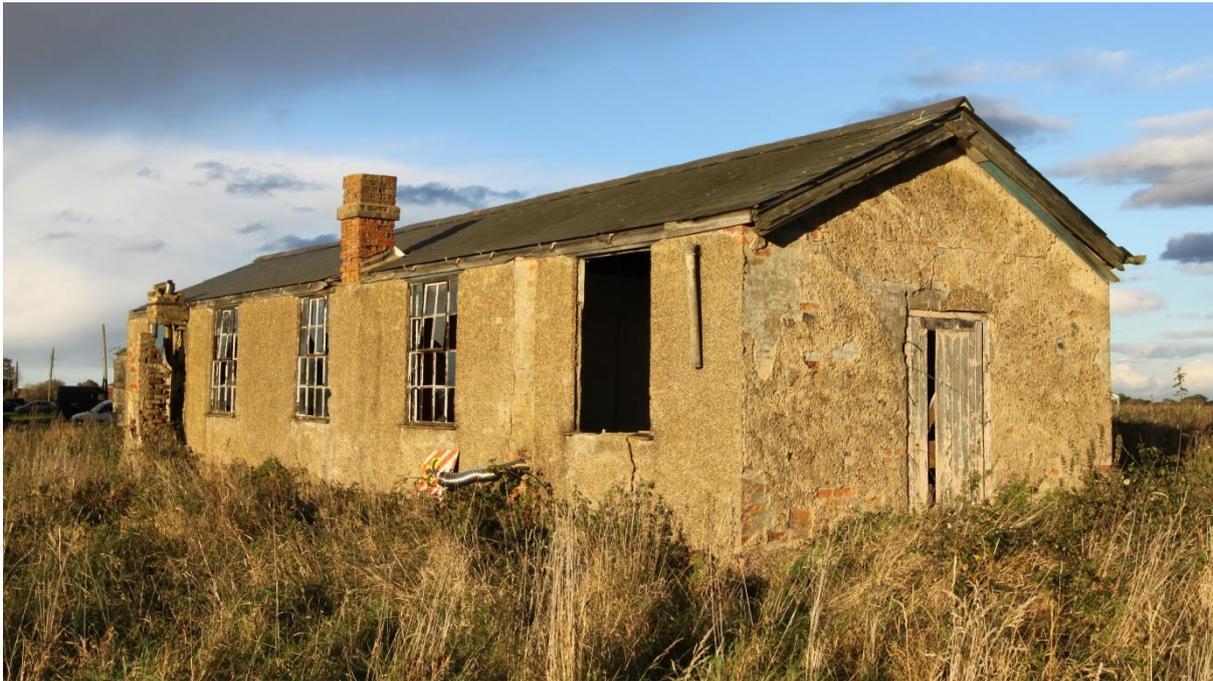
*Building 30 at Stow Maries Aerodrome. Photograph taken in November 2012 when it was first added to the Maldon District Council Heritage at Risk Register. It is a grade II\* listed building in a conservation area.*

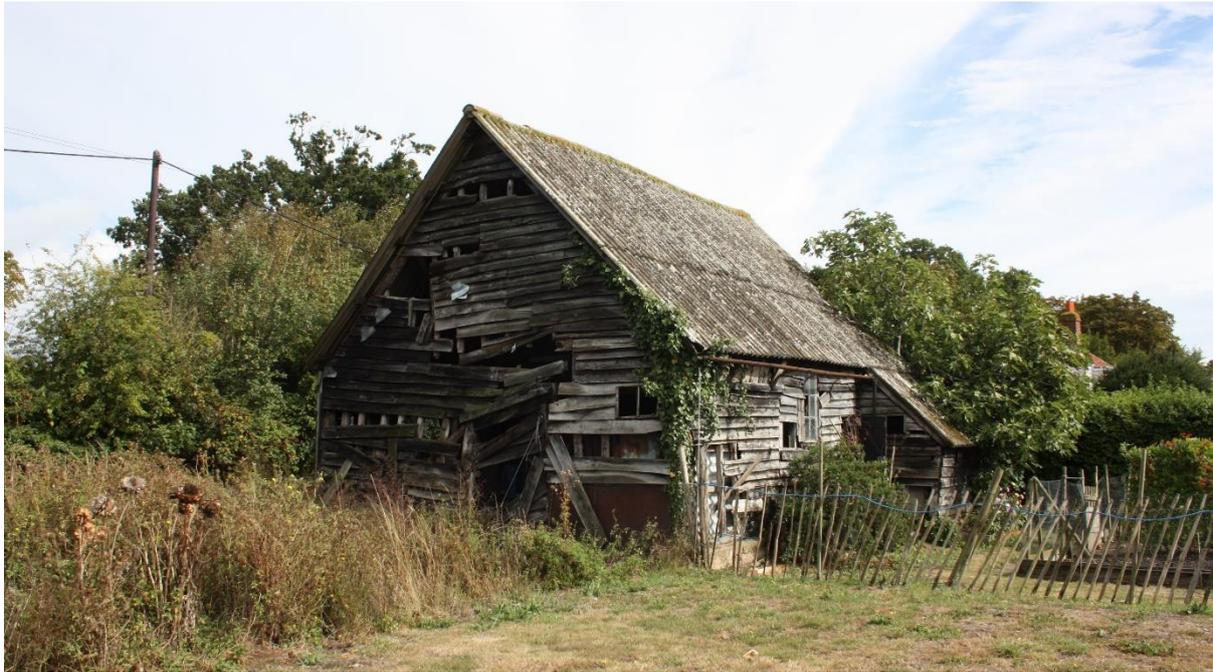
*Photograph taken 4<sup>th</sup> September 2019*

Designation:	Grade II listed
Priority:	<b>C</b> - Slow decay. No solution agreed.
Condition:	<b>Very bad</b> – An adjoining cartlodge has collapsed. The gable-end tie beam has become so decayed that it has snapped in two. In March 2020 the owner confirmed scaffolding has been installed to support the building.
Date registered:	2004
Ownership:	Private
For Sale:	No
Summary:	A meeting was held on the 4 <sup>th</sup> of September 2019 between the Council's Conservation and Heritage Specialist, the owners, and their builder to discuss the condition of the building. The Council's Conservation and Heritage Specialist made recommendations for minimal repair work necessary to stabilise the building. A listed building consent application was subsequently submitted to convert the building into accommodation ancillary to the main house (ref. LBC/MAL/20/00647). This application was refused in November 2020 due to unsympathetic aspects of the design. Prior to determination of the application, various amendments were recommended to overcome the conservation-related concerns, but no amended plans were received.

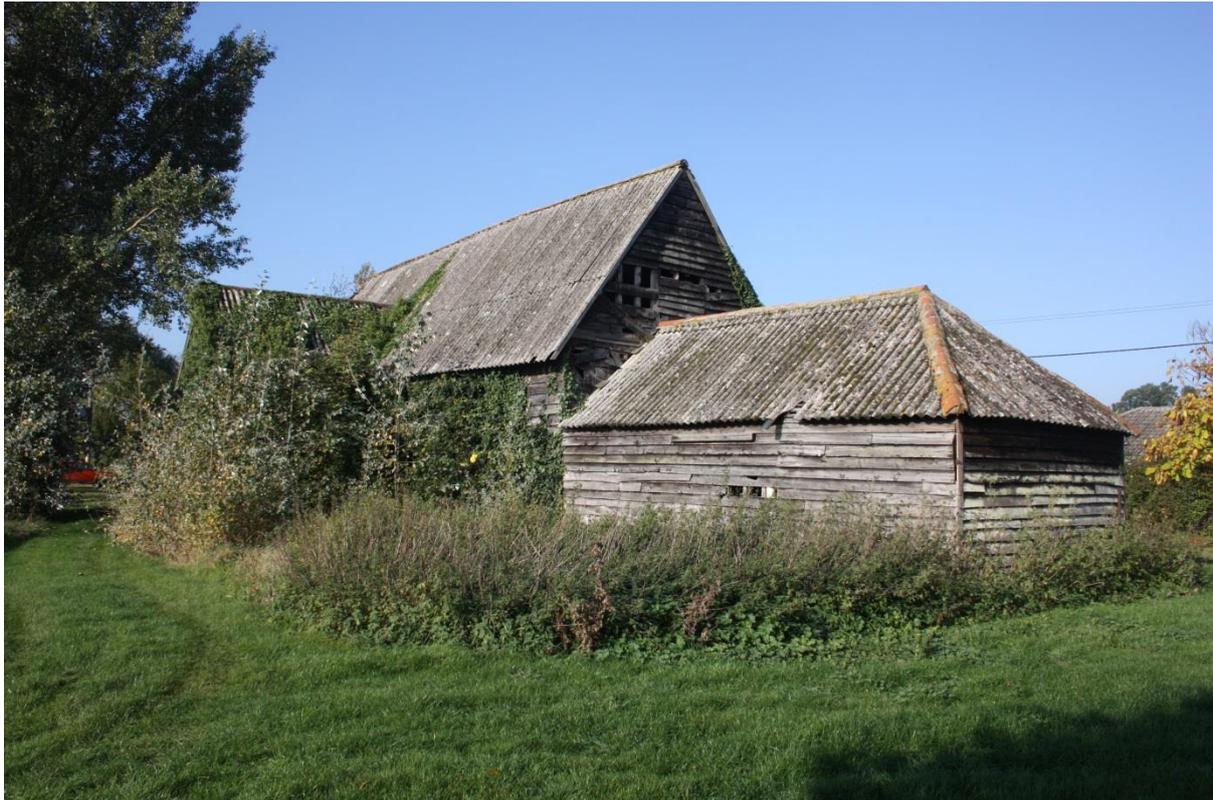
*Photograph taken 16<sup>th</sup> October 2018*

Designation:	Grade II listed
Priority:	<b>C</b> – Areas of missing cladding and damage by invasive ivy growth
Condition:	<b>Fair</b> – Appears to be structurally sound, but some areas of cladding need to be reinstated.
Date registered:	2018
Ownership:	Private
For Sale:	No
Summary:	This barn dates from the late 1500s or early 1600s, making it one of the oldest agricultural buildings to survive in the Maldon District. A meeting was held on the 4th of September 2019 with the owners and their builder to discuss the condition of the building. The Council's Conservation and Heritage Specialist recommended that the ivy be removed carefully as soon as possible. The owner has since confirmed that the ivy has been removed.

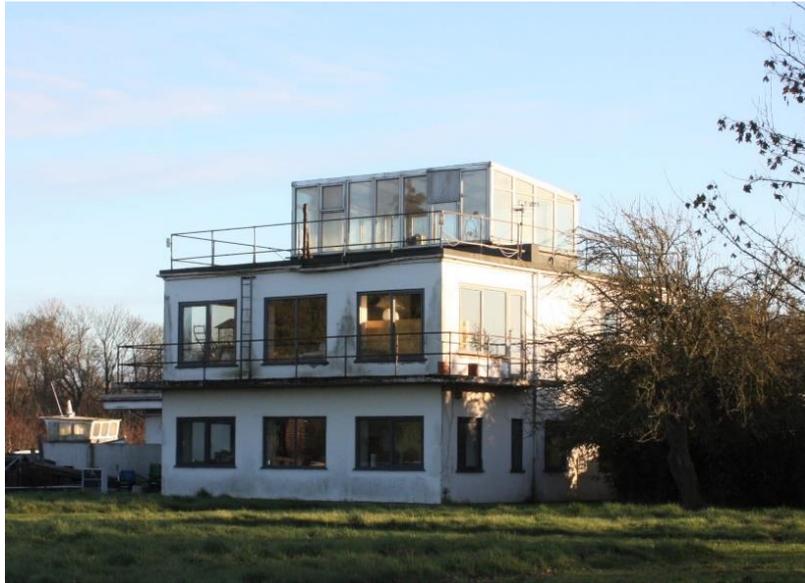
Photograph taken 20<sup>th</sup> of January 2020

Designation:	Local List
Priority:	<b>G</b> – This building is on the site of the proposed Bradwell B Nuclear Power Station and faces demolition if the development goes ahead.
Condition:	<b>Good</b> – The building is occupied and appears to be in good condition
Date registered:	2022
Ownership:	Private
For Sale:	No
Summary:	This Control Tower oversaw operations at Bradwell Bay airfield during WWII and was later converted to a residence. Along with the Station HQ and the four Blister hangars, the Control Tower is important to the history and heritage of Bradwell Bay airfield. The military historian Fred Nash has observed that “although they are all that remains of the 300+ buildings and structures that stood on the airfield they were, and are, of major significance in the hierarchy of airfield architecture” (Nash, 2010). Maldon District Council has emphasised the importance of this building in its response to the Bradwell B Power Station Stage One Consultation.

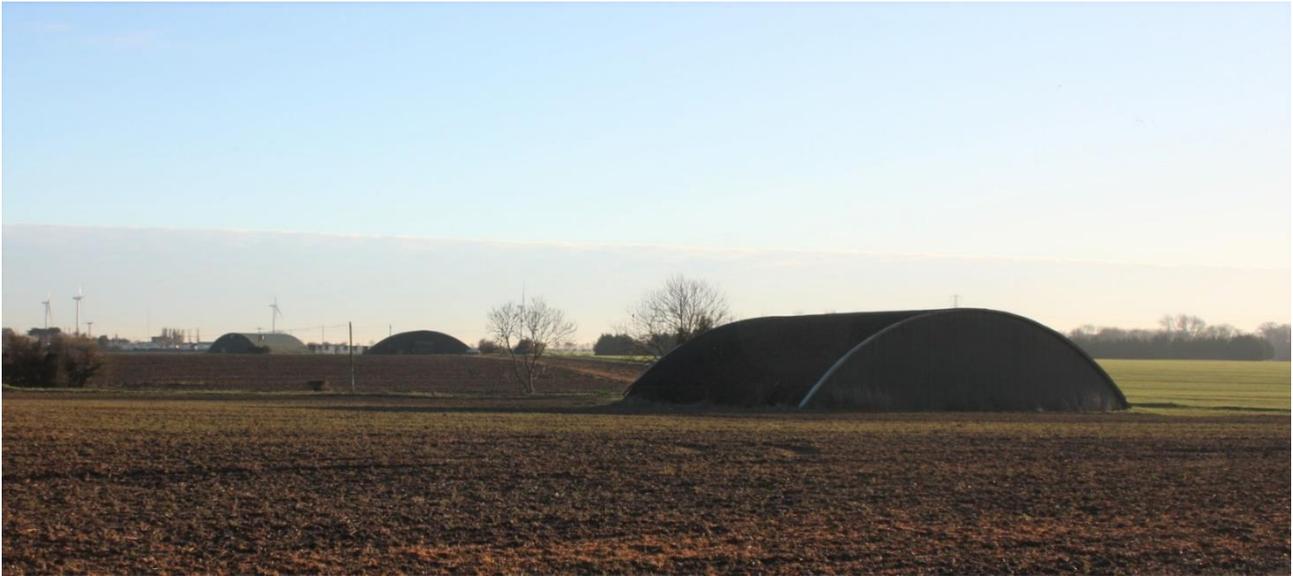
*Photograph taken 20<sup>th</sup> January 2020*

Designation:	Local List
Priority:	<b>G</b> – These structures on the site of the proposed Bradwell B Nuclear Power Station and faces demolition if the development goes ahead.
Condition:	<b>Good</b> – The buildings appear to be in good condition
Date registered:	2022
Ownership:	Private
For Sale:	No
Summary:	During WWII there were twelve Blister hangers dispersed across the airfield, of which only four survive. They are each approximately 90 feet in span x 60 feet in length. The military historian Fred Nash has observed that the few buildings which survive on from the WWII airfield are “of major significance in the hierarchy of airfield architecture” (Nash, 2010). Maldon District Council has emphasised the importance of these buildings in its response to the Bradwell B Power Station Stage One Consultation.

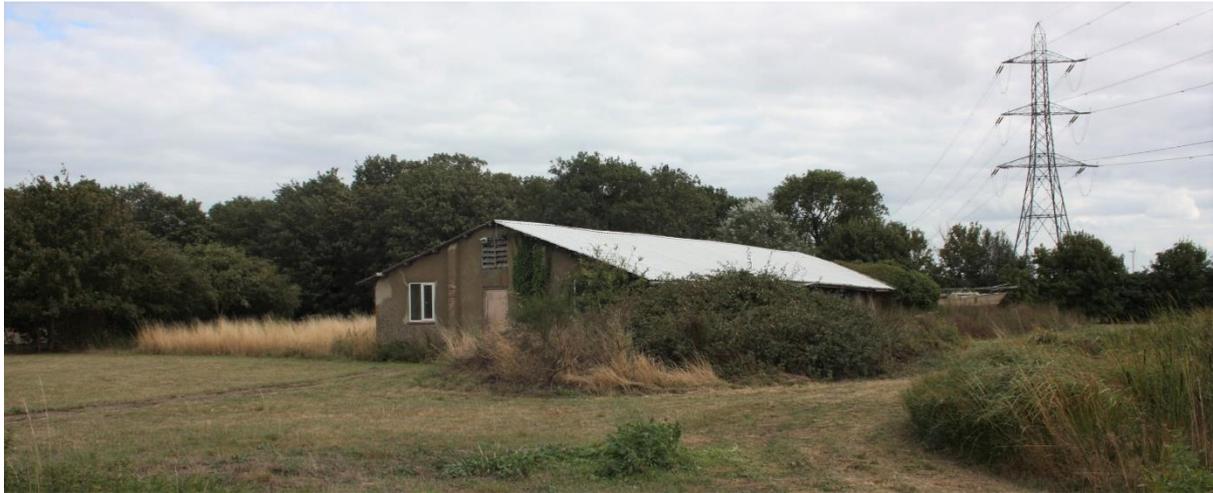
*Photograph taken 20<sup>th</sup> January 2020*

Designation:	Local List
Priority:	<b>G</b> – This building is on the site of the proposed Bradwell B Nuclear Power Station, and faces demolition if the development goes ahead.
Condition:	<b>Fair</b> – The building is weathertight but has suffered from some structural movement
Date registered:	2022
Ownership:	Private
For Sale:	No
Summary:	The Station HQ is a long single-storey building which has been repurposed as a workshop. The military historian Fred Nash has observed that the few buildings which survive on from the WWII airfield are “of major significance in the hierarchy of airfield architecture” (Nash, 2010). Maldon District Council has emphasised the importance of this building in its response to the Bradwell B Power Station Stage One Consultation.

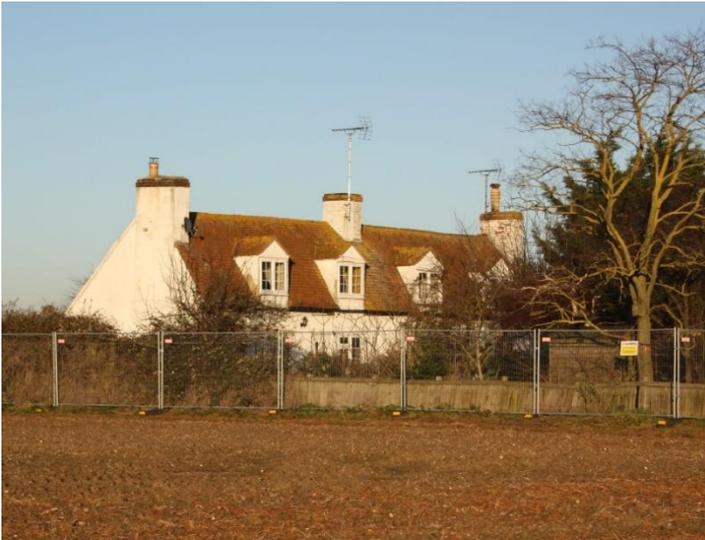
Photograph taken 20<sup>th</sup> January 2020

Designation:	Local List
Priority:	<b>G</b> – This building is on the site of the proposed Bradwell B Nuclear Power Station, and faces demolition if the development goes ahead.
Condition:	<b>Good</b> – The building appears to be in sound condition
Date registered:	2022
Ownership:	Private
For Sale:	No
Summary:	This pair of late-Georgian cottages was built to house agricultural workers at Weymarks Farm. It was converted into a single dwelling in the 20 <sup>th</sup> century. The building is 1 ½ storeys in height with a clay-tiled gambrel roof. The roof sweeps down in ‘cat-slide’ form at the back over rear lean-tos. Apart from replacement windows, the cottages appear to be well preserved. They are a good example of Georgian agricultural workers’ cottages servicing an isolated farm. Maldon District Council has emphasised the importance of this building in its response to the Bradwell B Power Station Stage One Consultation.

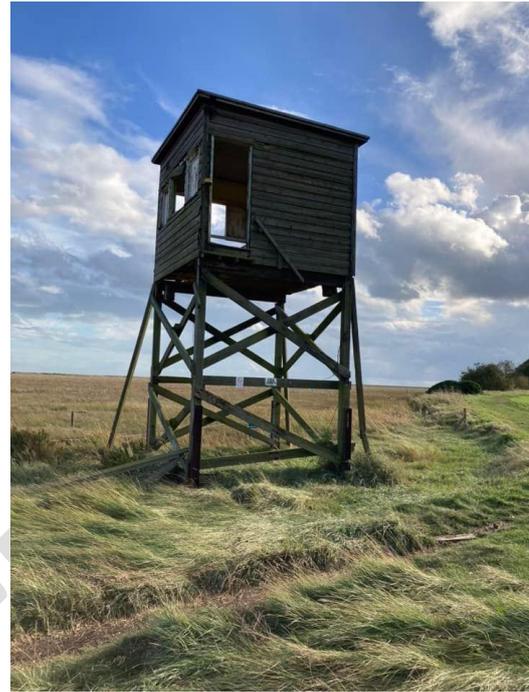
*Photograph taken by Neil Bonner  
November 2021*

Designation:	Non-designated heritage asset
Priority:	<b>C</b> - Slow decay. No solution agreed.
Condition:	<b>Poor</b> – The building has not been actively maintained for some time. It is slowly decaying. The stairs were removed within the last 20 years.
Date registered:	2022
Ownership:	Private
For Sale:	No
Summary:	A Firing and Bombing Range was created in 1937 on the marshes south east of St Peter's Chapel. The range had an accompanying airfield which in 1941 was redeveloped as RAF Bradwell Bay. The bombing range continued as a training facility into the 1960s by the RAF and USAF. The range was overlooked by three towers. The one near St Peter's Chapel is the only one to survive, known as the 'bearing station'. The Tower is a valuable survival of the bombing range, a feature reflecting the threat posed by the rise of Naziism in Germany from the mid-1930s. All other features of the bombing range have been removed. The RAF Bradwell Bay Preservation Group hopes to see the building repaired and an interpretation board set up. The group is approaching the landowner and intends to explore grant funding and recruiting a volunteer workforce to repair the structure.

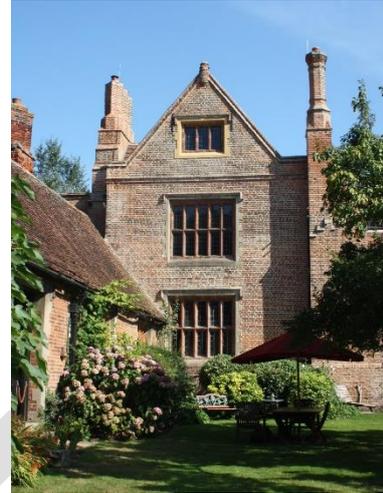
*West elevation of original wing,  
8<sup>th</sup> of September 2021*

Designation:	Grade II* listed
Priority:	<b>F</b> – Major repair scheme completed in 2021 but further works required to put whole building back into use.
Condition:	<b>Fair</b> – Recent repair works have hugely improved the condition and prospects of the building. However, further investment is needed to make the upper rooms in the north wing habitable. The condition of the north-west wing needs a careful review as roofs and chimneys are in a poor condition.
Date registered:	1993
Ownership:	Private
For Sale:	No
Summary:	This substantial Elizabethan house was derelict for many years, resulting in long-term deterioration of the building's fabric. Grants from Historic England in 2020 and 2021 funded repairs to the oldest part of the building including re-roofing, re-pointing, major timber-repairs, re-glazing windows, internal re-plastering and restoration of historic panelling. The repairs won the Building Conservation category of the 2021 Maldon Conservation and Design Awards. In 2021 minor alterations, involving the removal of 20th-century partitions, were carried out to enable the future use of the interior by wedding guests, although investment is needed to make these rooms habitable. The condition of the north-west wing needs a careful review as roofs and chimneys are in a poor condition.

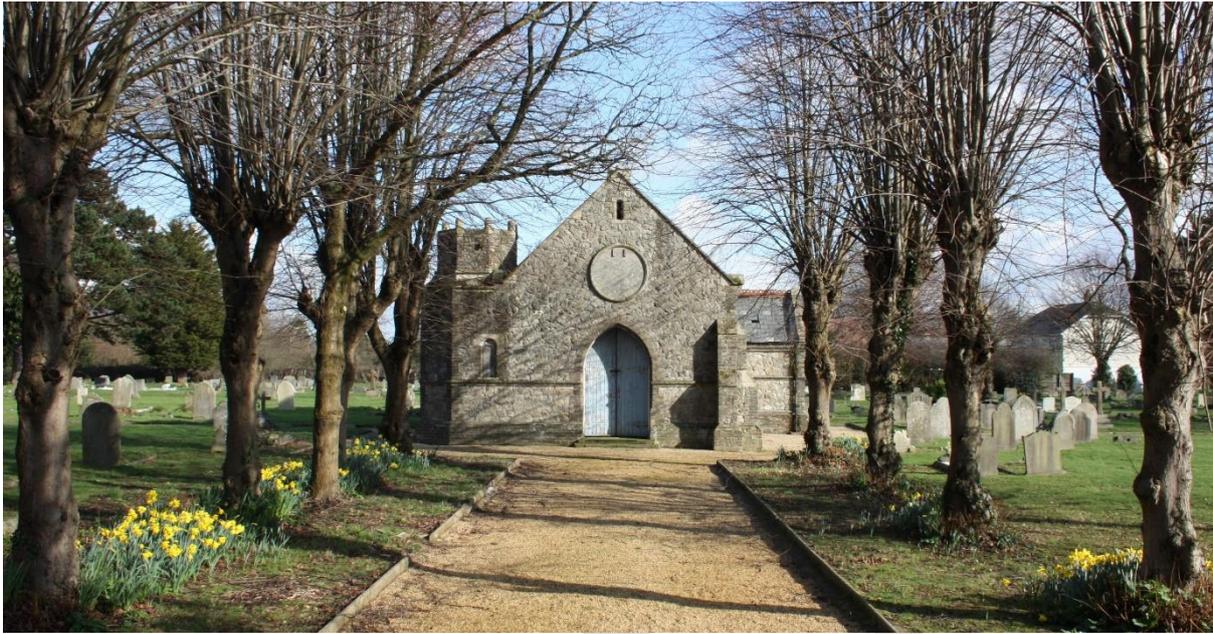
*Photograph taken 27<sup>th</sup> of February 2020*

Designation:	Non-designated heritage asset
Priority:	<b>A</b> - Immediate risk of further rapid deterioration. No solution agreed.
Condition:	<b>Poor</b> – Slipped slates have resulted in holes in the roof and the rainwater goods are defective.
Date registered:	2022
Ownership:	Maldon District Council
For Sale:	No
Summary:	The Burnham-on-Crouch cemetery chapel was built in 1894. It is a gothic-style building with walls constructed of Kentish Ragstone and Caen stone dressings and roofs clad in natural slate with decorative clay ridge tiles. It has a small octagonal tower on its north-west corner which was topped by a spire until its removal in the late-20 <sup>th</sup> century. The building has not been used for many years and would require substantial refurbishment to bring it back into use. Options for reusing the building are currently being explored. Interim repairs to the roof and rainwater goods, to make the building more weathertight, could help delay more serious problems developing.

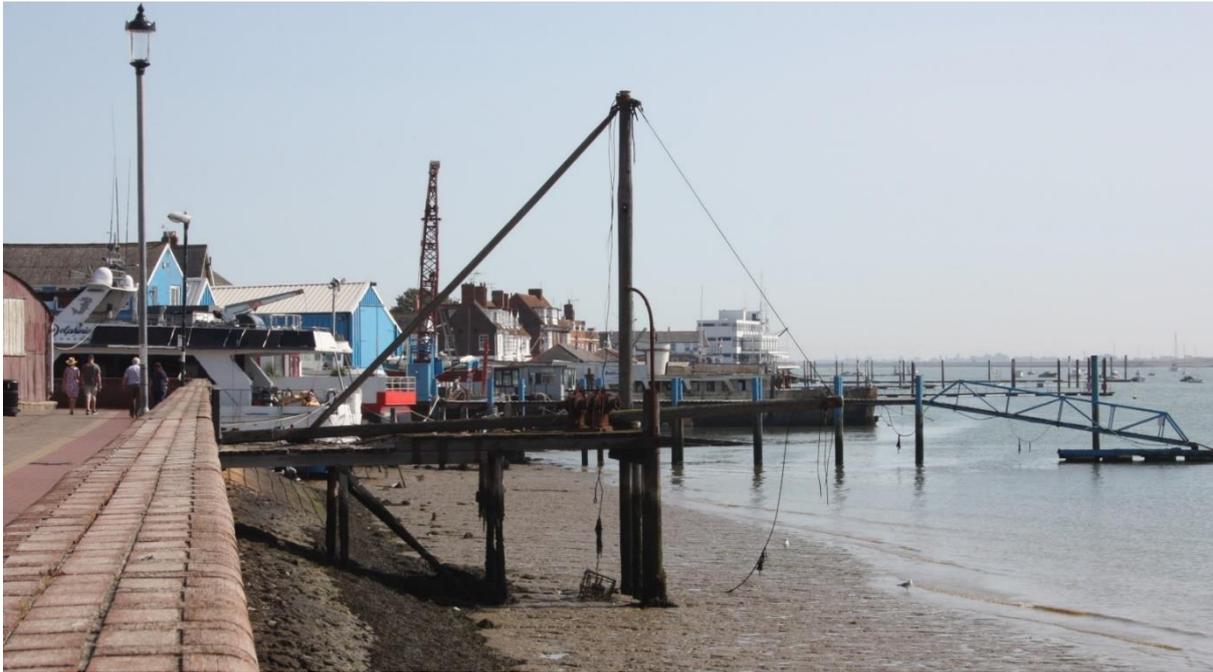
*Photograph taken 14<sup>th</sup> September 2020*

Designation:	Non-designated heritage asset within the Burnham Conservation Area
Priority:	<b>A</b> - Immediate risk of further rapid deterioration. No solution agreed.
Condition:	<b>Poor</b> – The structure is heavily decayed in places
Date registered:	2022
Ownership:	Private
For Sale:	No
Summary:	This jetty dates from beginning of the 20 <sup>th</sup> century. It was associated with William King and Sons Boatyard, established in 1901. The boatyard immediately to the west of the jetty eventually fell out of use and was redeveloped for housing in the late 1980s and early 1990s. In 2006 the boundary of the Burnham-on-Crouch Conservation Area was extended beyond the present seawall to the line of the low tide mark in an effort to protect the jetties and cranes which are a valuable part of the town's maritime character. At the encouragement of local resident John Boyce, the Kings residential management company has now acquired the section of foreshore including the old King's jetty. Mr Boyce has set up a heritage company to restore the jetty, and this company is currently negotiating a lease with the management company. A team of volunteers has been assembled and sources of grant funding to repair the structure are being actively investigated.

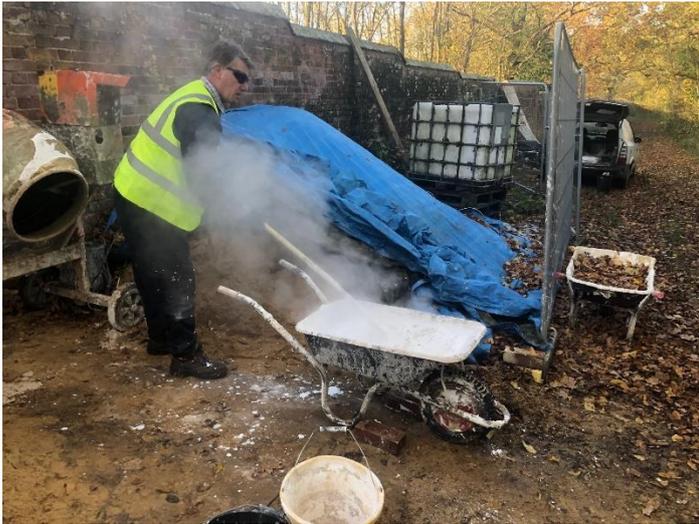
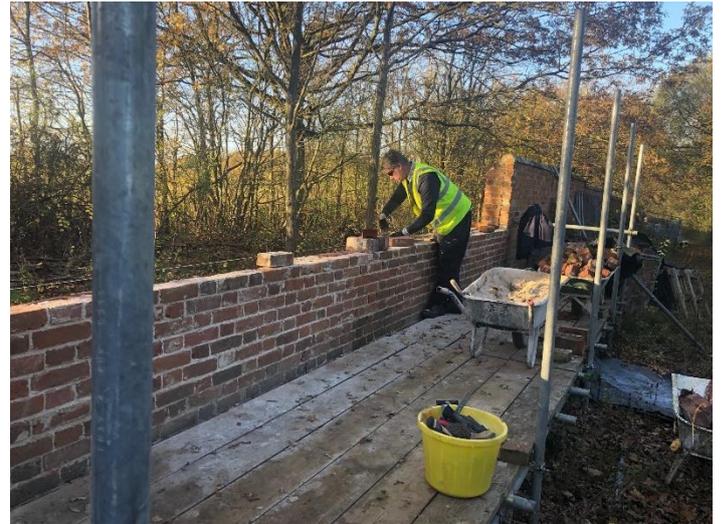
*Photographs of bricklayer John Shelley on 25<sup>th</sup> November 2021, slaking lime on the left and rebuilding a collapsed section of wall on the right*

Designation:	Grade II listed
Priority:	<b>F</b> – Currently undergoing repair
Condition:	<b>Poor</b> - The wall has suffered general deterioration, as well as occasional damage by vehicles on the road-side section and theft of coping bricks.
Date registered:	2011
Ownership:	Private
For Sale:	No
Summary:	Early-19 <sup>th</sup> century wall, approximately four and a half miles long, enclosing the Braxted Park Estate. The cost of repairing the wall (estimated at £1.25m) is being funded by a scheme of enabling development in the form of 14 new houses on the edge of the village. The repair work – initially undertaken by Bakers of Danbury but latterly by John Shelley – commenced in 2016. The initial target to complete the work by 2021 was unavoidably missed due to Covid-related shutdowns and further wall collapses. The owner believes sufficient funds remain from the original enabling development and from internally generated funds going forward to complete all remaining as well as ongoing and future repairs occasioned by collisions and recent collapses. The estate has committed to and resourced that outcome by retaining the services of a permanent conservation bricklayer.

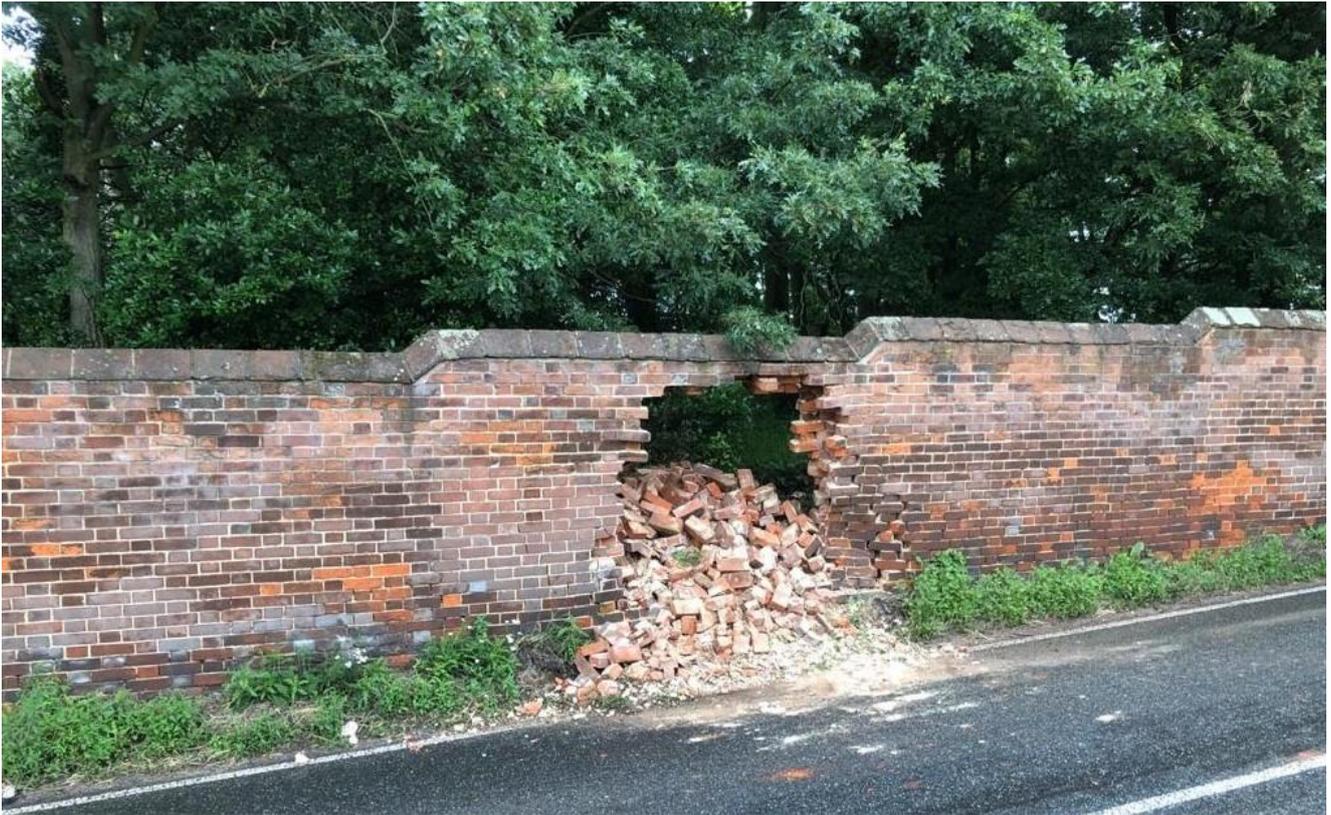
*Collision damage April 2021*

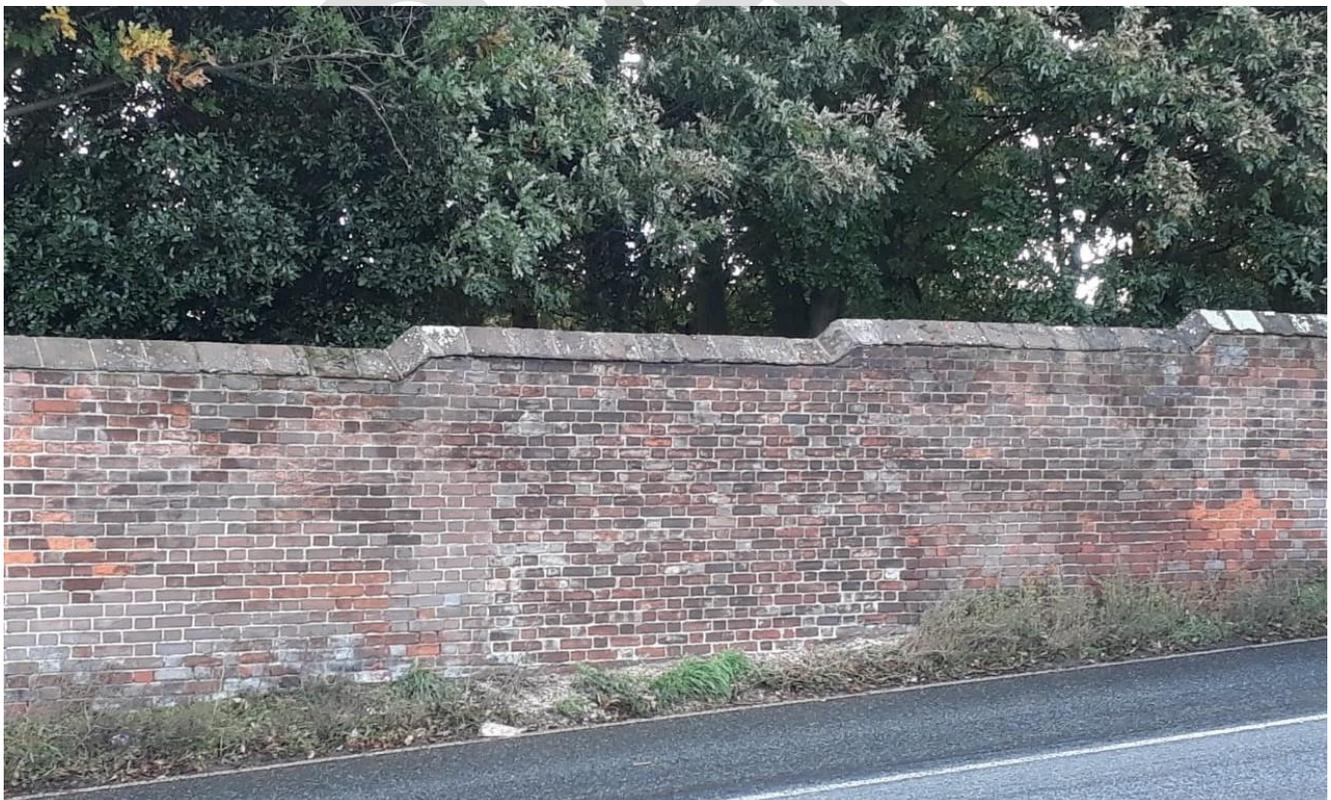
*The same section of wall in October 2021 following skilful repair by John Shelley*

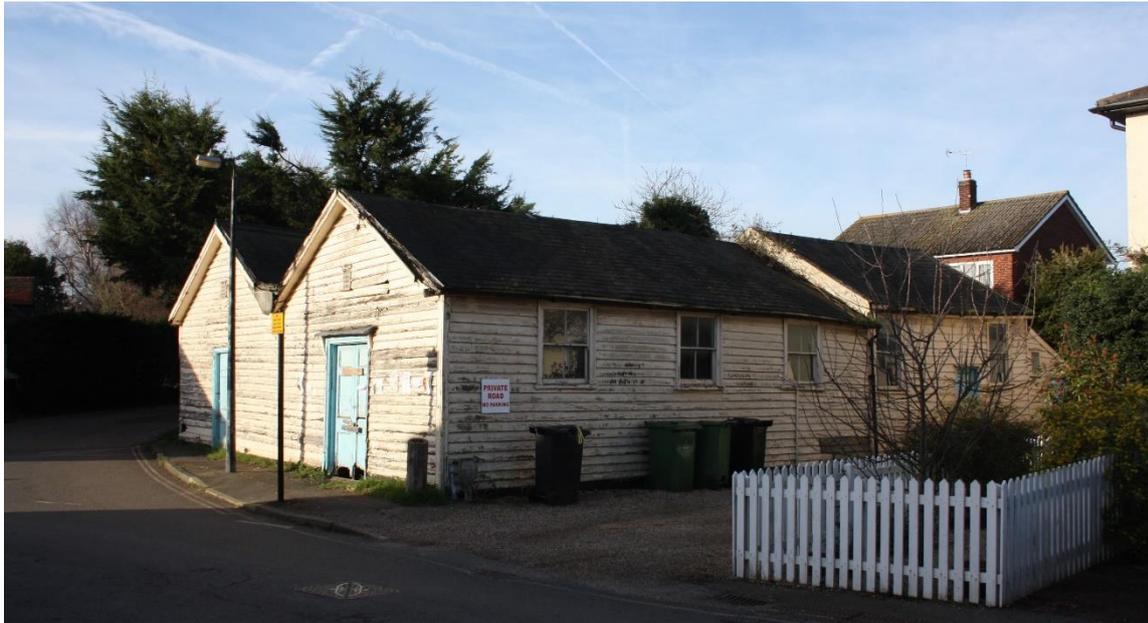
*Photograph taken 5<sup>th</sup> of February 2020*

Designation:	Within the Heybridge Basin Conservation Area
Priority:	<b>A</b>
Condition:	<b>Very bad</b> - The building has been redundant for many years and is in an increasingly dilapidated state. There are signs that much of the timber-frame structure has become severely decayed.
Date registered:	2010
Ownership:	Private
For Sale:	No
Summary:	This Victorian building is a good example of a vernacular weatherboarded chapel and a significant landmark in the conservation area. Planning applications in 2008 and 2017 to convert the building to a restaurant were refused. The option of residential conversion is complicated by the fact the building is situated in a flood zone. In early 2020, Rob Deering – a local roofer and conservation student – made a repair to the leaking roof valley free of charge, with permission from the owners. Following a recommendation by the Council's Conservation and Heritage Specialist, the owner boarded up the openings and cleared the rubbish from the interior. The owners also offered to sell for £200,000. Heybridge Basin has recently established its own Parish Council, and it has been suggested that the chapel could become the parish council offices / village hall / heritage centre / café. The Conservation and Heritage Specialist has provided advice on grant funding etc.

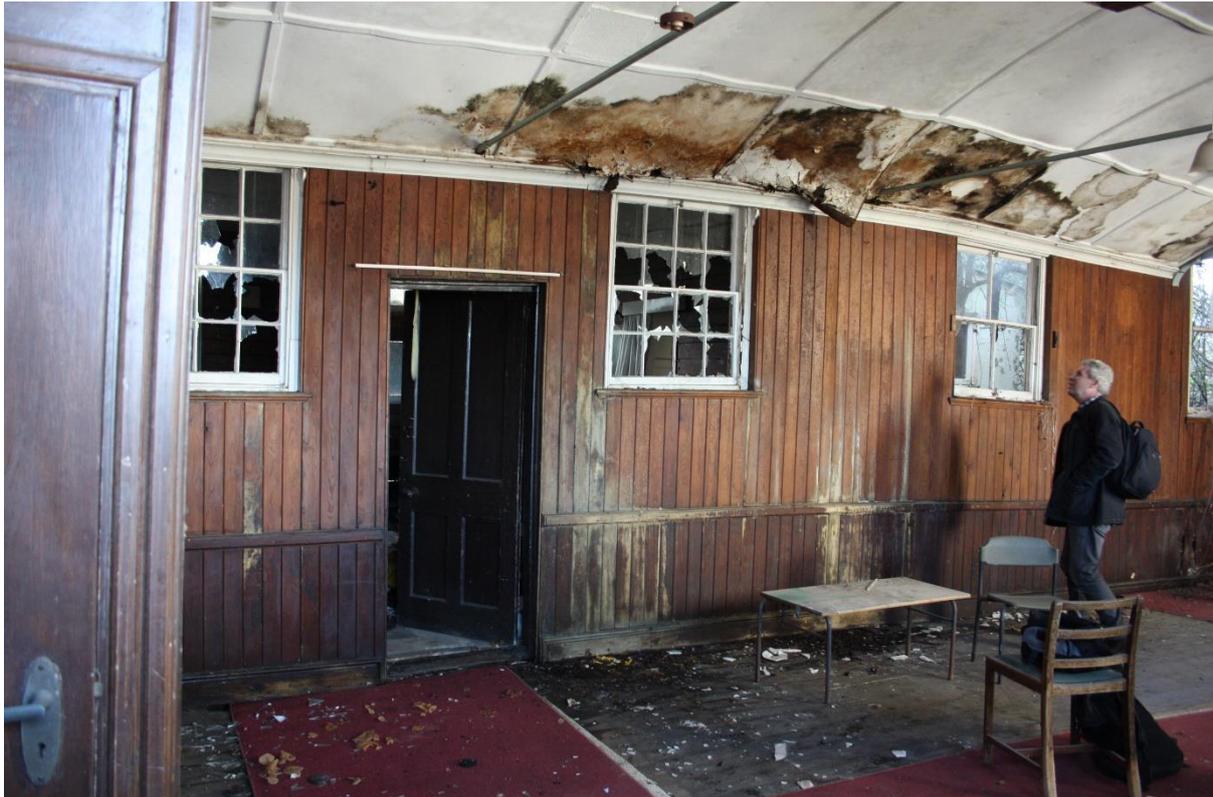
*The leaking roof valley of the Heybridge Basin URC Chapel being inspected by structural engineer Ed Morton on behalf of SAVE Britain's Heritage, 5<sup>th</sup> of February 2020*

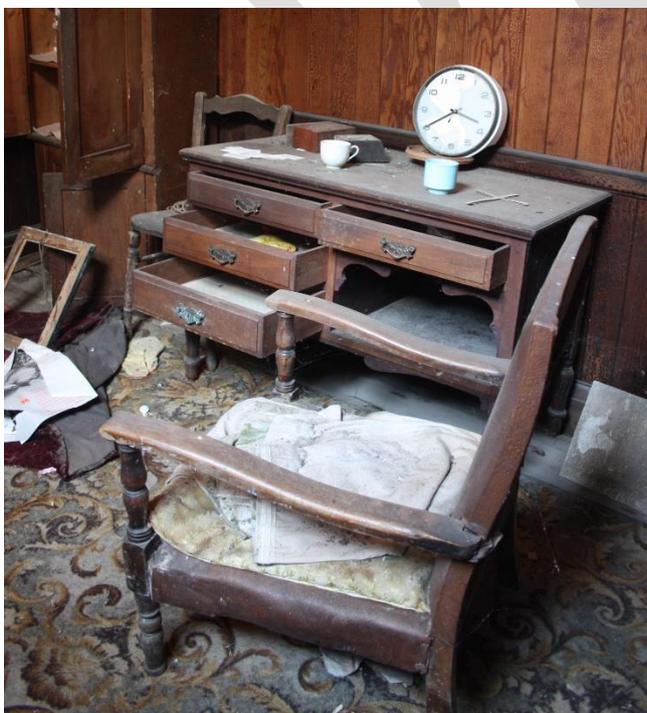
*The interior of the vestry of the URC Chapel, 5<sup>th</sup> February 2020*

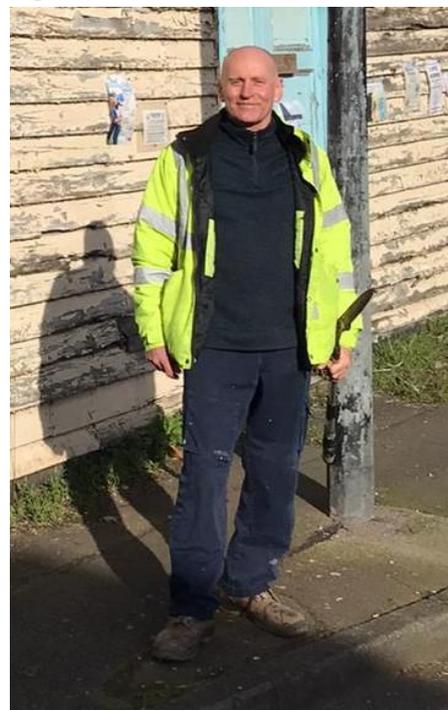
*Rofer Rob Deering, who repaired the leaking valley of the URC Chapel free-of-charge in February 2020*

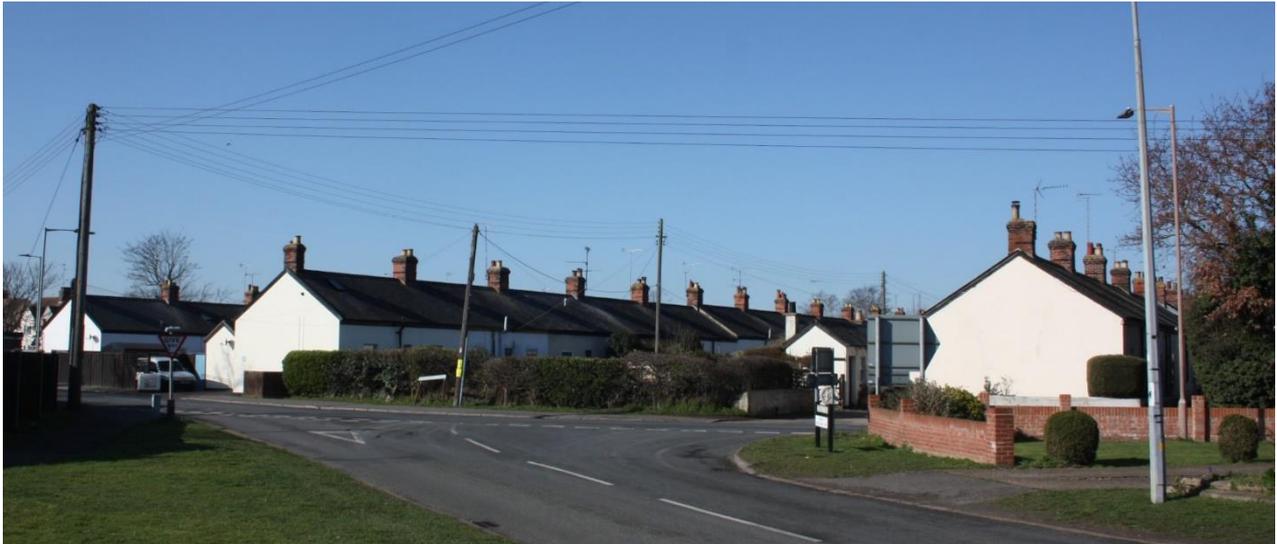
*Photograph taken 9<sup>th</sup> of March 2021*

Designation:	Conservation Area due to be designated in January 2022
Priority:	<b>C</b>
Condition:	<b>Poor</b> – Erosion of character due to high volume alterations and some properties in a poor condition
Date registered:	2022
Ownership:	Private
For Sale:	No
Summary:	Built in 1873 as homes for the employees of Bentall's Agricultural Works, the 41 single-storey cottages are a pioneering example of mass-concrete construction. Remarkably, until 1918, the cottages and outhouses had flat roofs and were known as the 'Flat Tops'. Although the cottages were designated as grade II listed buildings in 1971, several have been altered in ways that detract from their traditional character and some have fallen into a poor state of repair. Recent designation as a conservation area has created the opportunity for Maldon District Council to enter into a Conservation Area Partnership Agreement with Historic England, through which grant funding could be made available to owners for works which enhance the character of the area. A recently established Local Listed Building Consent Order will grant automatic consent for selected types of alteration, making it easier for owners of Woodfield Cottages to carry out sympathetic and restorative alterations.

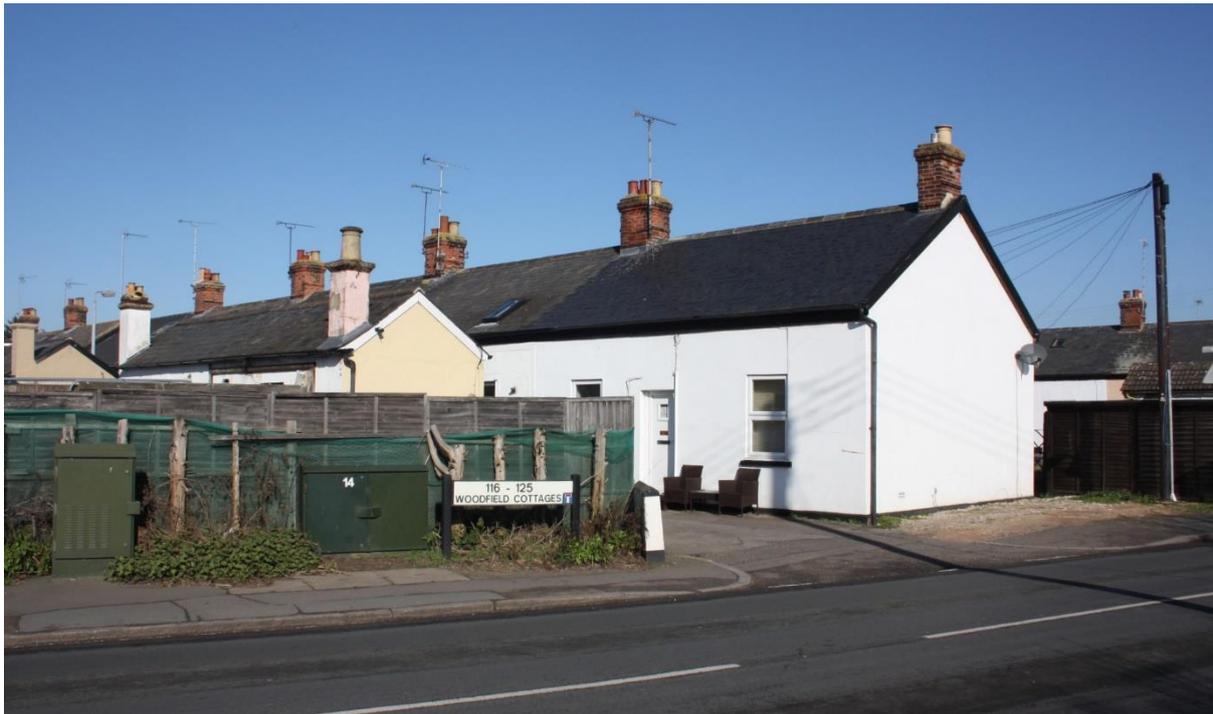
*Photograph of Woodfield Cottages taken March 2021 at the east end of the south row*
