# Maldon District Heritage at Risk Register 2022

January 2022

## Introduction

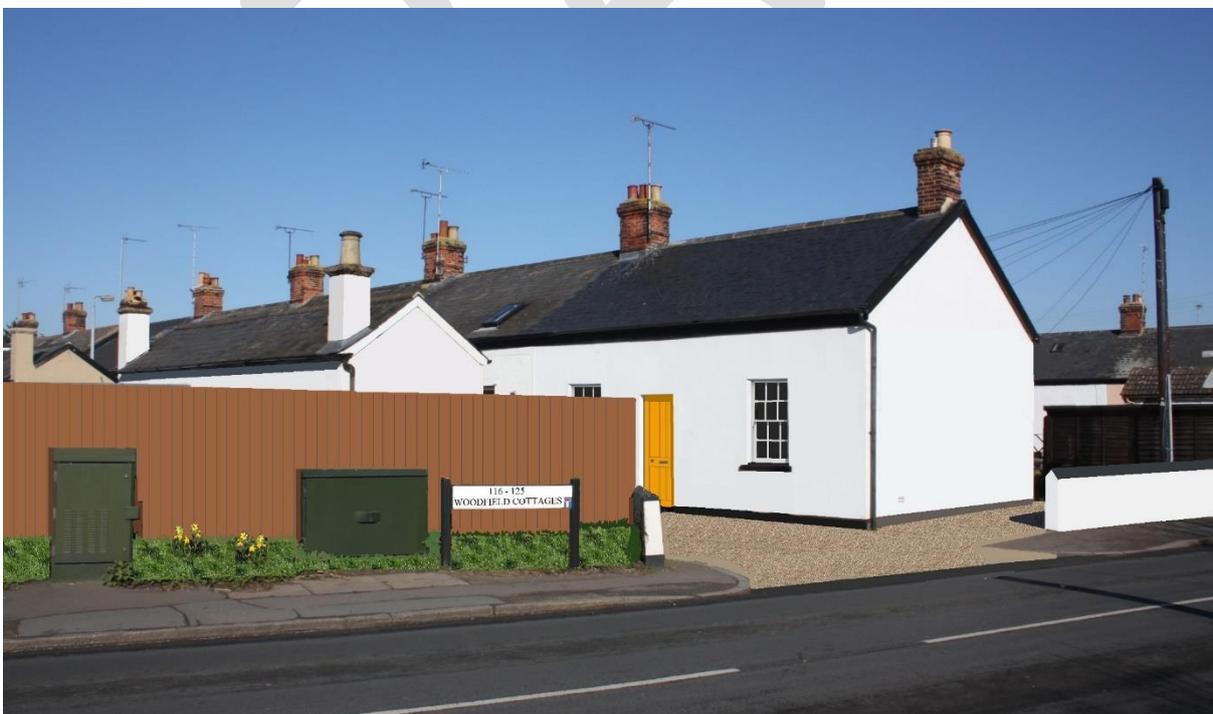
*A mock-up from the conservation area appraisal illustrating opportunities for enhancement at the entrance to the south row of Woodfield Cottages, including a replacement fence, reinstated low boundary wall and new sash windows and front door to No. 116.*

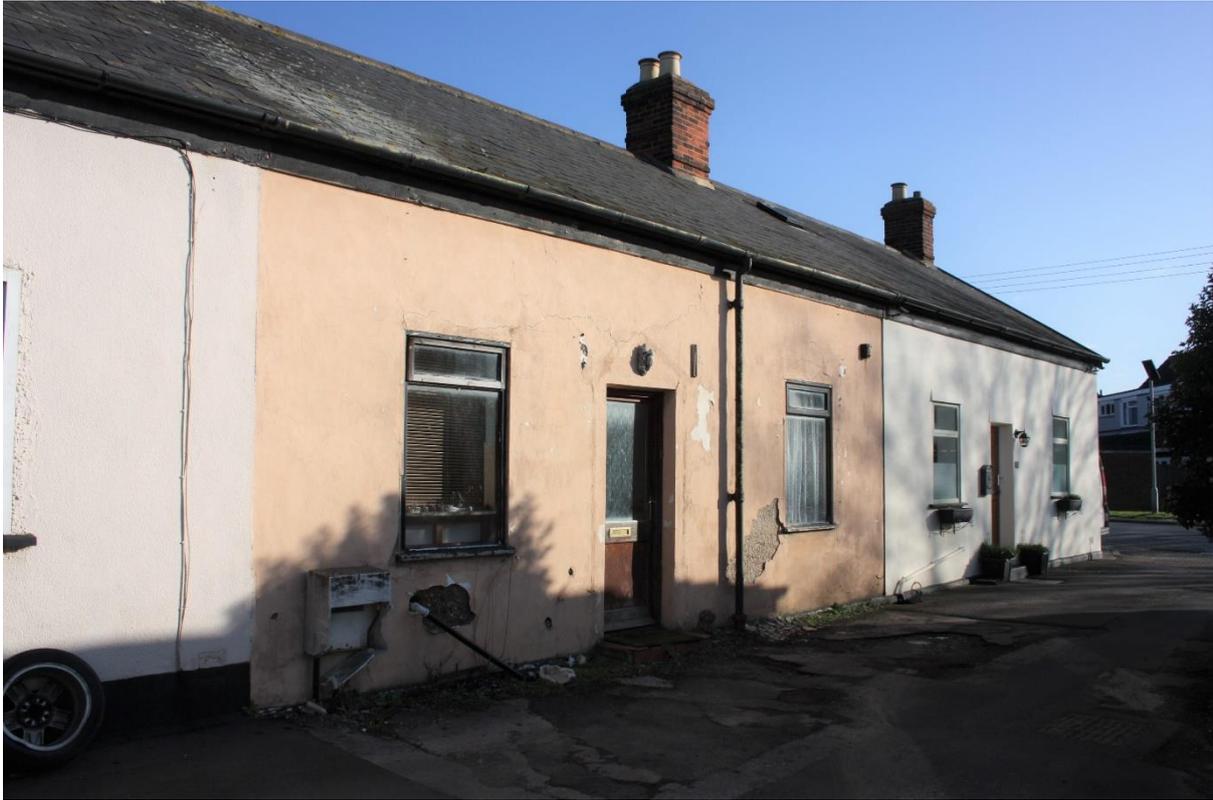
*Photograph taken 11<sup>th</sup> of February 2020*

Condition: **Poor** – Blocked gutters, slipped roof slates, render falling off

Summary: This property is redundant and has not been actively maintained for some time. Following the threat by Maldon District Council of an Urgent Works Notice, the owner has instructed a builder to make repairs to the roof and guttering. The urgent works are limited to the minimum necessary to make the buildings on the property weathertight and safe. There are other issues at the property which will need to be addressed in due course including the poor condition of the shared access lane in front of the cottage, the overgrown garden and generally unkempt appearance of the buildings, all of which is having an adverse effect on the amenity of the area.

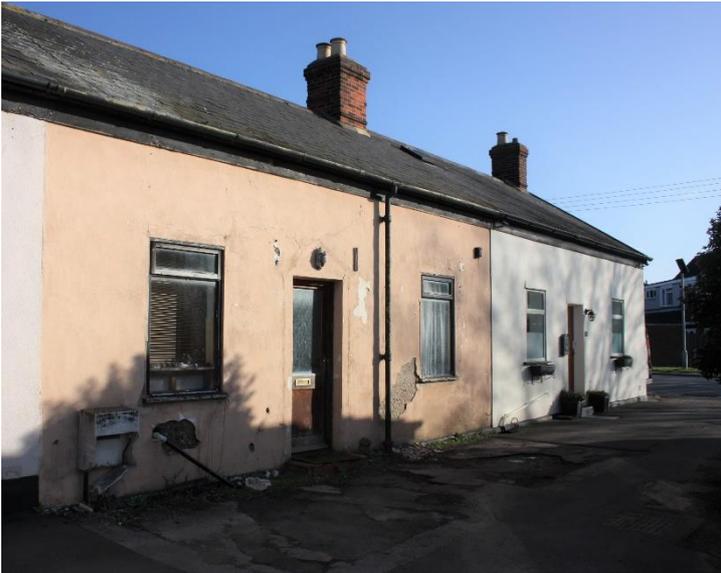
*A photograph of Nos 127 and 126 taken February 2020. No. 127 and the section of access lane in front of it is in an increasingly poor state of repair.*

*A mock-up showing how Nos 127 and 126 could be refurbished with sash windows, four-panel doors, and a resin-bonded-shingle surface to the lane.*

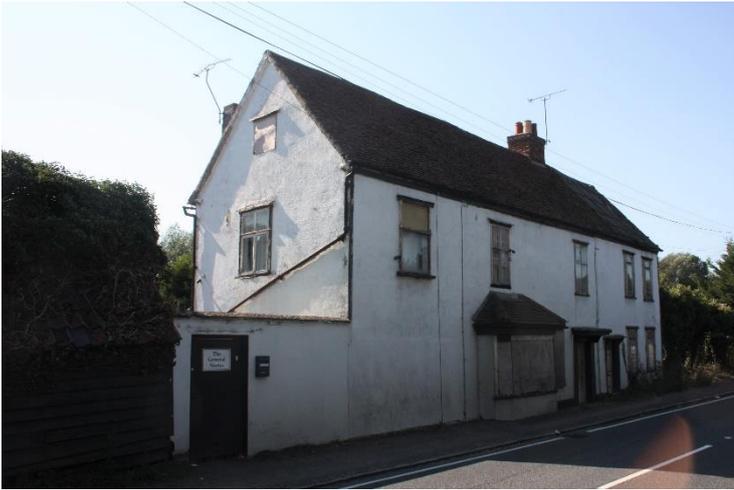
Photograph taken 14<sup>th</sup> September 2020

Designation:	Listed grade II and within the Langford Conservation Area
Priority:	<b>D</b> – Severely decayed windows and doors, temporary repair to roof. Solution agreed but not yet implemented
Condition:	<b>Fair</b> – The building, which is now two properties, is structurally sound but lacks maintenance and redecoration. A temporary emergency repair carried out to the roof in 2015 is now defective. The front wall received a coat of white paint in 2018 but the windows remain in an extremely poor condition. The building is an eyesore in the conservation area. The General Stores is currently occupied but Homestead is vacant.
Date registered:	2017
Ownership:	Private
For Sale:	No
Summary:	The list description dates the house to the 18 <sup>th</sup> century, but it actually incorporates the remains of a small late-medieval hall house. Listed building consent was granted in late 2016 to refurbish the building, including replacement windows and re-tiling the roof. The owners have been in ongoing dialogue with the Council's enforcement team and the Conservation and Heritage Specialist. At the time of writing both properties have recently been sold subject to contract.

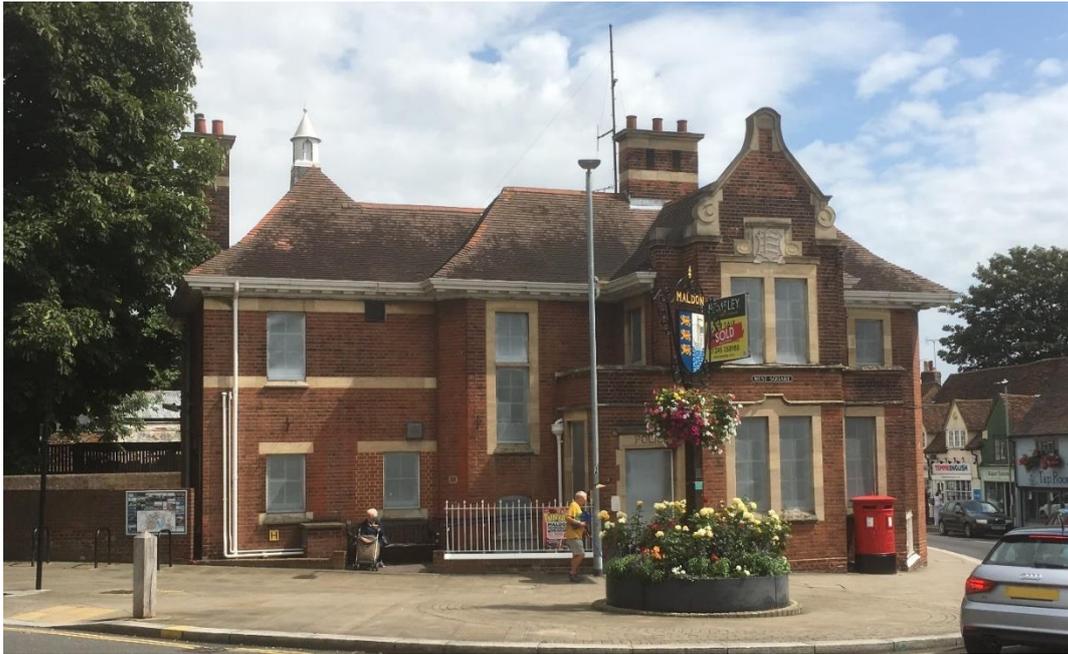
*Photograph taken 1<sup>st</sup> of August 2019*

Designation:	Locally listed building in the Maldon Conservation Area
Priority:	<b>E</b> - Fair condition, but no user identified
Condition:	<b>Fair</b> - Structurally sound but lacking general maintenance.
Date registered:	2022
Ownership:	Private
For Sale:	Yes, at the time of writing (November 2021).
Summary	This police station was built in 1913 to designs by the County Architect F. Whitmore. The building has considerable local interest as a well-preserved early-20th-century police station of very good architectural quality. It is an important building, occupying a prominent position at an entrance to the High Street. It has been redundant since July 2017. A planning application to convert the building into five apartments was dismissed at appeal in 2021 (Maldon ref. FUL/MAL/20/00270) due to the permanent loss of the building as a place of employment or as a community use. The design of the scheme was deemed acceptable in terms of its impact on the locally listed building and character of the conservation area. The building is being marketed for sale at the time of writing (November 2021).

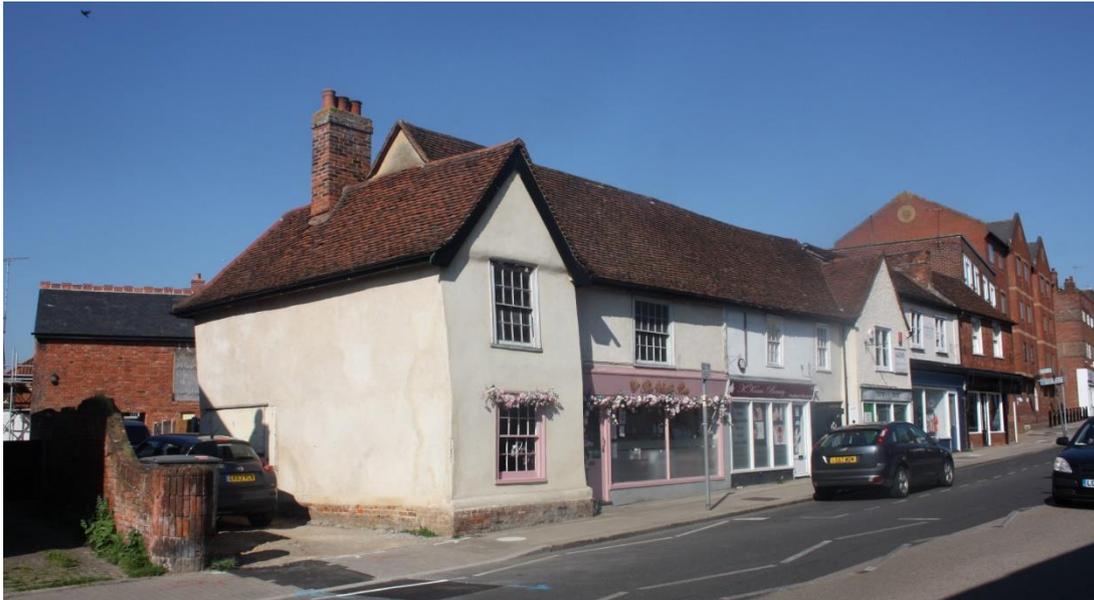
*Photograph taken 1<sup>st</sup> June 2021*

Designation:	Listed grade II and within the Maldon Conservation Area		
Priority:	<b>C</b> - Slow deterioration. No solution agreed.		
Condition:	<b>Poor</b> - The first-floor windows, render and parts of the timber-framed structure require repair. Otherwise the building is wind and weathertight.		
Date registered:	1986		
Ownership:	Private	For Sale:	No
Summary:	<p>This medieval and later timber-framed building has a long planning and enforcement history. Most of the ground-floor rooms have been refurbished and are in use, but the first-floor rooms remain derelict and in a poor condition. In response to concerns raised by the Conservation and Heritage Specialist in 2018, the trustees which own the building made repairs to failing areas of lime render. The render – which needs a limewash finish – has since developed further cracks with small areas having fallen off the building. The rear corner of the building is currently propped internally by ‘strongboys’ due to timber decay in this area. A concrete slab incorporating a drainage gully and manhole has recently been cast adjacent to the base of the rear gable wall. The cast-iron rainwater pipe above has broken away, allowing stormwater to discharge directly against the face of the wall and into the surrounding ground. In 2021 an application to replace a Georgian sash window with studwork was refused due to lack of structural justification and the harm it would cause to the building’s significance (ref. LBC/MAL/21/00200).</p>

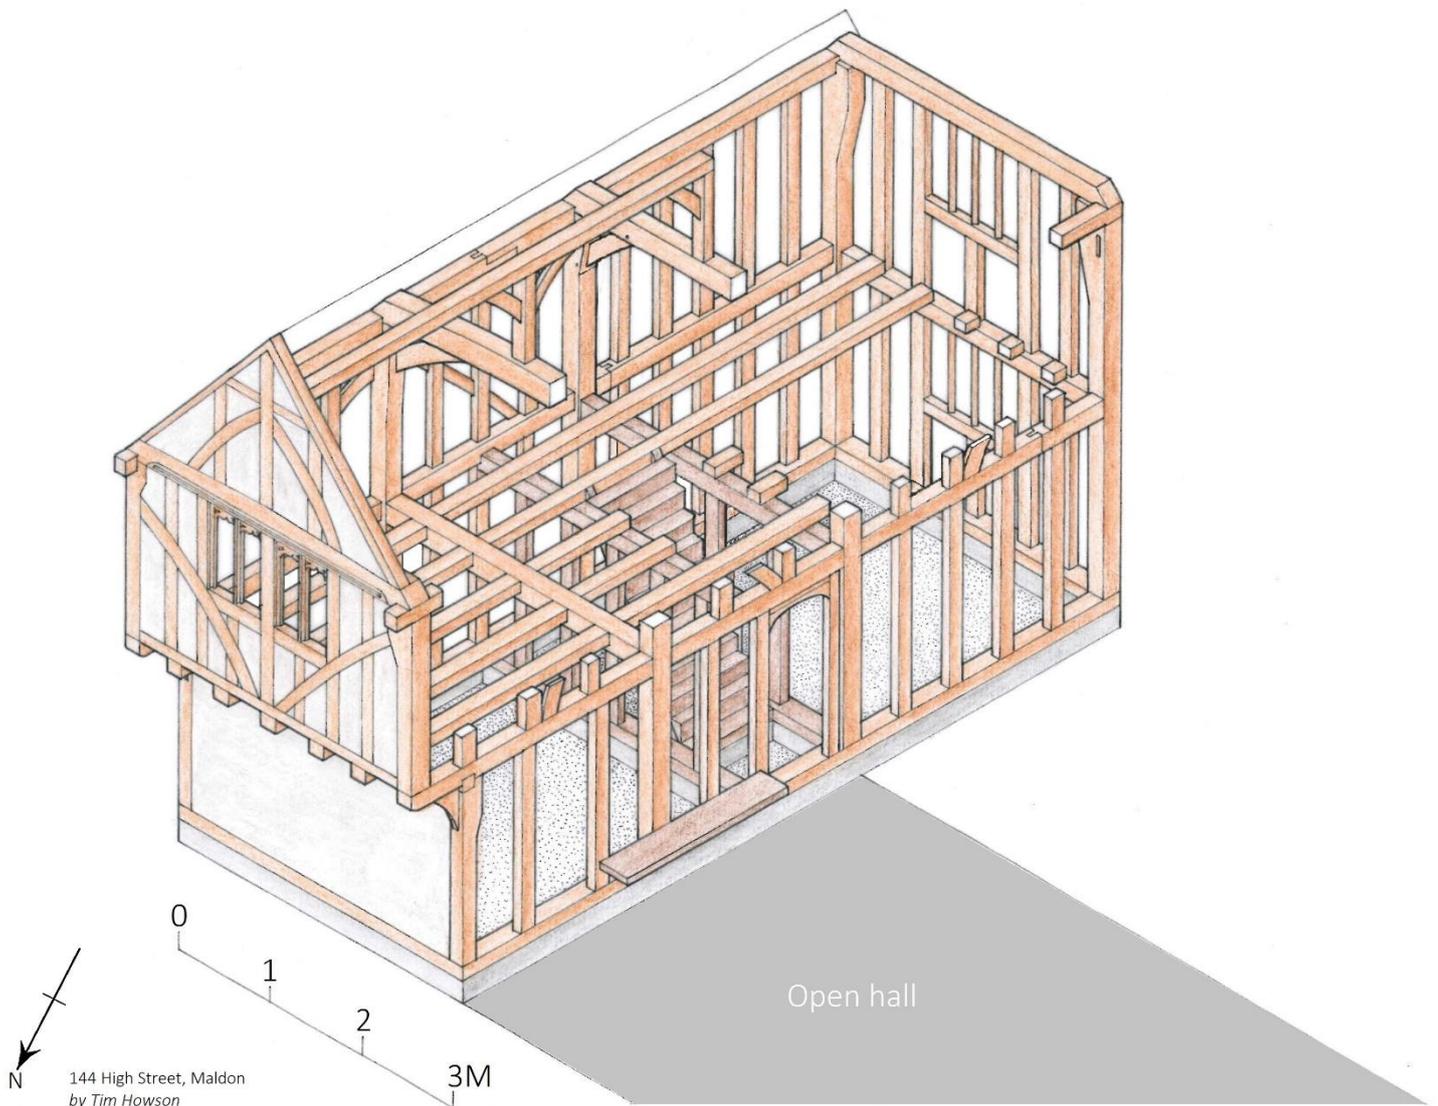
*A cutaway isometric drawing by Tim Howson of the cross-wing at 144 and 144A High Street, showing aspects of its original design insofar as they can be deduced from evidence in the building*

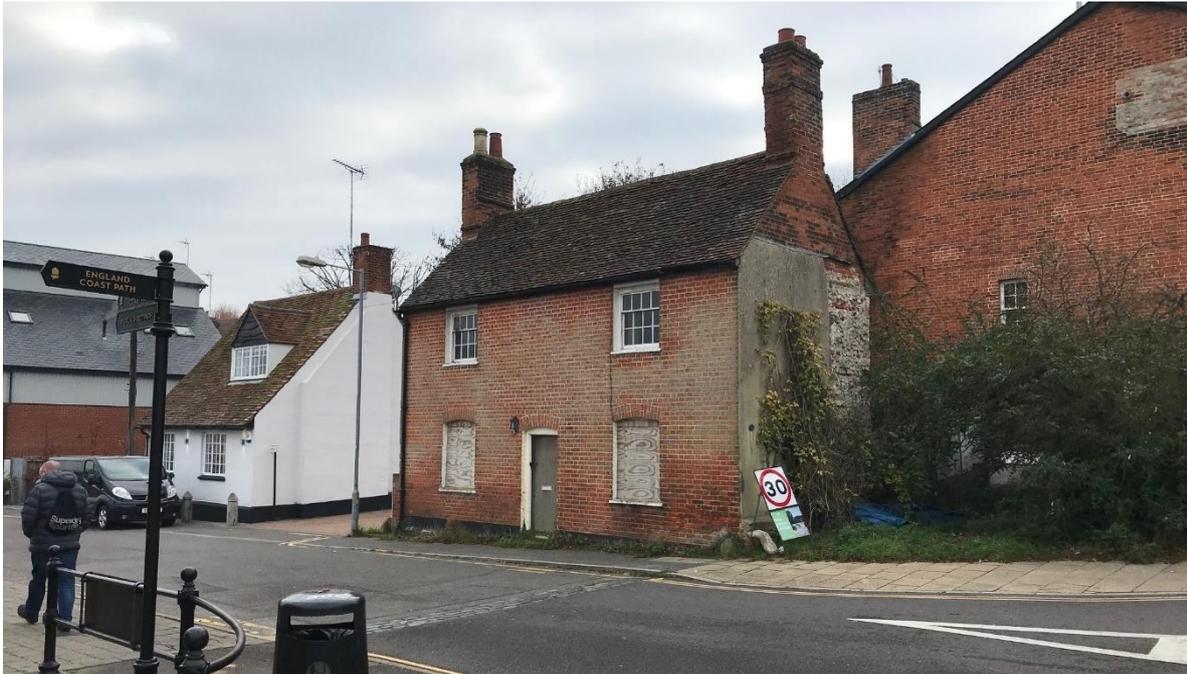
*Photograph taken 24<sup>th</sup> November 2021*

Designation:	Listed grade II and within the Maldon Conservation Area
Priority:	<b>E</b> – Seemingly in fair condition, but it has been vacant for over a decade with no indication that will be put back into use soon
Condition:	<b>Fair</b> – Apparently structurally sound and weathertight but lacking active maintenance. The boarded-up windows and scruffy site detract from the character of the listed building and the conservation area.
Date registered:	2022
Ownership:	Private
For Sale:	No
Summary:	This mid-19th-century house has been vacant for many years now. In 2005 listed building consent was granted for an additional dwelling on the site, but planning permission for the same scheme was refused due to lack of adequate parking provision. In 2008 Maldon District Council served an Urgent Works Notice requiring the then owner to repair a hole in the roof. The owner failed to comply, so the Council undertook the repair work itself and reclaimed the expense from the owner. In 2016 the Council's Conservation and Heritage Specialist held a site meeting with the current owner, providing advice on the options available, in an effort to encourage them to put the building back into use. The owner has no immediate plans to complete refurbishment of the building (as per telephone conversation 23/11/2021). The front gutter has broken and the site is becoming increasingly overgrown.

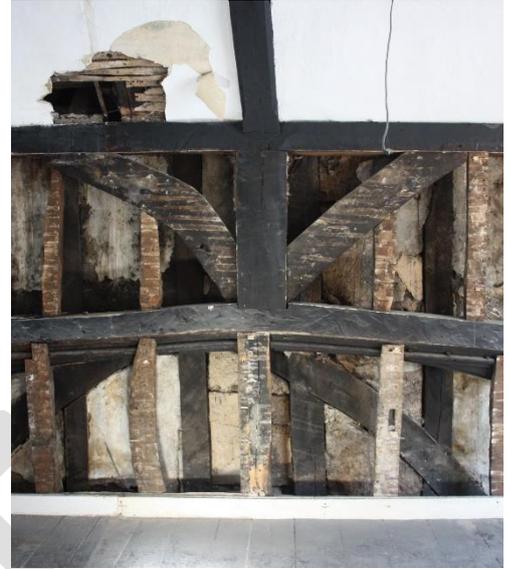
Photograph of medieval timber framing and wattle and daub taken 6<sup>th</sup> of November 2020

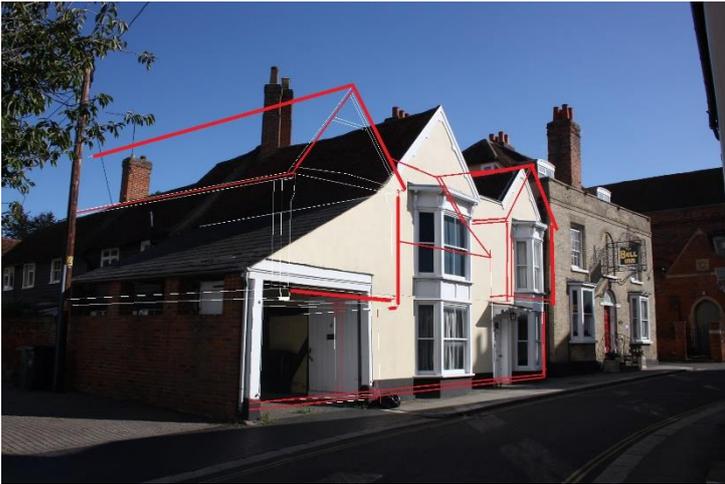
Designation:	Grade II* listed and within the Maldon Conservation Area
Priority:	<b>C</b> - Slow decay. No solution agreed.
Condition:	<b>Poor</b> – The building has been vacant for several years. Investigation in 2020 uncovered extensive timber decay. Long-term leaks to the roof valley were discovered but urgent roof repairs undertaken by the current owner appear to have resolved the issue. The interior remains very damp. The building requires considerable investment to repair and refurbish it.
Date registered:	2022
Ownership:	Private
For Sale:	No
Summary:	This house was recently discovered to date from c.1400, retaining many important early architectural features. It is one of the oldest and most valuable historic houses in the town. Listed building consent for refurbishment was refused in June 2021 due to concerns around certain aspects of the scheme. A revised scheme, amended to overcome the reasons for refusal, is awaiting determination at the time of writing (November 2021).

*A photograph of 4 Silver Street in June 2020 with the form of the medieval house sketched over it in red*

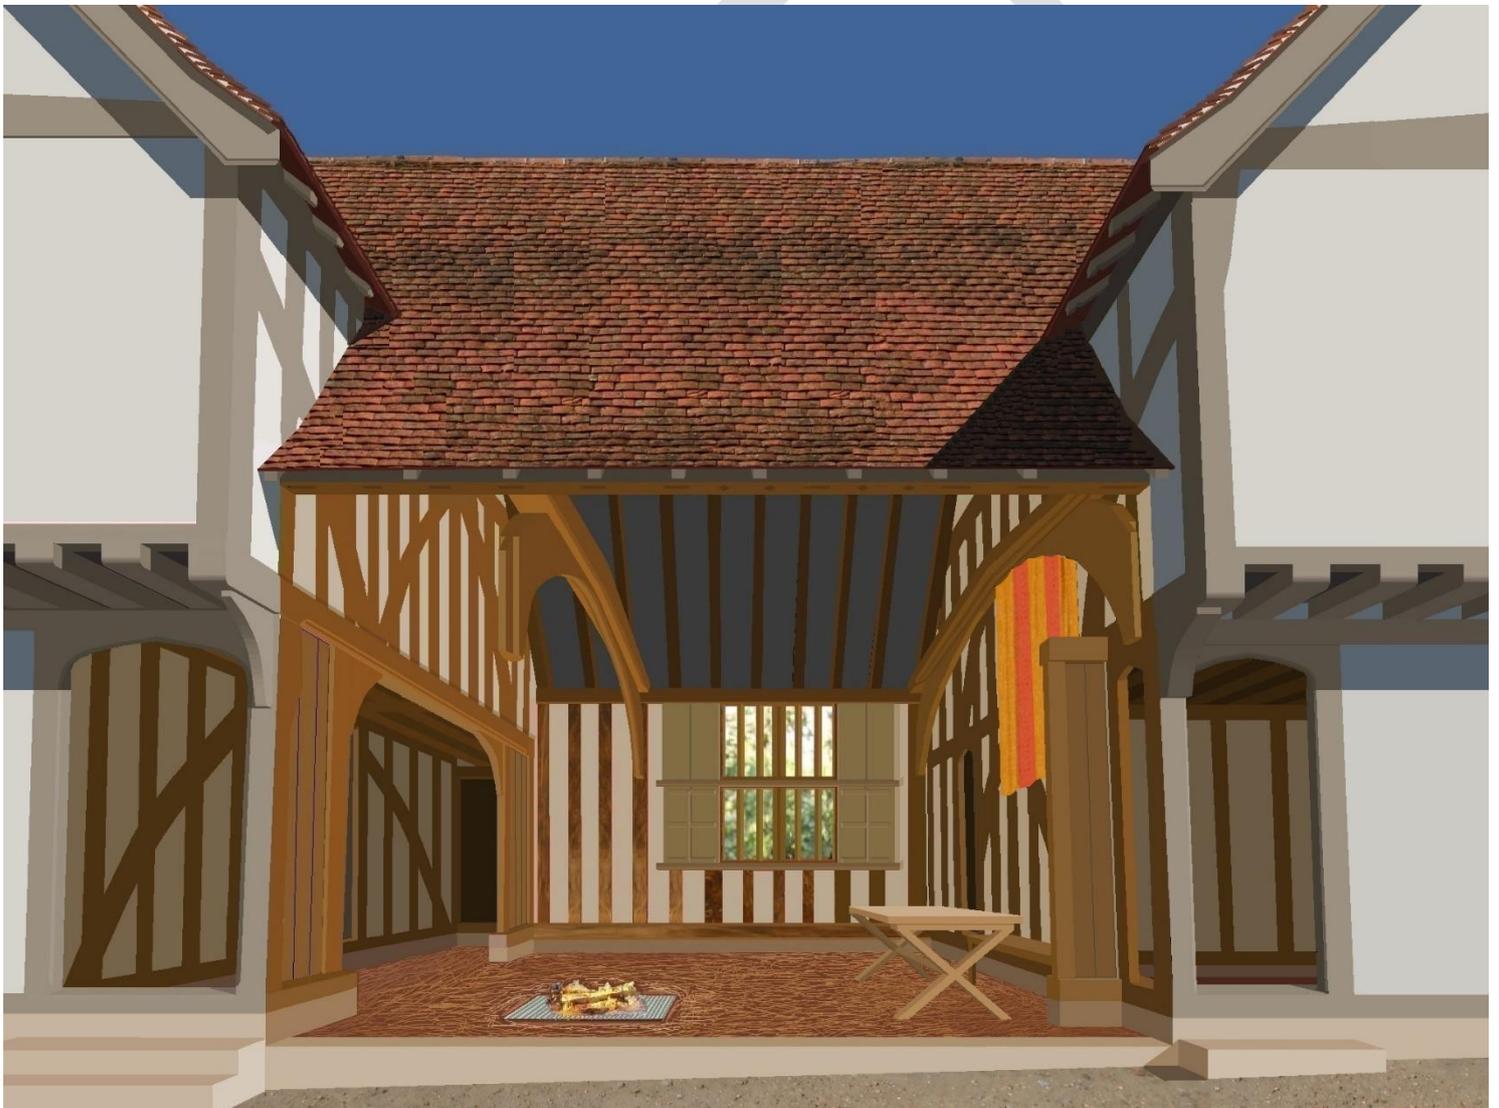
*A cutaway reconstruction drawing of 4 Silver Street showing the interior of the open hall in the medieval period. The base of the original hearth was discovered in 2020 as well as fixings for a fabric wall hanging.*

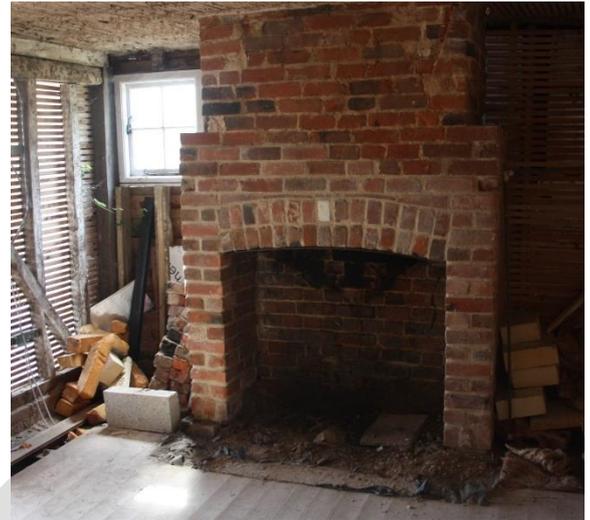
Interior showing the recently restored fireplace and new laths awaiting lime plaster. 10<sup>th</sup> of August 2021

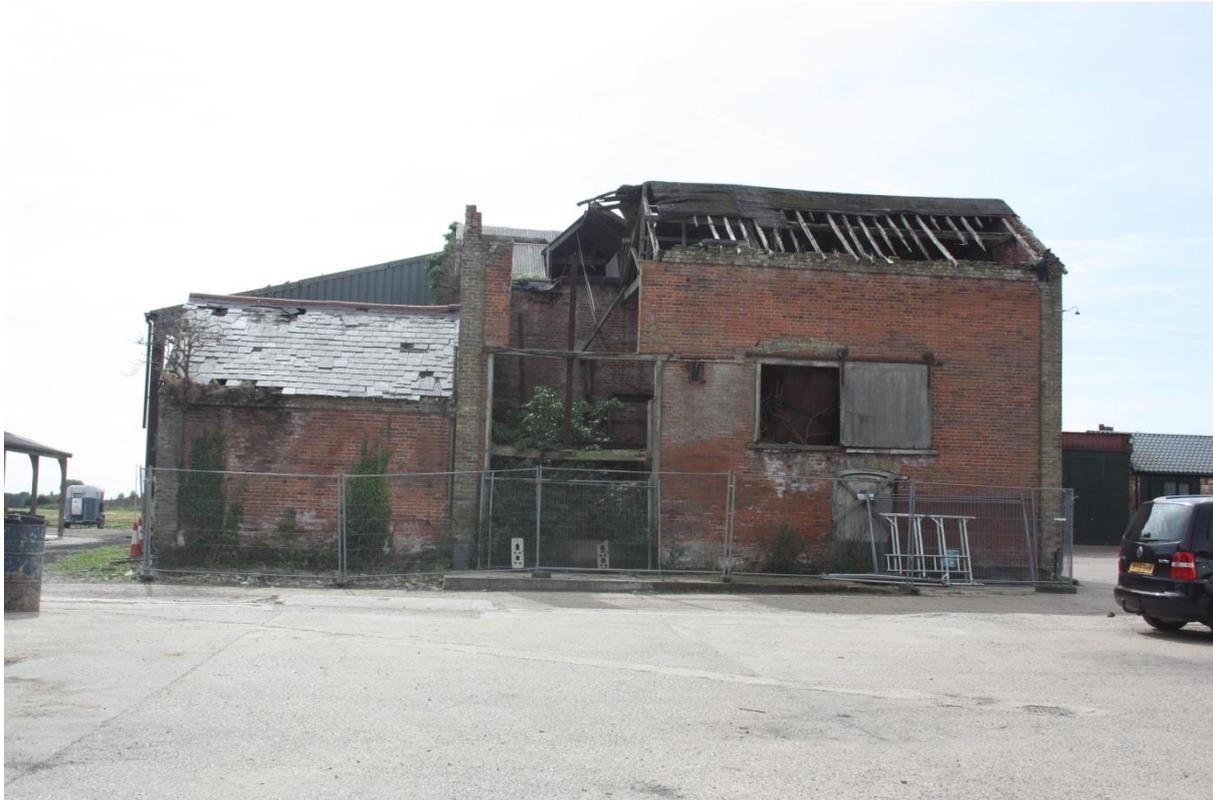
*Photograph taken 10<sup>th</sup> of September 2018*

Designation:	Grade II listed
Priority:	<b>C</b> - Slow decay. No solution agreed.
Condition:	<b>Very bad</b> - Many years ago the main roofs were covered by a form of felt, which quickly failed and led to the deterioration of the timber structure.
Date registered:	2004
Ownership:	Private
For Sale:	No
Summary:	This redundant late-19 <sup>th</sup> -century brick-built grain drying unit is situated in the middle of a working farmyard. Over the past decade, there have been various efforts to find a new viable use for the building. A feasibility study was prepared by the Mid Essex Historic Buildings Trust, with financial assistance from Maldon District Council and input from students on the MSc Building Conservation Course at Anglia Ruskin University. A report by the structural engineer Edward Morton in 2013 found that, due to extensive decay, little if any of the original roof or floor structures would be salvageable.

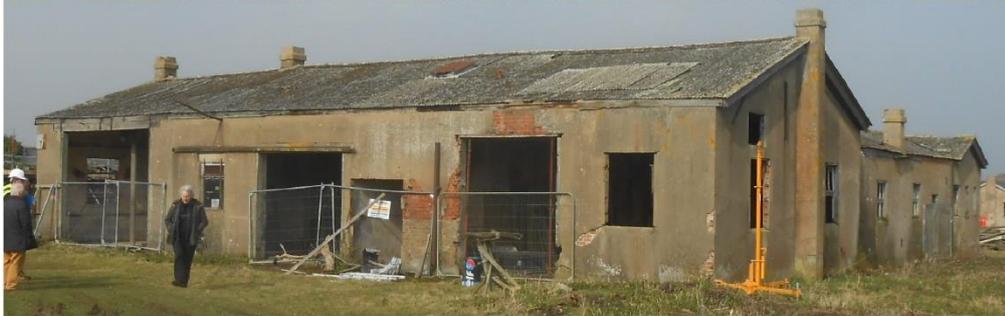
Designation:	Grade II* listed and in the Stow Maries Aerodrome Conservation Area.
Priority:	<b>C</b> - Slow decay. No solution agreed.
Condition:	<b>Very bad</b> – Following collapse of the roof structure the end walls have been shored up.
Date registered:	2012
Ownership:	Private
For Sale:	No
Summary:	One of twenty-four original buildings remaining at Stow Maries World War One Aerodrome. Following collapse, the materials were recorded and the salvageable timber trusses put into storage. It is the long-term aim of the Aerodrome Trust to reconstruct the building.

*The south elevation of the Officers' Mess in March 2016*

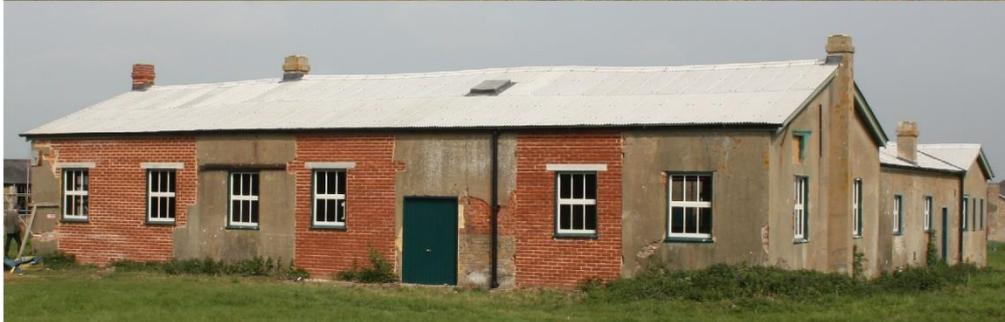
*The south elevation of the Officers' Mess on 1<sup>st</sup> May 2019*

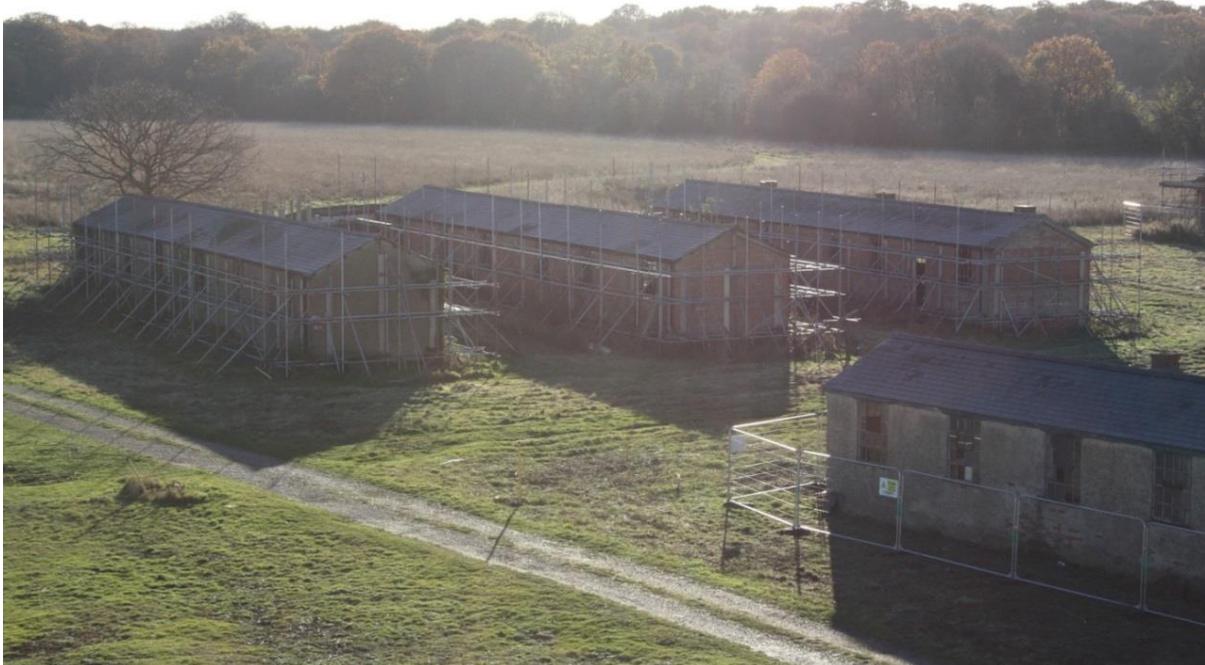
*Photograph taken 29<sup>th</sup> of November 2016*

Designation:	Grade II* listed and in the Stow Maries Aerodrome Conservation Area.
Priority:	<b>E</b> – Major repairs to the roof, walls windows and rainwater goods completed in recent years with grant assistance from Historic England. The building is in sound condition but requires considerable internal renovation to put it back into use.
Condition:	<b>Fair</b> – Grant funding from Historic England and WREN has recently enabled the repair of the roof, and the reinstatement of windows
Date registered:	2012
Ownership:	Private
For Sale:	No
Summary:	This E-shaped complex is the largest original building to survive at Stow Maries World War One Aerodrome. Only two other Royal Flying Corps Officers' Messes are listed in this country. The interior is remarkably unaltered with a good survival of internal fixtures and fittings.

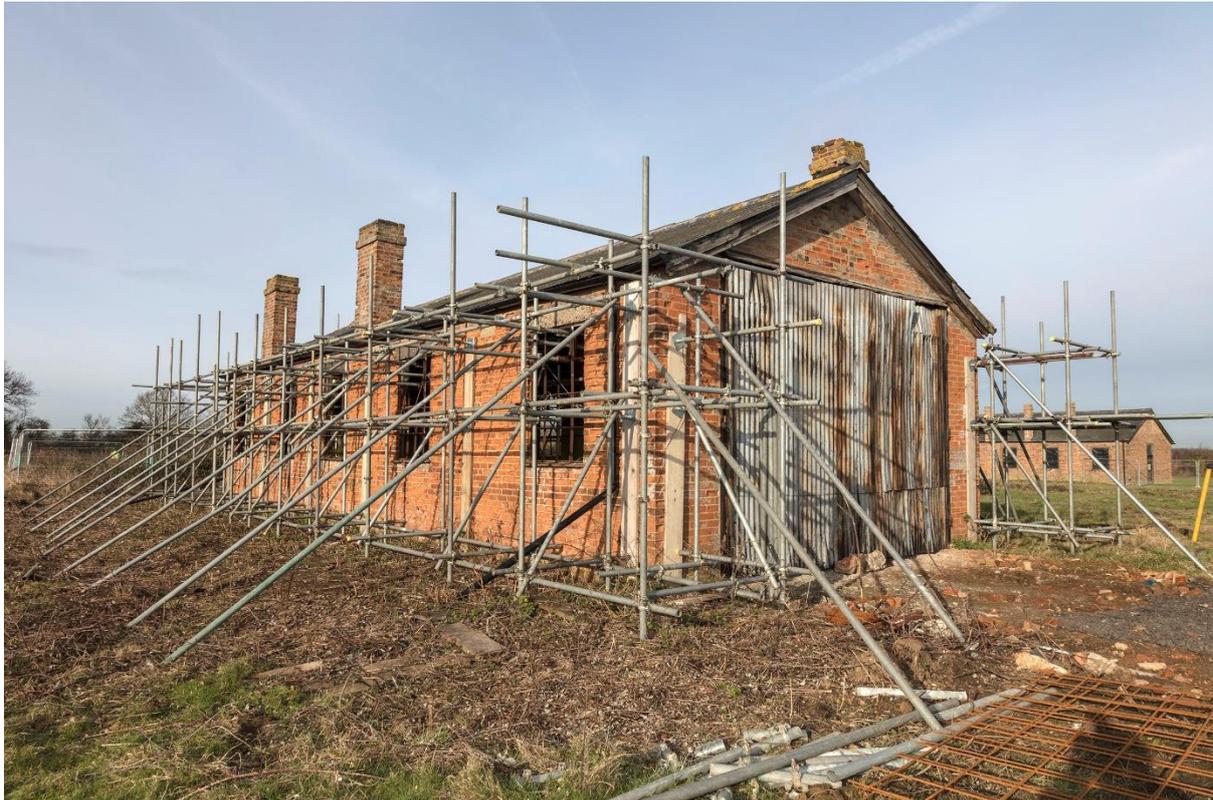
*Photograph taken January 2019*

- Designation:** Grade II\* and in the Stow Maries Aerodrome Conservation Area.
- Priority:** **E** – In recent years steelwork has been introduced to stabilise the walls of these buildings, thereby addressing the imminent risk of collapse.
- Condition:** **Poor** – Although now structurally stable, the windows and doors are all in extremely poor condition and the buildings require significant further investment to put them back into use.
- Date registered:** 2012
- Ownership:** Private
- For Sale:** No
- Summary:** Three of the twenty-four original buildings remaining at Stow Maries World War One Aerodrome. Each of the three parallel ranges is connected at the southern end by a block for toilets and washroom which has partially collapsed. Listed building consent was granted in 2018 for stabilisation works which have been completed with grant assistance from Historic England.
