WOODFIELD COTTAGES, HEYBRIDGE

CONSERVATION AREA CHARACTER STATEMENT

This document was produced by Maldon District Council.

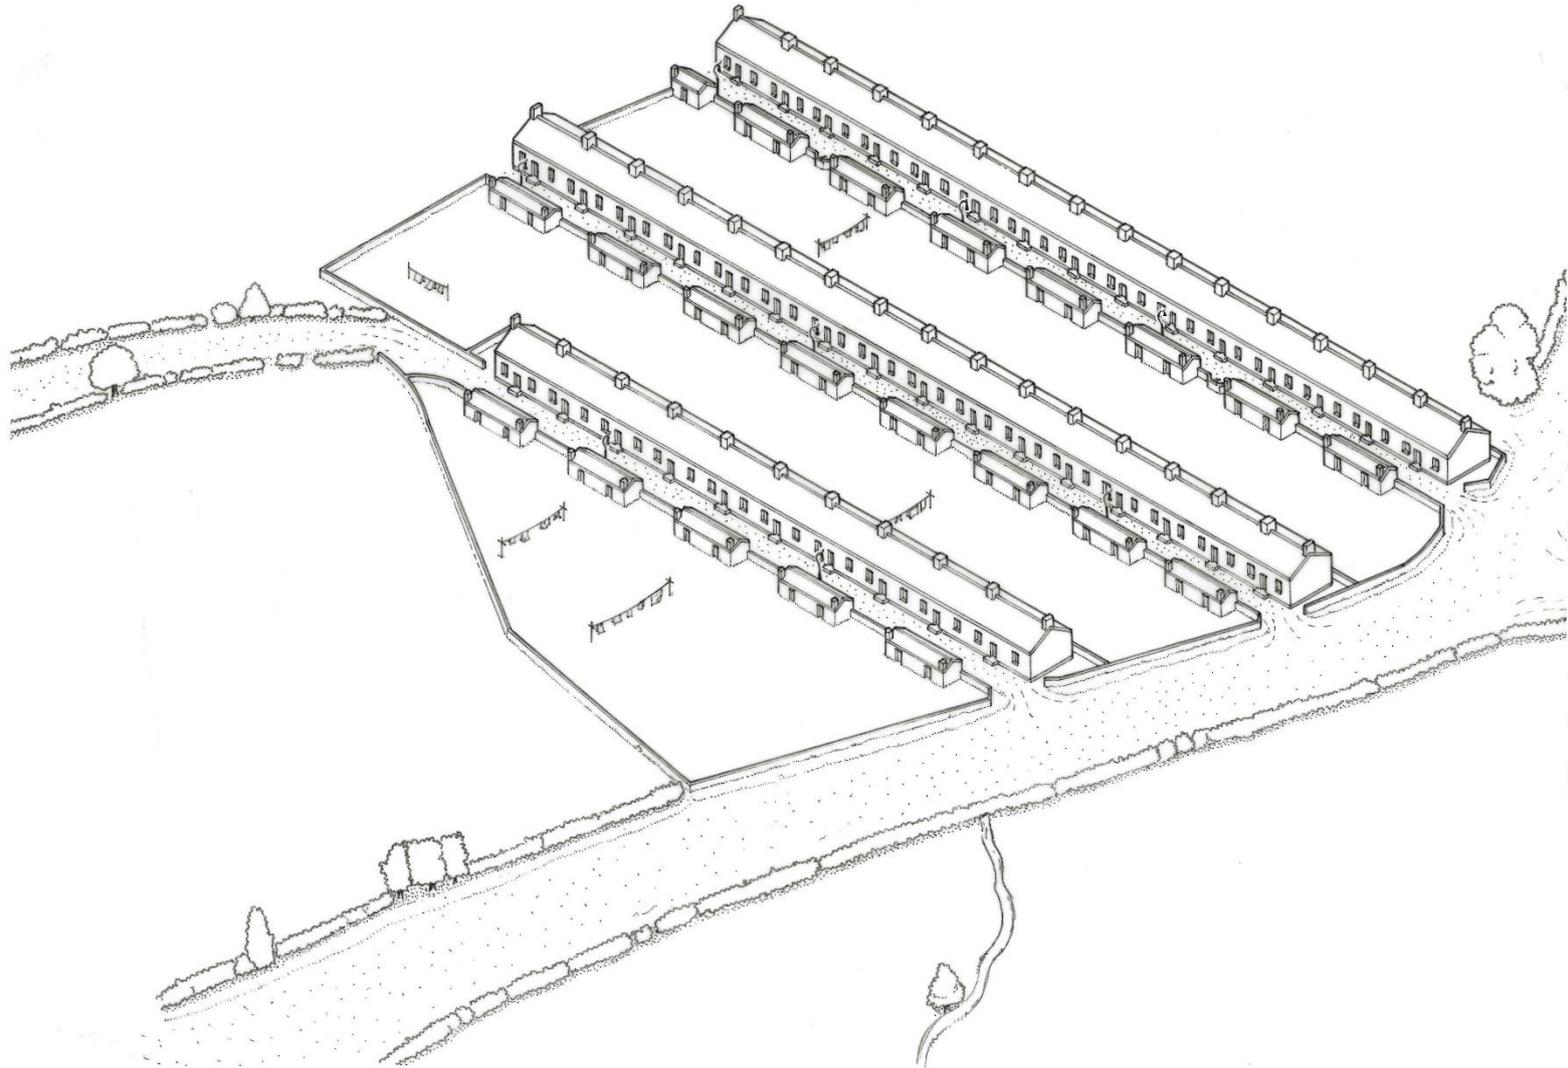
Fig 1: *Isometric reconstruction of Woodfield Cottages c. 1920*

Low concrete walls originally lined the outer boundaries of the settlement and separated the gardens from the access lanes (Fig. 1). Most of the walls have been replaced by fences or removed to make space for car parking. Sections of concrete wall survive at the eastern entrances to the lanes, along the south side of the garden to the west of No. 125, and on the north and west boundary of the garden to No. 156 (Figs 36 and 37).

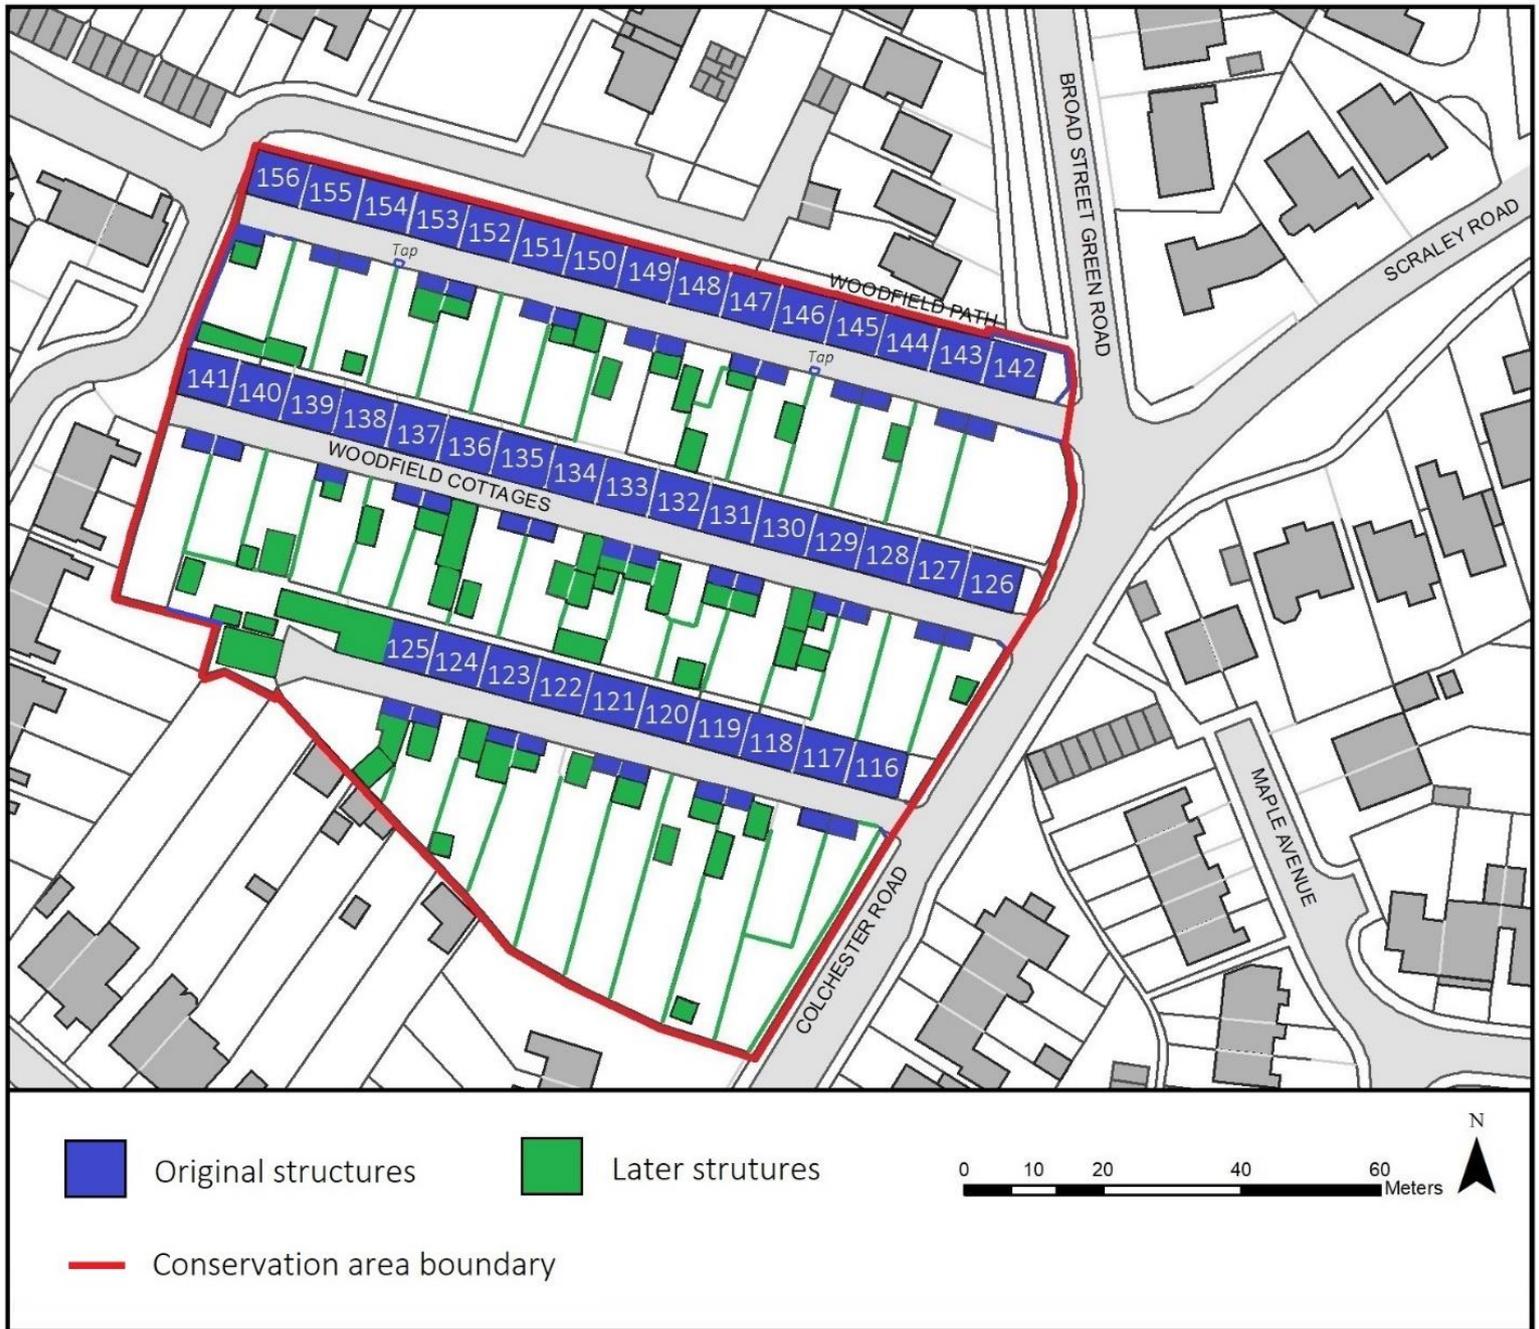
Fig 2: Map of proposed conservation area highlighting original and later structures

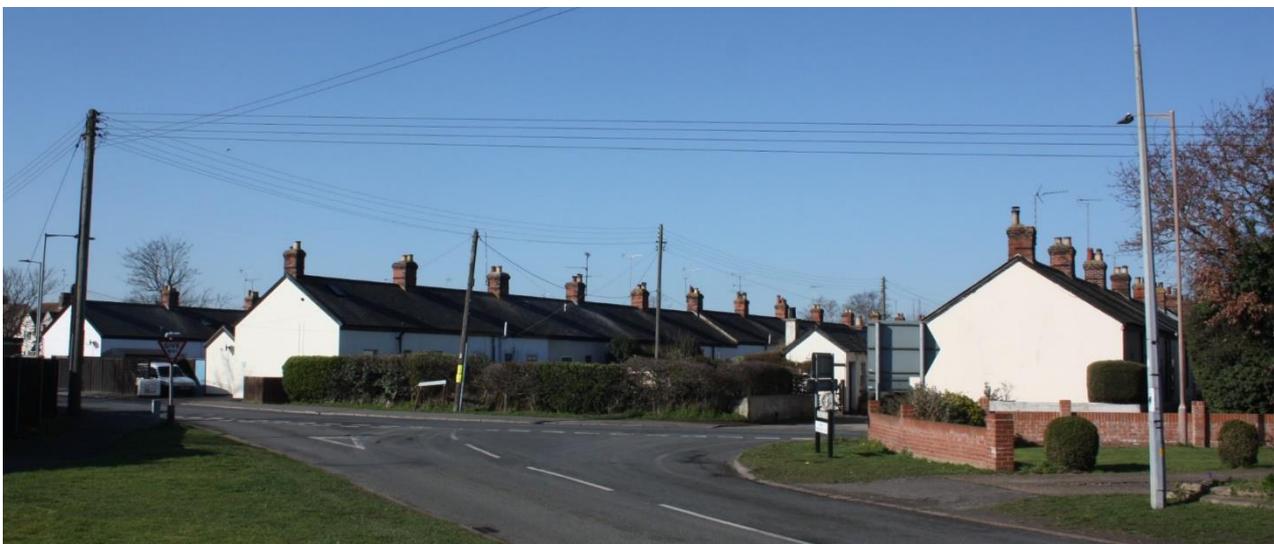
Fig. 3 - A photograph of Woodfield Cottages taken from Scraley Road in March 2021

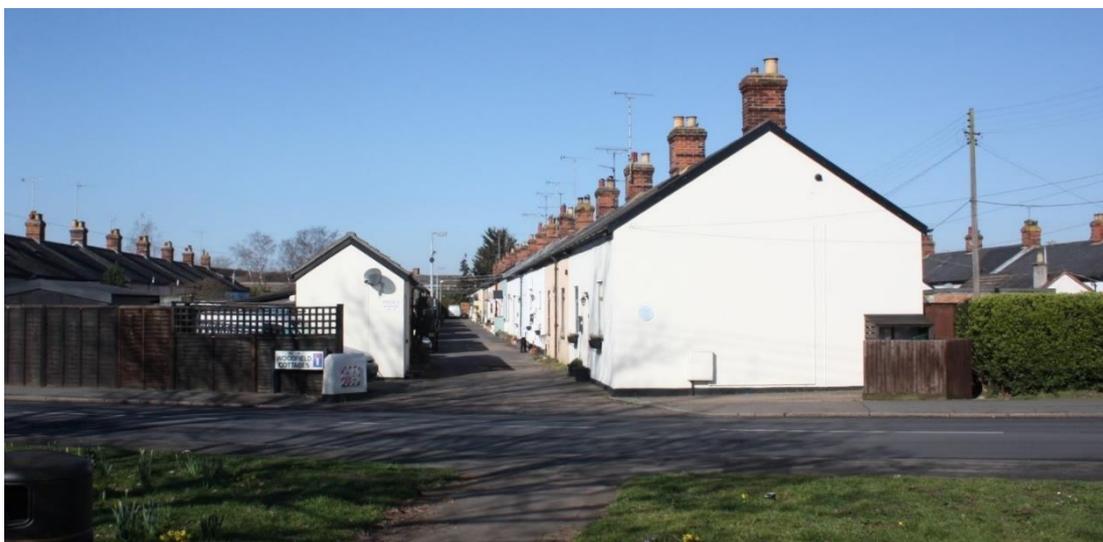
Fig. 4 - A photograph of the middle row of Woodfield Cottages taken from Colchester Road in March 2021

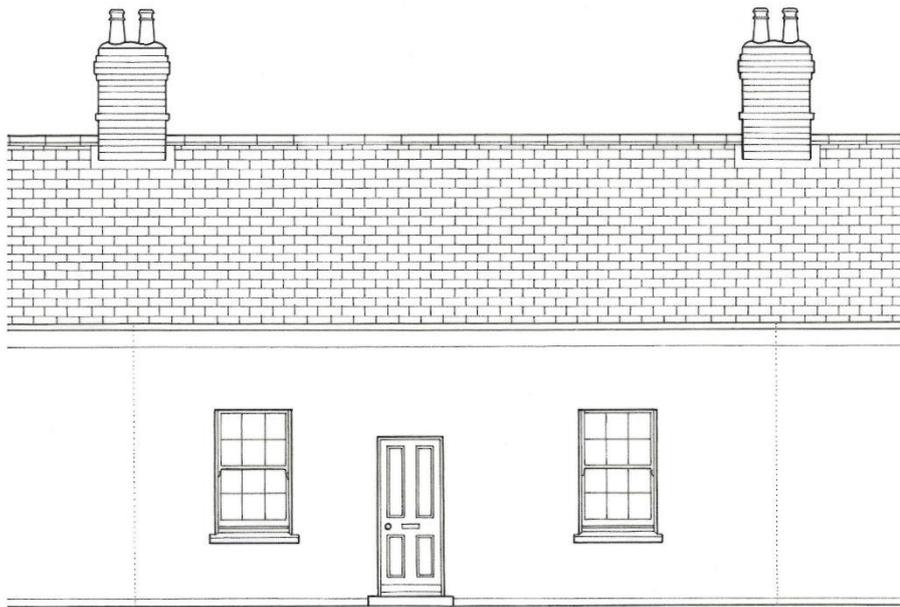
Front elevation

Fig. 10 - Typical front and rear elevations following the addition of pitched roofs, based on a survey of No. 155

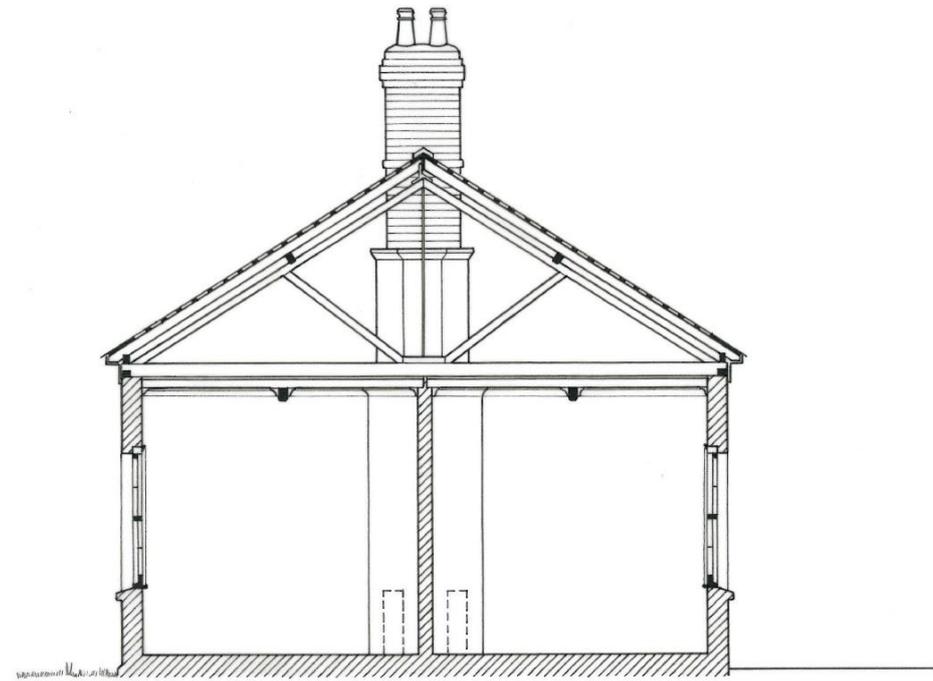
Section through cottage following addition of pitched roof c.1918

Section through a cottage prior to addition of pitched roof

Fig. 11 - Typical sections through a cottage, based on a survey of No. 155

The present pitched roofs were added to the cottages in 1918. Prior to that the cottages had flat roofs; a remarkably early example of flat-roofed construction (Fig. 11). In the attics of the later pitched roofs, the original octagonal concrete chimneys survive with the 1918 red brick chimneys built on top of them (Fig. 12). Interestingly, the original concrete chimneys bear no trace of paint, suggesting that the external face of the cottages may originally have been left bare. Painted finishes may not have been introduced until the 20th century following the addition of the pitched roofs. The roofs most likely had simple parapets with openings in them for guttering, as can be seen on the Lodge to The Towers, which retains its flat roof (Fig. 9). The flat roofs were removed when the pitched roofs were added, but the original ceiling joists remain *in-situ* with lath and plaster ceilings fixed to the underside of them. Scars on the chimneys show where the flat-roof structure joined the chimneys and indicate that the structure (possibly comprising joists finished with asphalt) was only 100mm thick. There are remnants of black tar at the base of some of these chimneys, evidently applied in an attempt to waterproof the roofs. According to Richard Twinn, his Great Grandmother – Harriet Elizabeth Lewis, who lived at No. 141 – would recount how the tar that sealed the roof would drip through into the cottage during hot weather (pers. comm.). She and her family had to move out temporarily while the pitched roofs were added. Initially the loft spaces were undivided, but later in the 20th century party walls were introduced to provide a fire-break and as some of the attics were converted to habitable space.

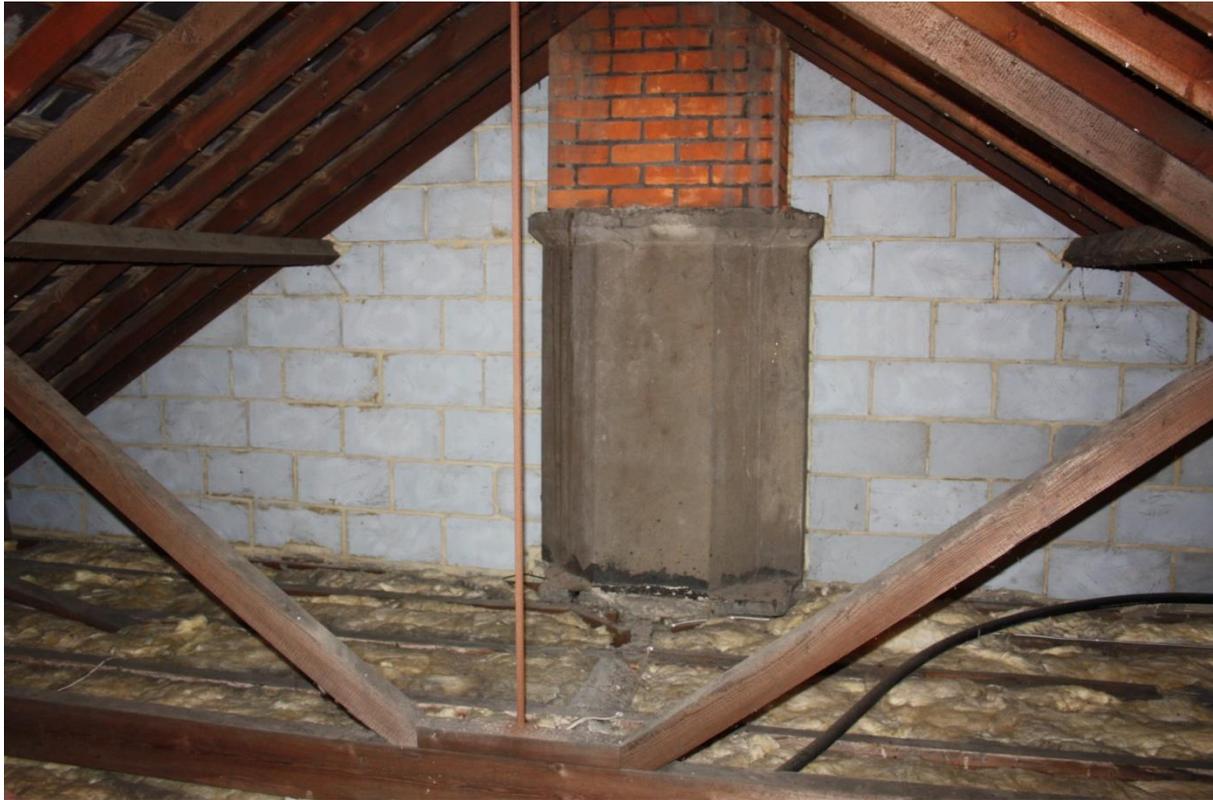
Fig. 12 - A photograph of the inside the attic of No. 155 showing an original concrete chimney

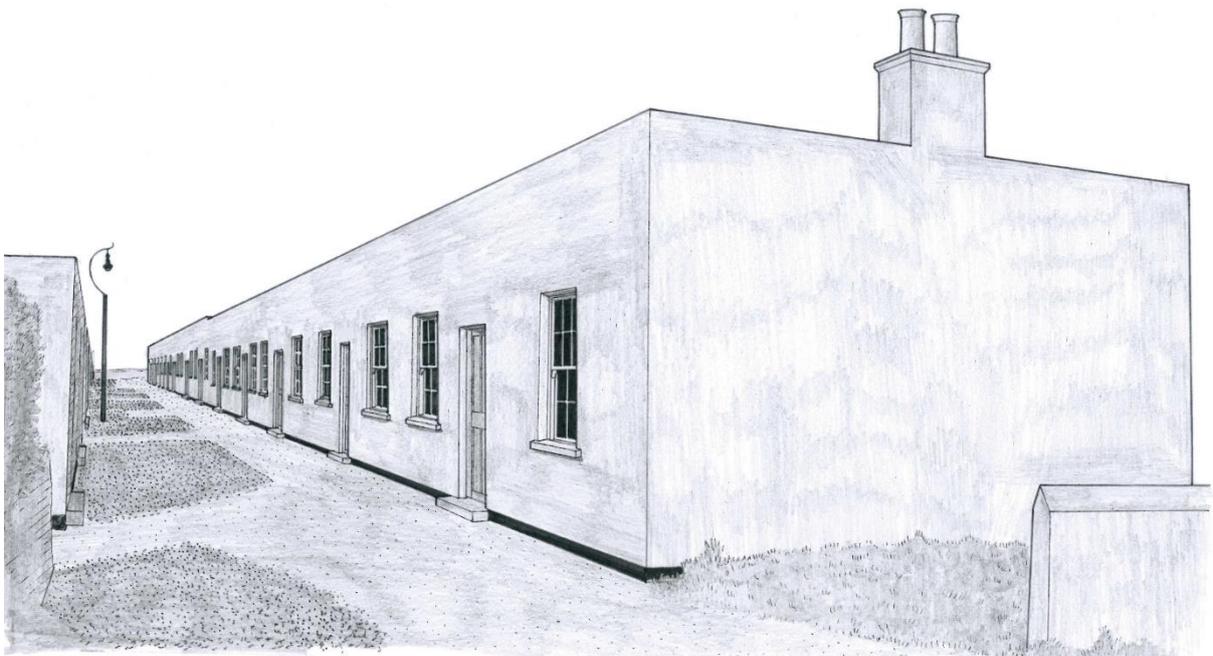
Fig. 13 - A sketch reconstruction of the north row of the Woodfield Cottages as it would have appeared prior to the addition of pitched roofs. From this angle most of the chimneys would have been hidden by the parapet around the roof.

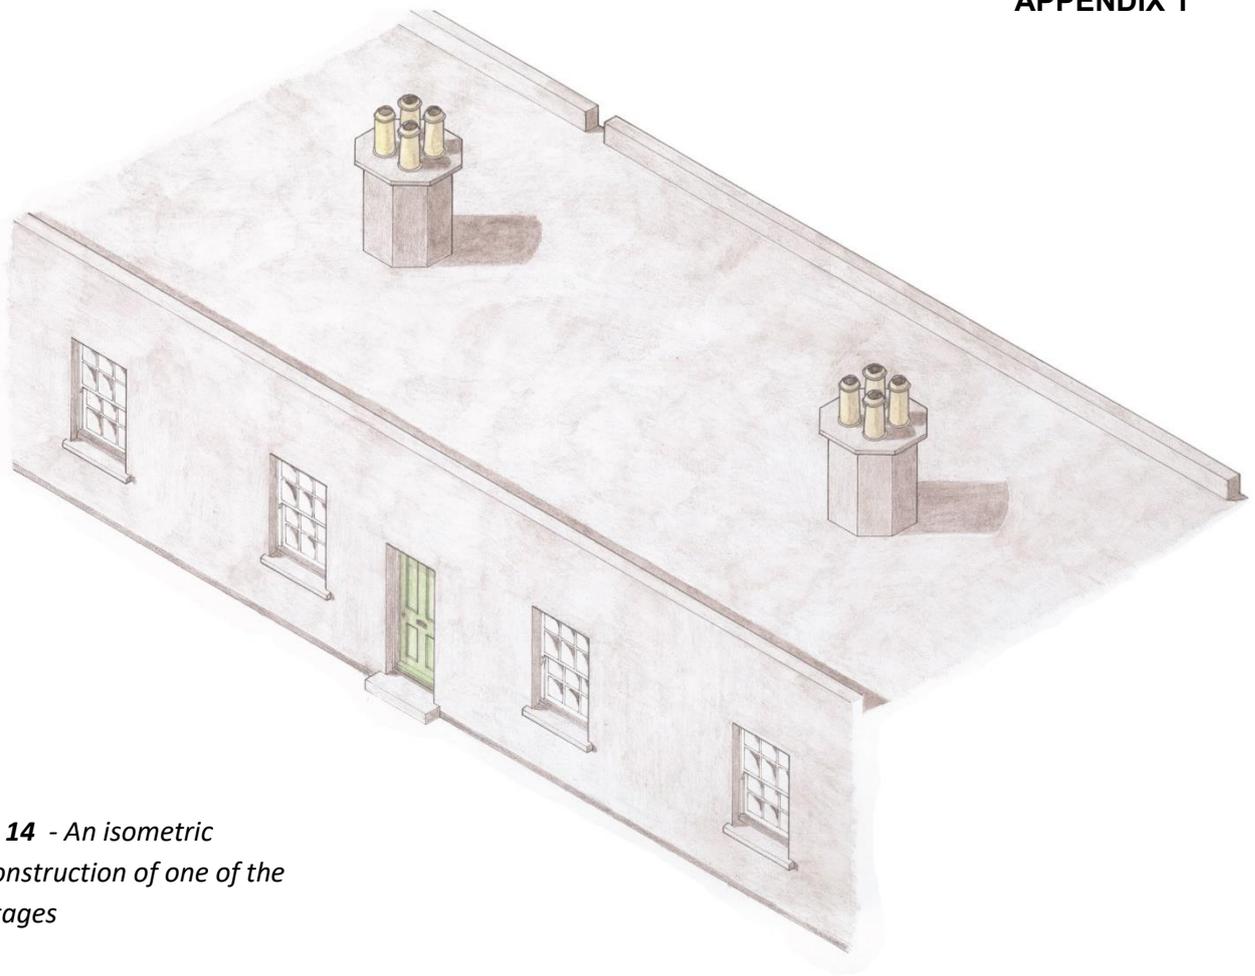
Fig. 14 - An isometric reconstruction of one of the cottages

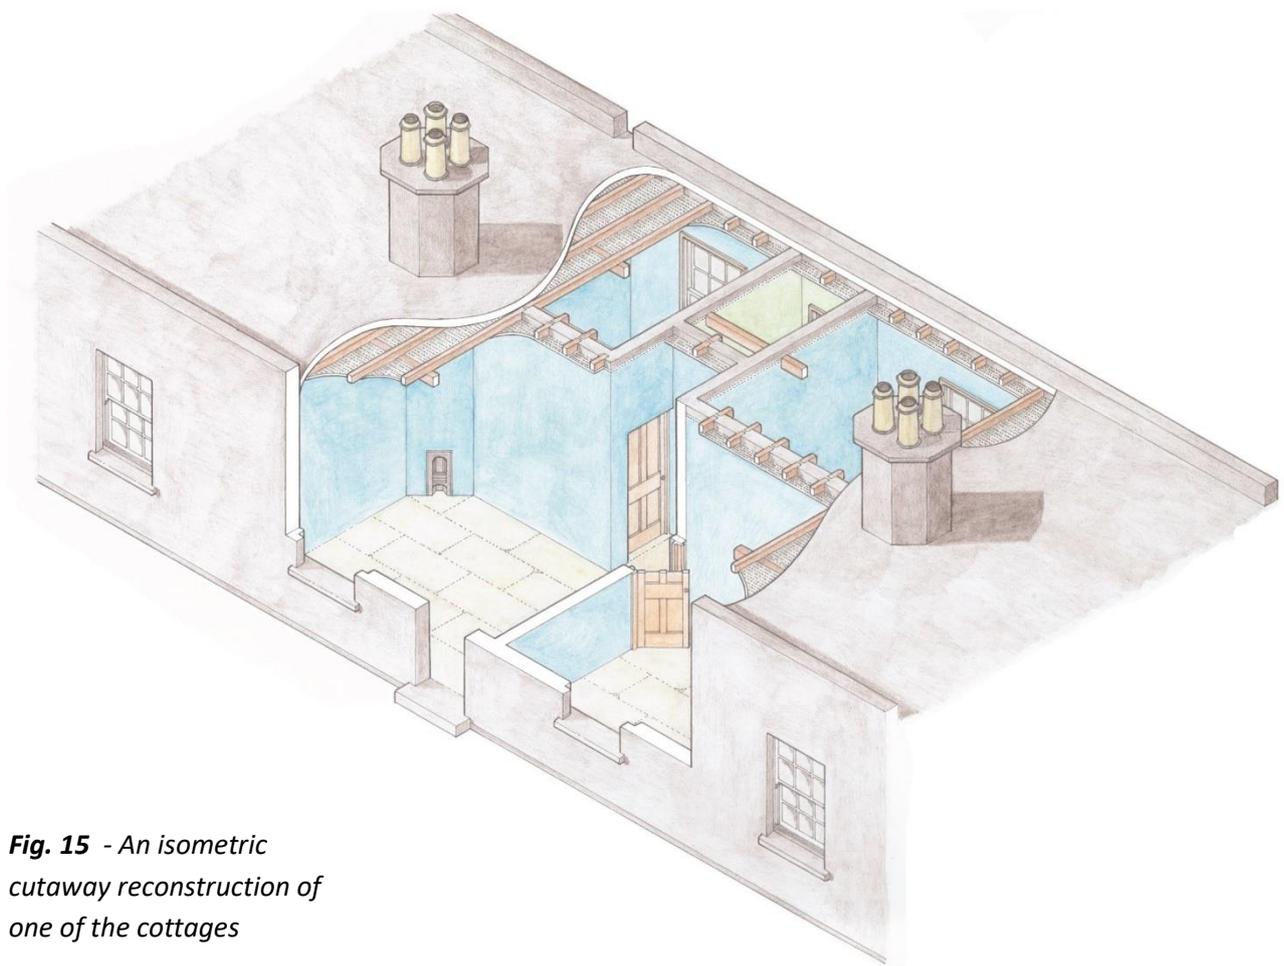
Fig. 15 - An isometric cutaway reconstruction of one of the cottages

Each cottage was designed to contain four main rooms and a small walk-in pantry between the two back rooms (Fig. 15). The front entrance to each cottage led directly into the front-left room, although some cottages later had a partition installed to create an entrance passage. The rooms have high ceilings, measuring almost three metres from floor to ceiling. Principal ceiling joists are exposed and have chamfered corners. In Nos 131 and 155, adjoining the flanks of the principal ceiling joists and at the top of the walls is simple coving in each of the rooms which is almost certainly original (Fig. 11). The four main rooms were heated by corner fireplaces. Most of the original fireplaces appear to have been removed or blocked up, but an original cast iron grate survives inside Nos 127 and 145. Simple, painted timber four-panel doors were hung in the internal doorways to the back rooms and the front-right room. Flag stones have been seen to survive beneath the modern flooring in No. 131 and a past resident of No. 150 has confirmed that the floors of the cottages were once laid with flag stones. Originally the cottages had no running water, no bathroom and no indoor toilet, and this was still the case for No. 148 in the 1950s. Later the pantry of most cottages was converted into a bathroom.

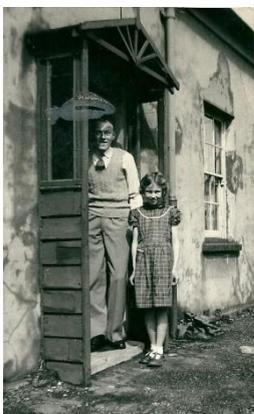
Fig. 16 - A lightweight wooden front porch to No. 134. Photograph taken 1954 or earlier

All the workers' houses in Heybridge belonging to Bentall's – including Woodfield Cottages – were put up for sale in 1930 (Essex Record Office: D/DCf B191). After being sold off, the houses gradually began to be altered in an *ad-hoc* manner as owners sought to modernise and personalise their homes. By the time the cottages were grade II listed in 1971, many of the houses had undergone a degree of alteration (Figs 19-21). Old photographs show that by the early 1950s some houses had acquired small flimsy wooden open front porches, none of which have survived to the present day (Fig. 16). From the late-1960s, larger and more permanent brick porches were added to some of the cottages (Fig. 17). Many of the larger brick porches look out of proportion with the cottages and where the brickwork is exposed they appear incongruous against the rendered finish of the elevations. Of all the existing porches, the small rendered examples at Nos 142 and 155 are most sympathetic to the cottages' scale and character. These small porches set a useful precedent for what may be deemed acceptable in future work (Fig. 18).

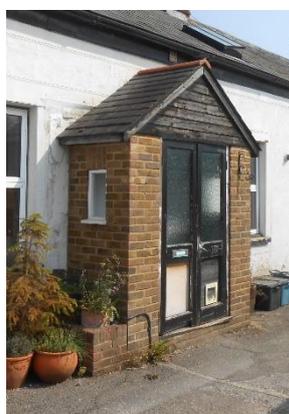
Fig. 17 - A brick porch to No. 117, probably dating from the 1980s. It replaced a wooden lean-to porch which was in place by 1971.

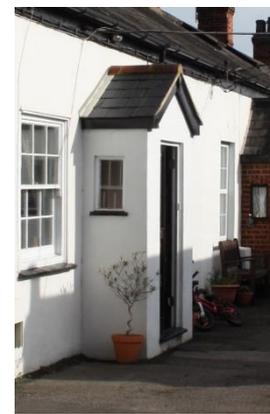
Fig. 18 - A small rendered porch at No. 155 granted listed building consent in 2014

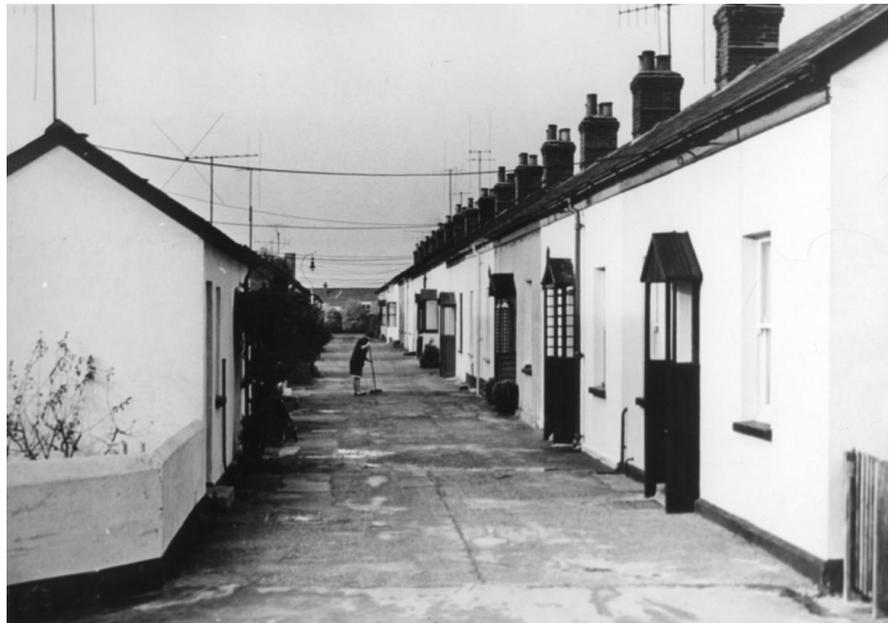
Fig. 21 (below) – The south row of Woodfield Cottages in 1971

At least 17 of the cottages have had loft conversions. Nos 123 and 125, at the west end of the south row, have front dormer windows. The dormers on No. 125 were introduced prior to the listing of the cottages (Fig. 21). The dormers at No. 123 were installed in 1985 (Fig. 31). The dormer windows have dramatically altered the character of these cottages. The other houses with loft conversions incorporate rooflights which are more discreet (Fig. 32). The rooflights are largely invisible from the lanes, although noticeable in longer views from the gardens and surrounding roads. Dormer windows should continue to be resisted but it has proven possible to convert the lofts of the cottages sympathetically using a limited number of small rooflights.

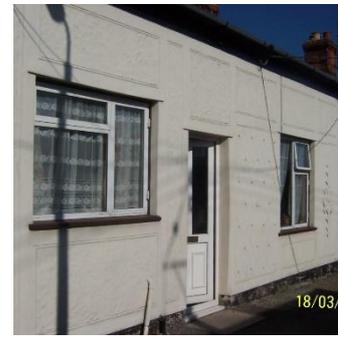
Fig. 25 – 1980's(?) aluminium windows at No. 118

Only 5 of the houses at Woodfield Cottages retain original multi-paned sash windows on their front elevations (Figs 22 and 30). More original windows survive on the north-facing rear elevations. From the third quarter of the 20th century timber windows with top-opening fanlights began to be introduced. No. 143, for example, had windows like this by 1970 (Fig. 23). In more recent decades some aluminium and plastic windows were introduced without listed building consent (Figs 25 and 26). Six houses have aluminium windows and four now have plastic windows. All these modern windows detract from the special character of the area. The shape of the front window openings has been altered in 25 of the houses. A common alteration is that the front-left window has had its cill raised to create space for kitchen units (Fig. 25). Tilt-opening sash-style timber windows were approved at Nos 142 and 144 in the early 2000's. While the upper casements of these windows incorporate horns in imitation of sash windows, the effect is undermined when the windows are open (Fig. 27). There are some relatively recent examples of windows made to resemble the original fenestration more closely. At No. 132 unsympathetic modern front windows were replaced in 2006 with single-glazed vertically sliding sash windows which are close to the original design although they are not recessed and do not have horns (Fig. 28). At No. 155 modern windows were replaced in 2014 with sliding sash windows incorporating discreet slim-profile double glazing (Fig. 29). These windows are much more sympathetic than their predecessors, but they were made to fit altered openings, so the proportions do not match the originals.

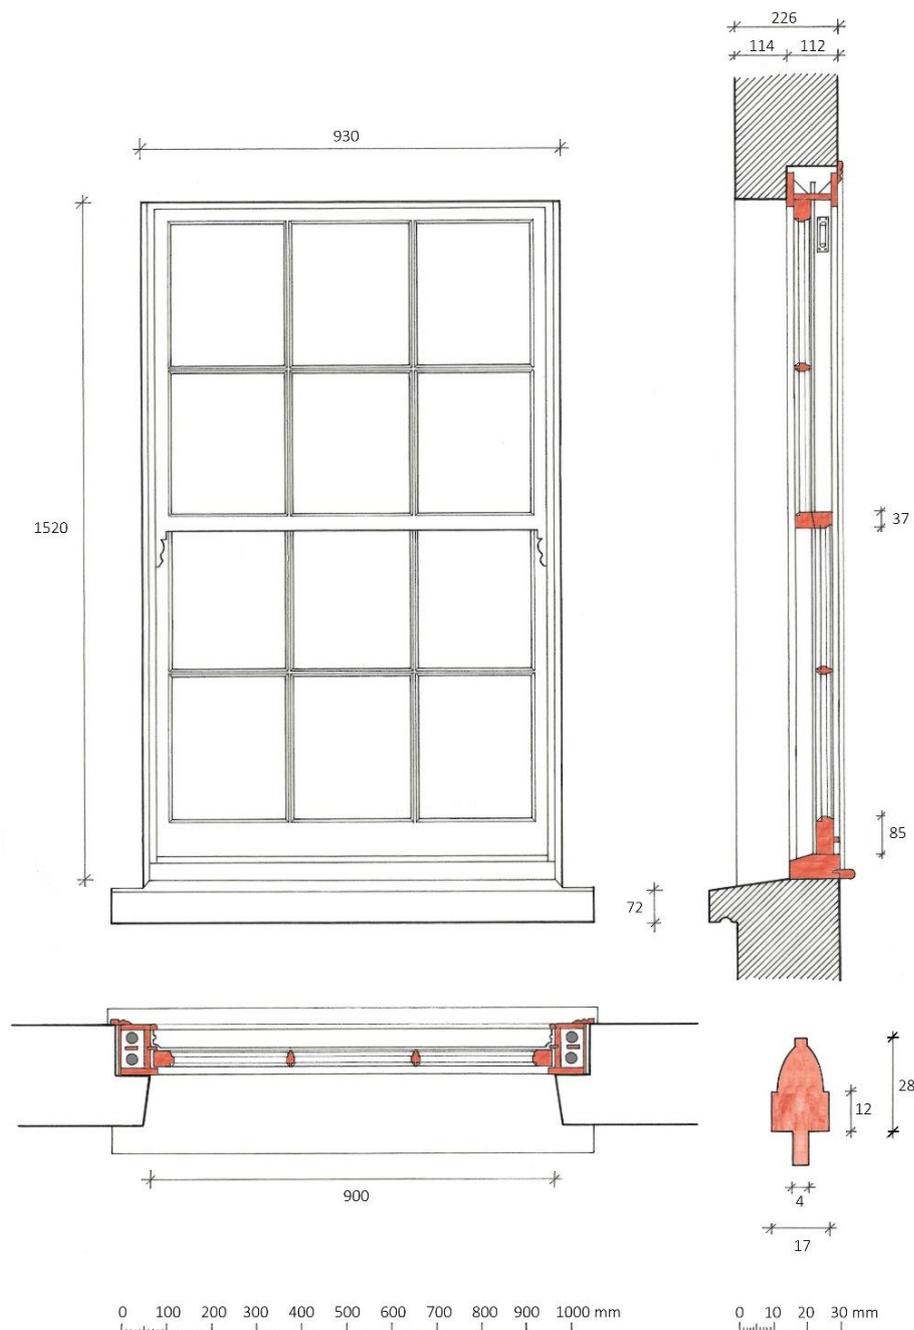
Fig. 30 – A measured drawing of an original sash window which survives on the north elevation of No. 155

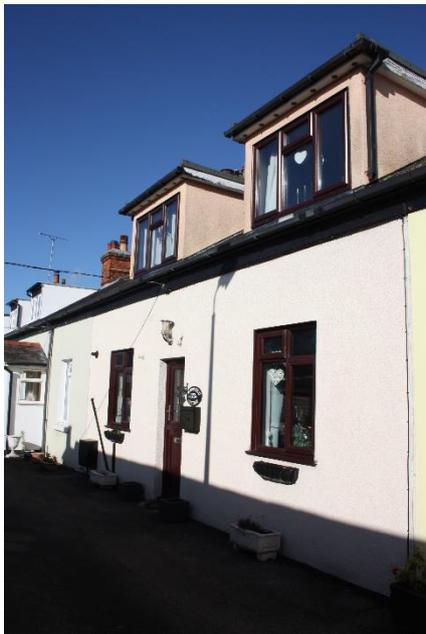
Fig. 31 – A loft conversion with dormer windows at No. 123

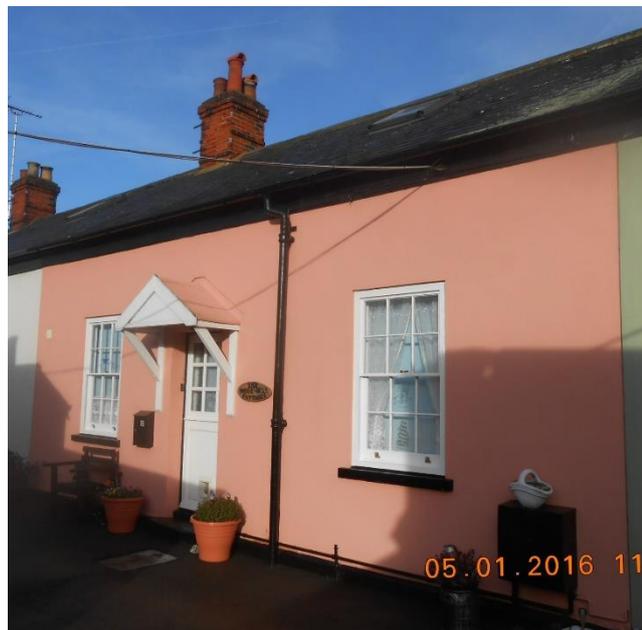
Fig. 32 – A loft conversion with a single front rooflight at No. 132

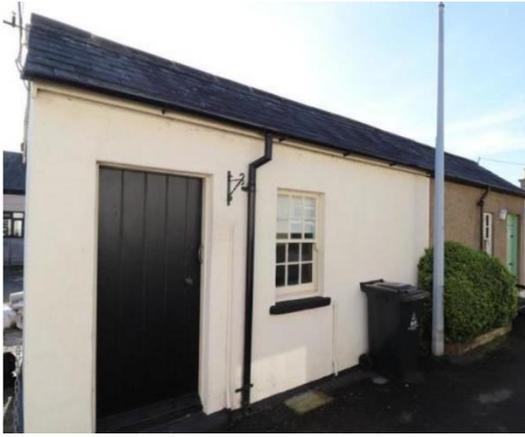
Fig. 33 – The principal (north) elevation of the washhouses to Nos 134 and 135

Several of the washhouses have had their chimneys removed. The washhouse serving No. 139 was completely demolished in 1985. Some washhouses have garages and sheds attached to them. These additions, alongside some modern replacement windows and doors and concrete roof tiles have eroded the character of the washhouses. The reinstatement of lost features and finishes would improve their appearance. Some of the washhouses (such as those to Nos 116 and 127) are suffering from a lack of maintenance and would benefit from repair and repainting.

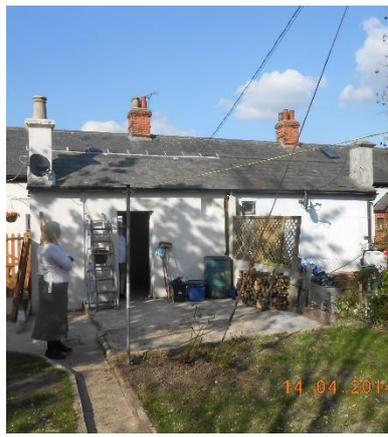
Fig. 34 – The garden (south) elevation of the washhouses to Nos 154 and 155

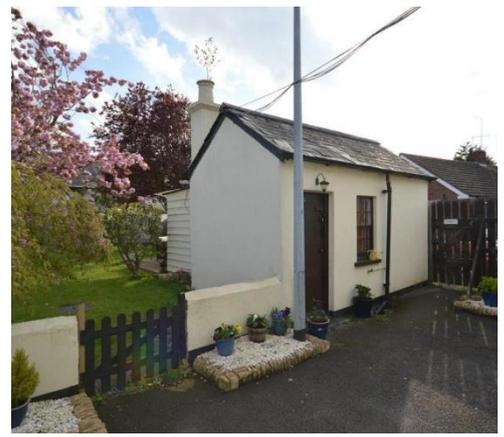
Fig. 36 – The detached outhouse serving No. 156

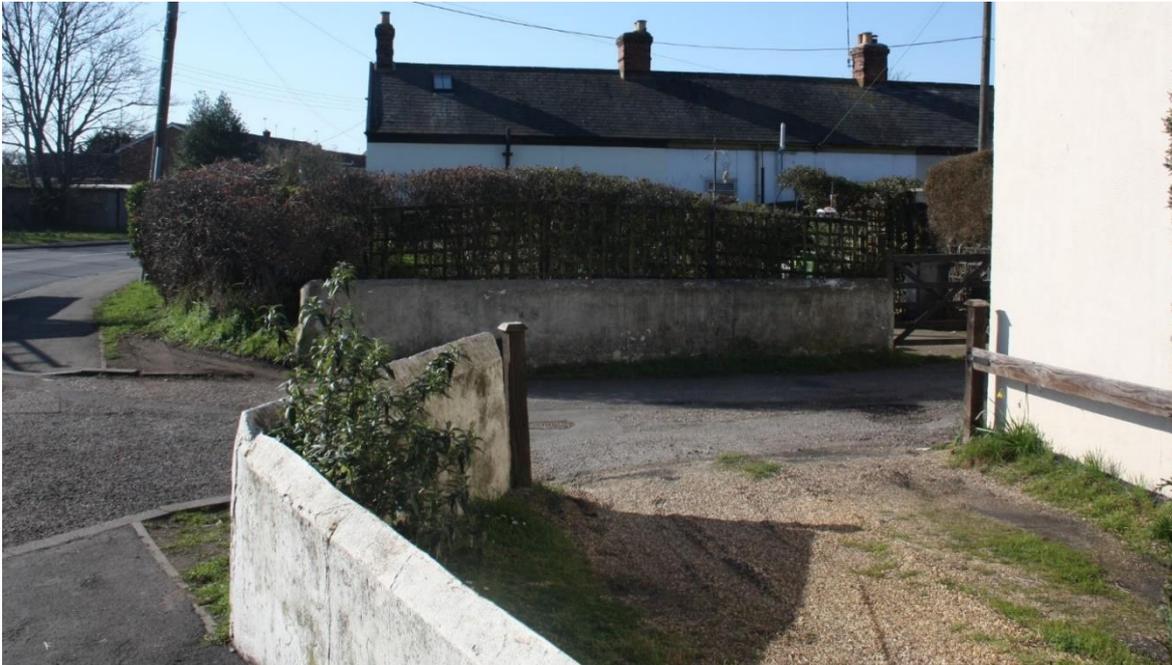
Fig. 37 – Low concrete boundary walls at the east entrance to the north row

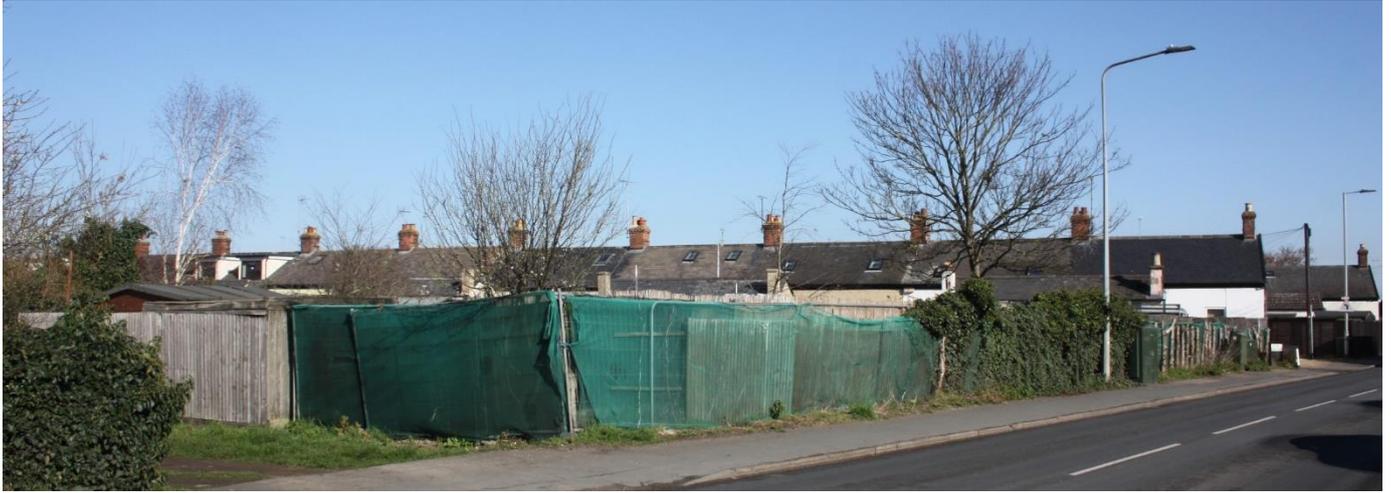
Fig. 38 – *The boundary to the garden at the east end of the south row currently consists of ramshackle timber fencing, dead leylandii, heras fencing and green netting*

Map evidence suggests that originally there were no formal boundary treatments between gardens (p. 10). One past resident recalls being permitted as a child to walk across all the gardens in her row in the 1950s. Later maps show that fences began to be erected between the gardens from the middle of the 20th century. A photograph taken in 1992 shows the gardens at the east end of the middle row separated only by very low fences made from posts and wire mesh. Over time, taller fences have been introduced as residents have increasingly sought greater privacy. Most gardens are now surrounded by fences approaching 2 metres in height. These taller fences have obscured the once open views of the terraces, but realistically it is now too late to reverse the trend. Native hedges, like those at the east end of the north row, offer a softer and more sympathetic alternative to fences, although take some time to become established (Fig. 37). Good quality painted-timber close-boarded fencing with timber posts represents a more suitable option than standard fencing with concrete posts and gravel boards. The ramshackle fencing around the garden at the east end of the south row has had a negative impact on the character and appearance of the area (Fig. 38); its replacement with a better boundary treatment would significantly improve the appearance of the area and the setting of the cottages (Fig. 39).

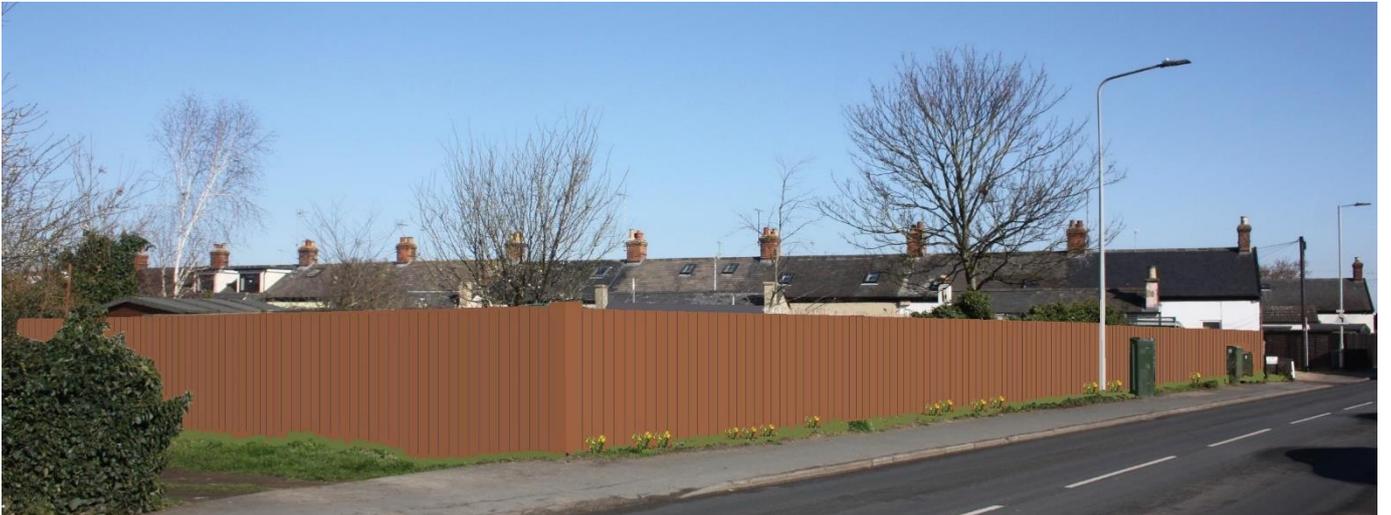
Fig. 39 – *How the boundary to the garden at the east end of the south row could be improved with a good-quality close-boarded fence painted chestnut brown*

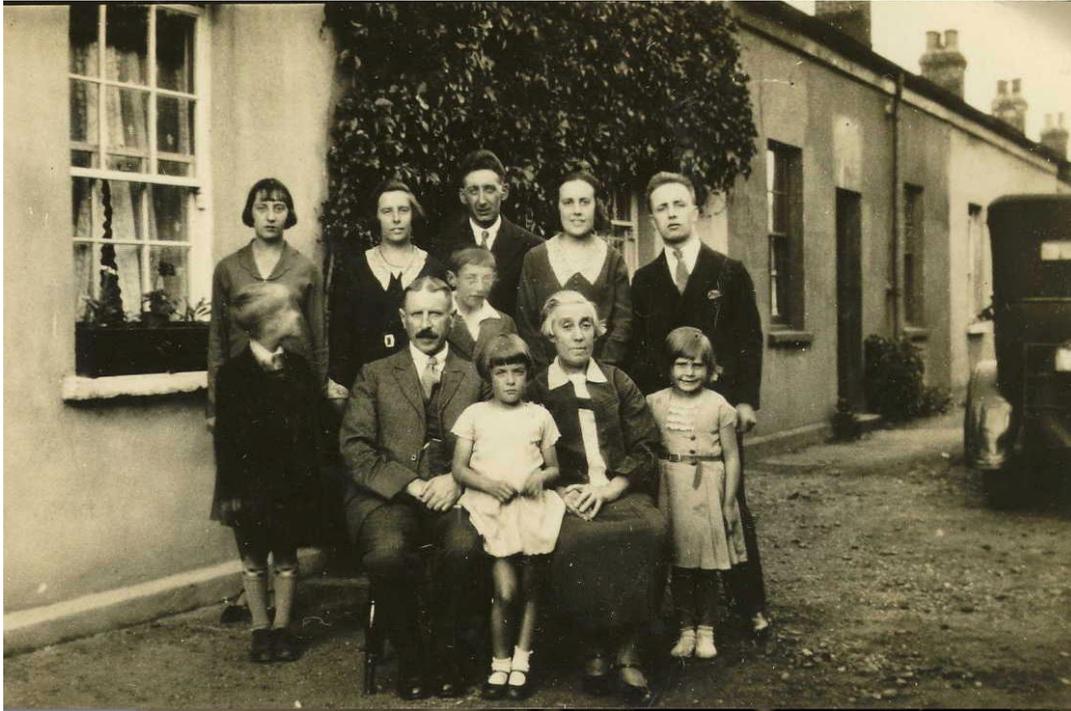
Fig. 40 – The Fenn family outside Nos 153 and 154 c. 1930. This is the oldest known photograph of Woodfield Cottages. Reproduced with permission from Shirley Cole.

The owners of each cottage are responsible for the maintenance of their section of the shared access lane. Fig. 40 shows that c.1930 the north lane was finished with unbound gravel. By the 1950s most had concrete laid between their homes and the washhouse (S. Cole, 2020). Now most sections are finished with black tarmac. The section outside No. 127 is in a very poor state of repair. Resurfacing the lanes with resin-bonded shingle would positively enhance the character of the area.

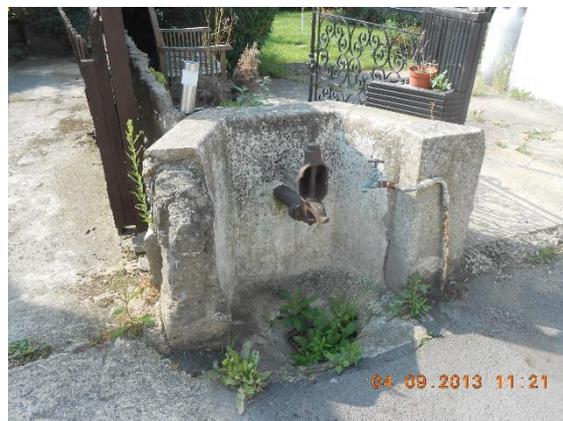
Fig. 41 – The communal water tap opposite No. 154

The two communal water taps which survive on the north row are a valuable survival. Similar communal taps existed on the other two rows. The two surviving taps would benefit from refurbishment. Bringing one or both of the taps back into working order would be a commendable project.

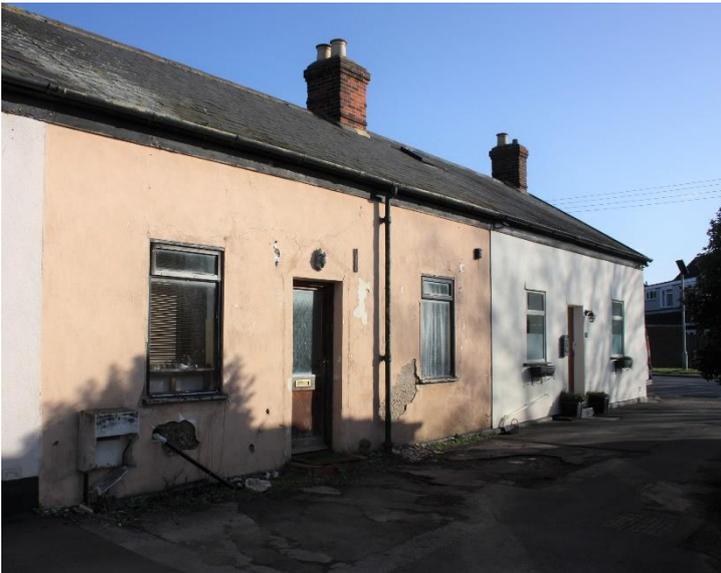
Fig. 42 – A photograph of Nos 127 and 126 taken February 2020. No. 127 and the section of access lane in front of it is in an increasingly poor state of repair.

The restoration of the original design of front windows and doors on the cottages is one of the most obvious ways to enhance the character of the area (Figs 42 and 43). This may be harder to achieve where the shape of the window openings has been altered; but restoration of the original design will have the most benefit and could be supported by grant funding. Where modern windows are being replaced, new painted-timber sash windows which closely match the original design could incorporate slim-profile double-glazed units with which it is possible to imitate traditional detailing.

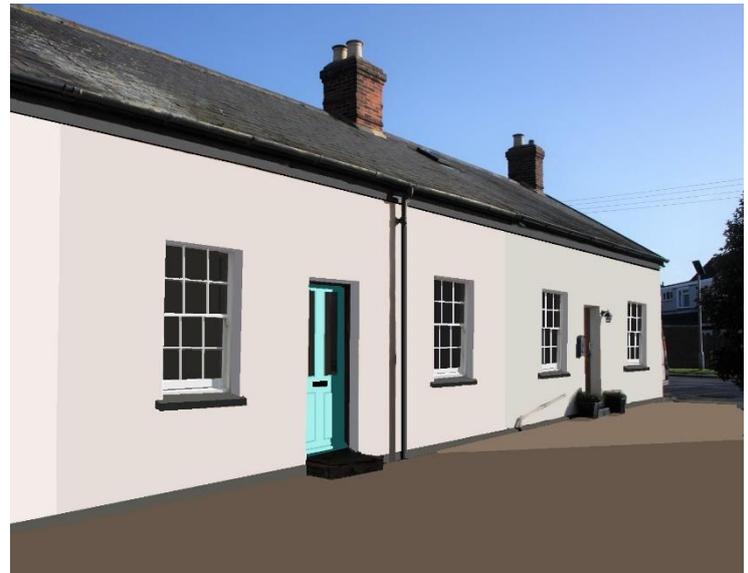
Fig. 43 – A mock-up showing how Nos 127 and 126 could be refurbished with sash windows, four-panel doors, and a resin-bonded-shingle surface to the lane.

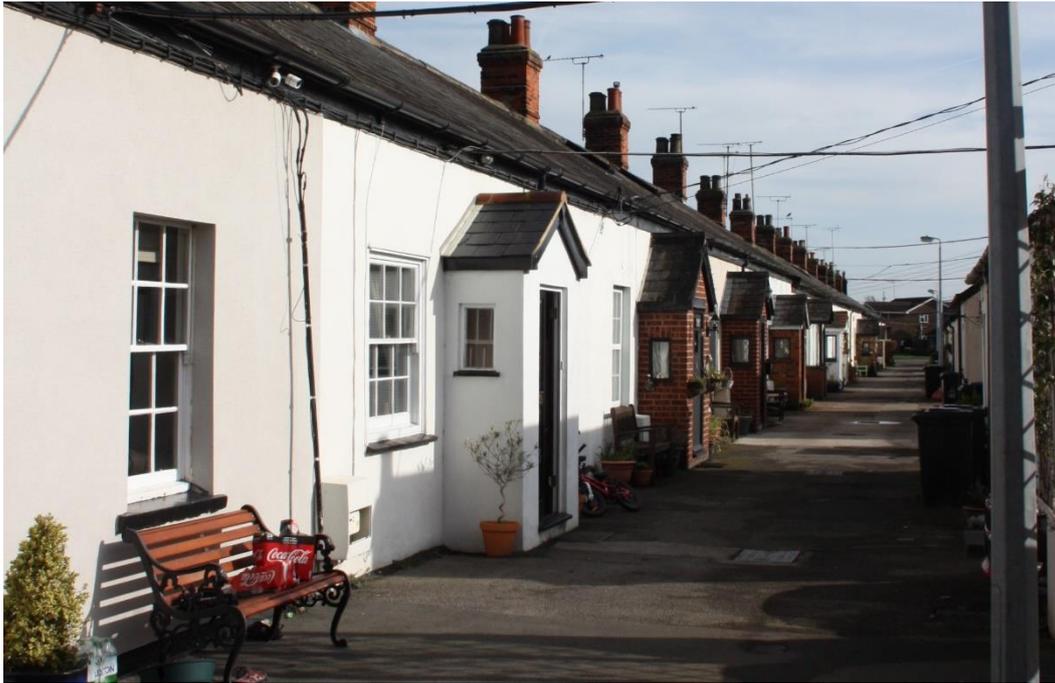
Fig. 44 – Photograph taken February 2020, depicting the north row of Woodfield Cottages looking east, with No. 155 in the foreground

The removal of over-scaled and poorly detailed brick porches should be encouraged. Alternatively, where the porches have exposed brick, simply rendering and painting them to match the front elevations of the cottages them would restore a greater sense of coherence and uniformity (Figs 44 and 45).
