WOODFIELD COTTAGES, HEYBRIDGE

CONSERVATION AREA CHARACTER STATEMENT

This document was produced by Maldon District Council.

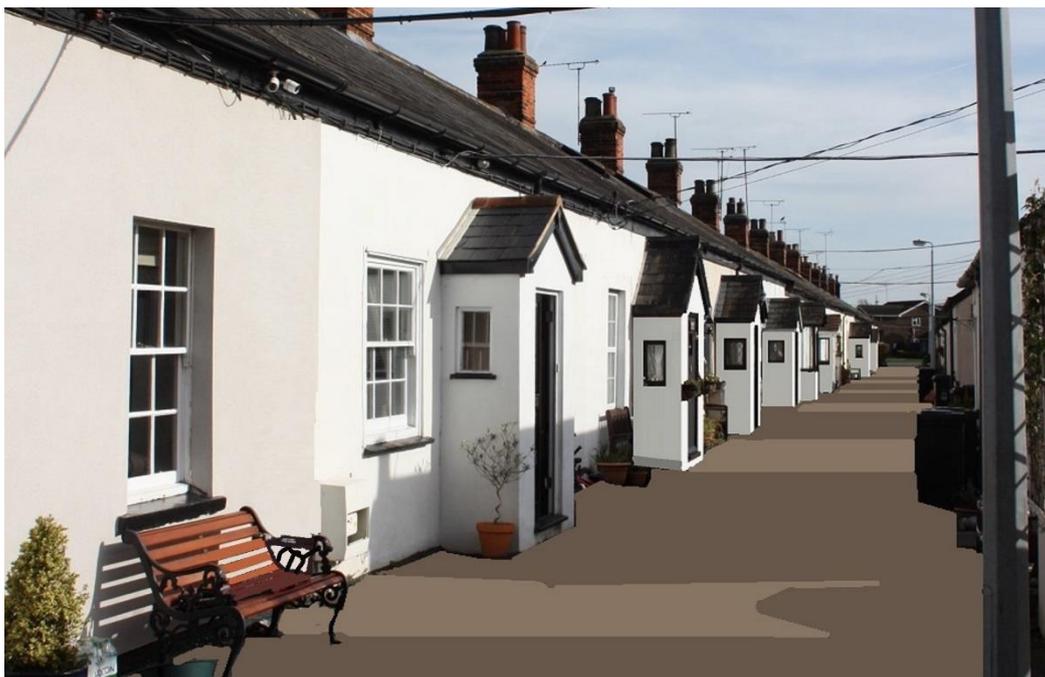
Fig. 45 – A mock-up showing the north row with render applied to the brick porches and a resin-bonded-shingle finish to the lane

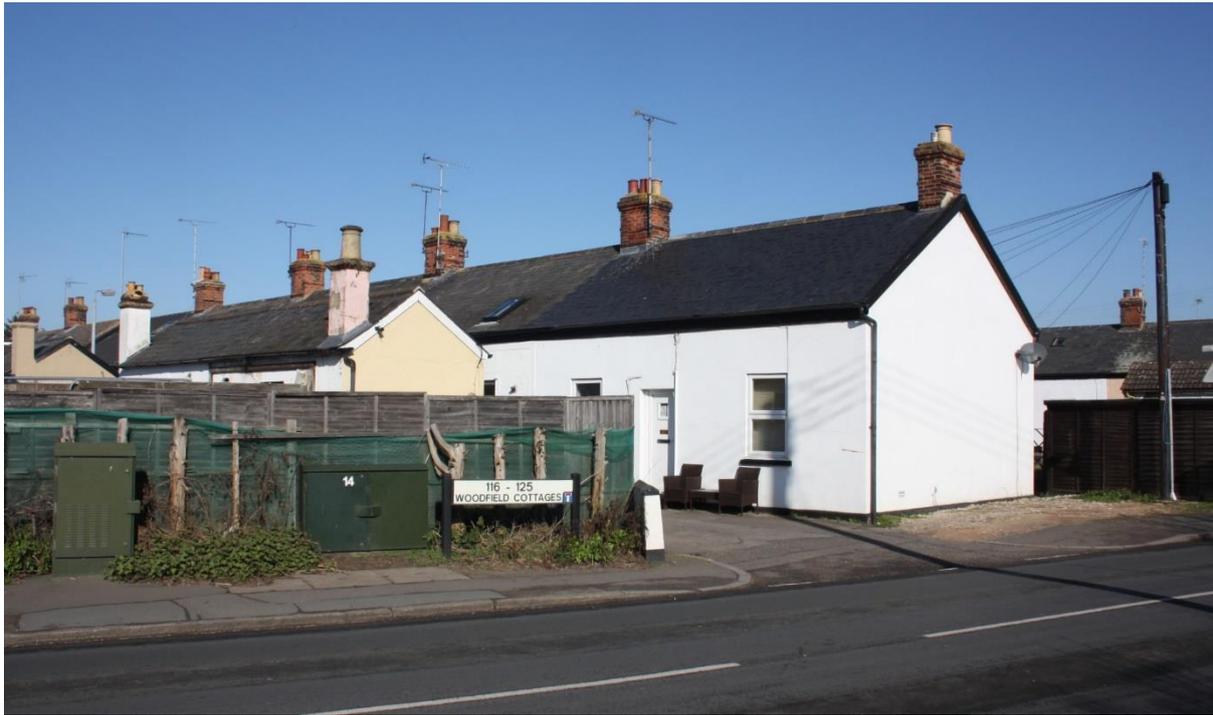
Fig. 46 – Photograph taken March 2021 at the east end of the south row

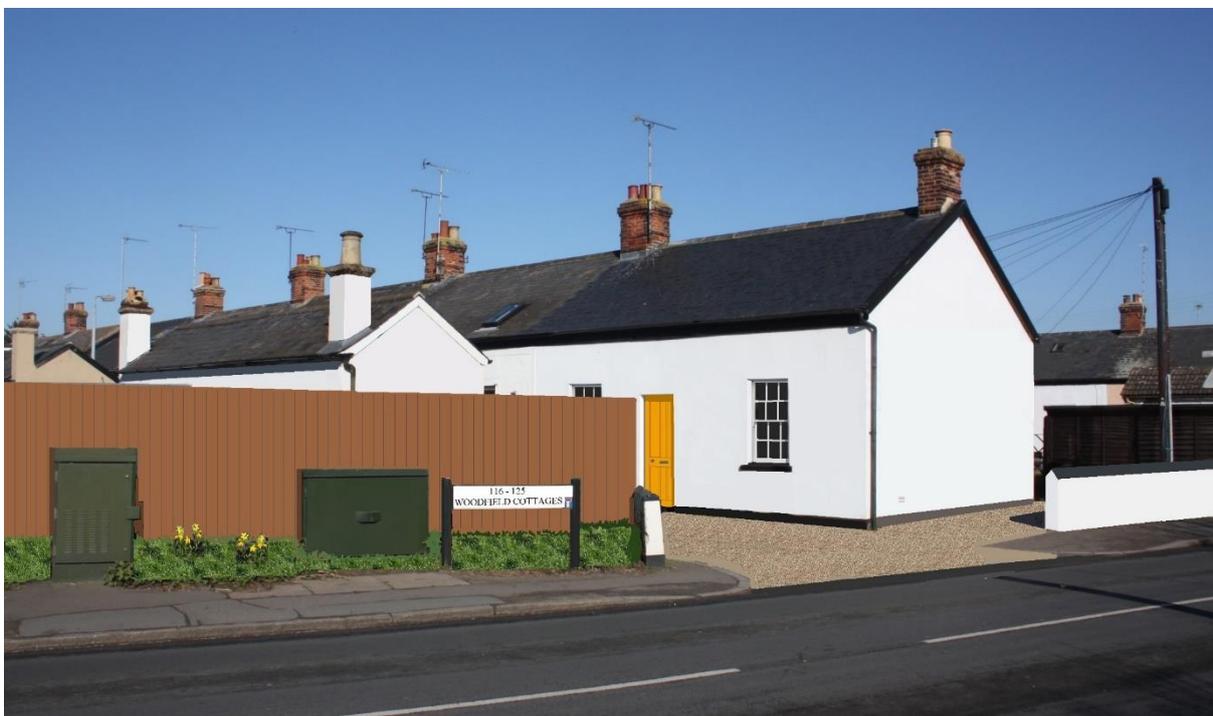
Fig. 47 – A mock-up of the entrance to the south row with a replacement fence, reinstated low boundary wall and new sash windows and front door to No. 116.

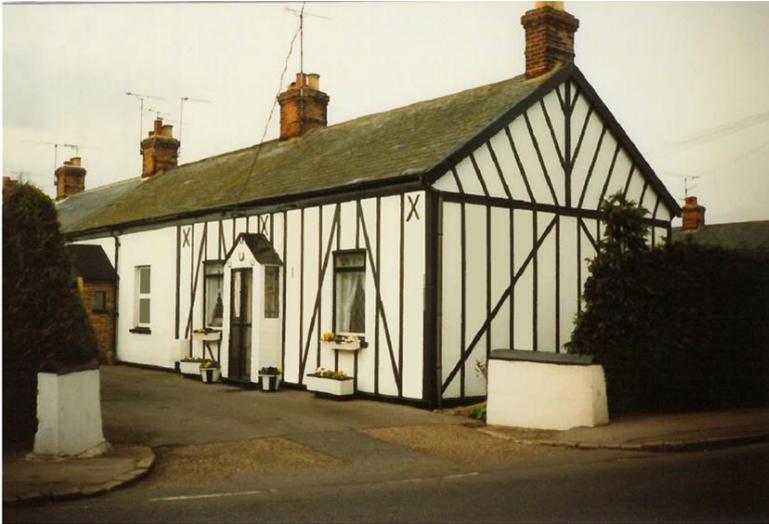
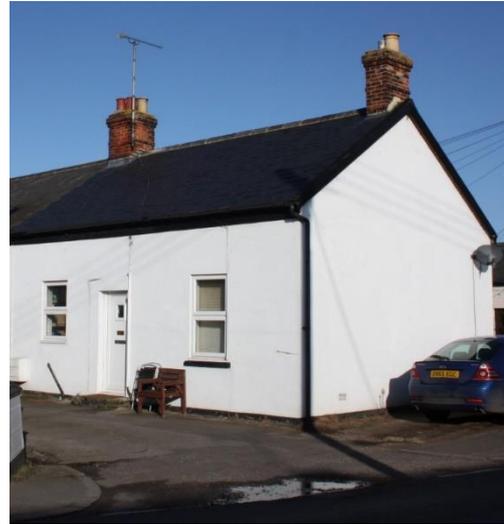
NO. 116

History	<p>In 1911 the residents of this cottage were Susannah Hutchinson and her daughter, Rose (who were both employed doing 'laundry work') and her son Charles Hutchinson (a nut and bolt maker). In 1939 the property was lived in by Cyril Evans (a Press Tool Operator), his wife Nellie, and their two children Roy and Minnie.</p> <p>In 1991 an application to retain 'black mock-Tudor effect timbers' which had been applied to the external walls was refused, although they were still in place in 1993 (91/00827/LBC).</p>
State of preservation	<p>To the right of the house, a small surviving section of original concrete boundary wall has been demolished to create a parking space.</p> <p>Between 2013 and 2015 the house was substantially refurbished. At this time, the 20th-century lead-glazed timber windows were replaced by the current tilt-opening uPVC windows. The size of the left-hand window was altered and the original concrete window cill was removed. A white plastic front door has been installed. Modern slates have been replaced by new slates. A black plastic fascia was applied to the roof verges. A satellite dish was installed on the gable end. These works have altered the character of the building but were not the subject of a listed building consent application.</p> <p>There are issues with the garden boundary, but ownership of this appears to have been transferred to No. 118 so is considered below in relation to that property.</p>

Opportunities for enhancement	<p>Fig. 47 on p. 27 illustrates possible enhancements to this cottage.</p> <ul style="list-style-type: none"> • Installation of white-painted-timber sash windows and a painted-timber front door to reflect the original design • Reinstating painted-timber bargeboards, • Relocating the satellite dish to a less prominent position, • Reinstating the demolished section of boundary wall (perhaps in a way that allowed the retention of the parking space)

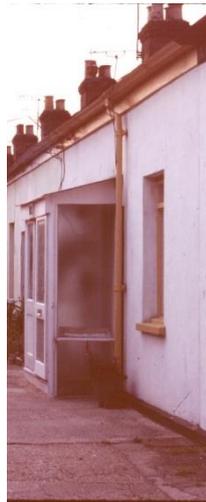
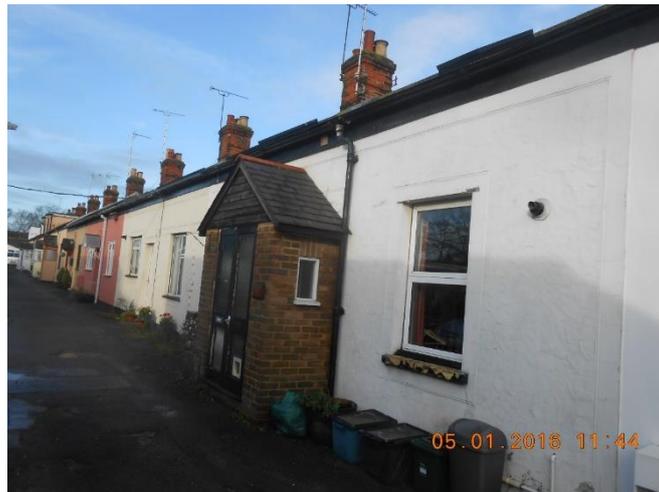
NO. 117

History	<p>In 1911 the residents of this cottage were Ernest and Mary Everitt and their two children. Ernest was a Mechanical Engineer. In 1939 the property was lived in by Ezra Linnett and Ellen Linnett. Ezra was an Agricultural Painter.</p> <p>In 2007 consent was granted to convert the loft, involving the installation of two rooflights on both slopes (07/00919/LBC). In 2008 consent was granted to replace the roof covering and install vents for the central heating boiler (08/00048/LBC)</p>
State of preservation	<p>Aside from the loft conversion, re-roofing and vents which were granted consent, three other alterations were carried out to frontage between 1979 and 2005, apparently without permission. A timber lean-to porch – which existed in 1971 – was replaced by a larger and somewhat over-scaled porch built using brown bricks. Modern timber windows with fanlights were replaced by aluminium windows. The front wall was re-rendered with a simple pargetted finish.</p>

Opportunities for enhancement	<ul style="list-style-type: none"> • Installation of white-painted-timber sash windows and a painted-timber front door to reflect the original design • Removal or replacement of porch • Smooth rendering of front wall

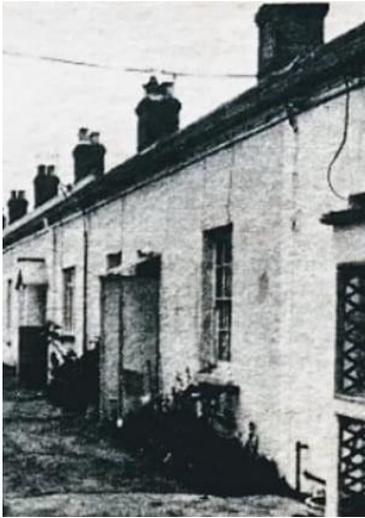
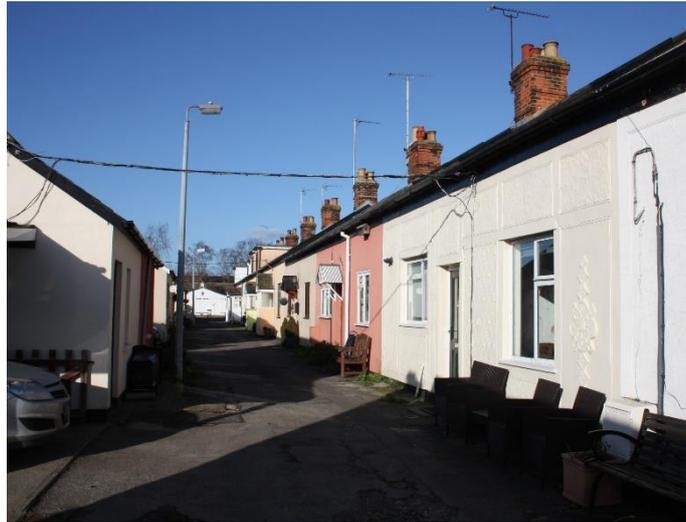
NO. 118

History	<p>In 1911 the residents of this cottage were Eliza Betts, her daughter, son-in-law, granddaughter and one boarder. In 1939 the property was lived in by a Ms Woodcraft and Ellen Pratt.</p> <p>In 2002 an application to convert the loft involving the installation of two flat-roofed dormer windows was refused (02/00407/LBC). Later that year consent was granted to convert the loft, using rooflights instead of dormers (02/00754/LBC).</p>
State of preservation	<p>There is a lean-to car port attached to the east flank of the outhouse which was already in place in 1971.</p> <p>Between 1979 and 2005 several alterations were carried out, apparently without permission. The left-hand front window opening was widened and the cill raised. Aluminium windows were installed. The front wall was re-rendered with elaborate pargetted decoration.</p> <p>Prior to 2016, the garden to No. 118 was extended over the ends of the gardens to Nos 116 and 117. A section of 'Heras' fencing and green netting has been installed along the boundary facing the street, alongside the stumps of dead Leylandii trees. A pair of metal gates have been installed to the side of the outhouse opposite No. 116. On the gate is an ugly sign which reads "PRIVATE PROPERTY KEEP OUT".</p>

Opportunities for enhancement	<ul style="list-style-type: none"> • Replacement of the fencing and gates which face the street and access track with a more sympathetic form of fencing or planted boundary treatment (see Figs 38 and 39 on p. 23). • Installation of white-painted-timber sash windows and a painted-timber front door to reflect the original design • Smooth rendering of the front wall

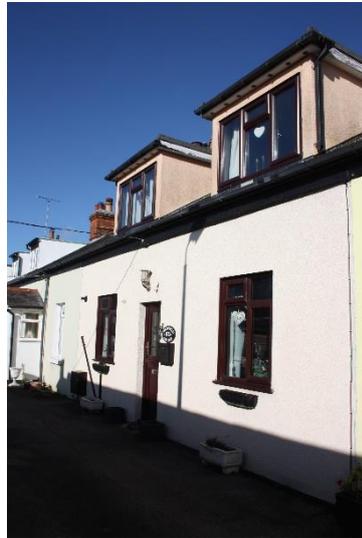
NO. 123

History	<p>In 1911 the residents of this cottage were James Robinson (an Iron Moulder), his wife Mary and their daughter. In 1939 the property was lived in by John Bowtle (Iron Moulder) and one other.</p> <p>In 1984 building regulations approval was granted to convert the loft, involving the introduction of two flat-roofed dormers, but no records have been found of a listed building consent for this work (84/00357/DROFP).</p>
State of preservation	<p>The front windows and front door of the cottage and the outhouse are all of brown coloured plastic. A FENSA certificate for this work was lodged with Building Control in 2003 but there are no records of a listed building consent.</p> <p>A photograph taken in 1993 shows that one of the ground-floor windows was an 8-over-8 timber sliding sash window.</p>
Opportunities for enhancement	<ul style="list-style-type: none"> • At ground-floor level, installation of painted-timber sash windows and painted-timber front door on both the cottage and the outhouse to reflect the original design • Replacement of the brown plastic windows in the dormers with white-painted flush timber casements without fanlights.

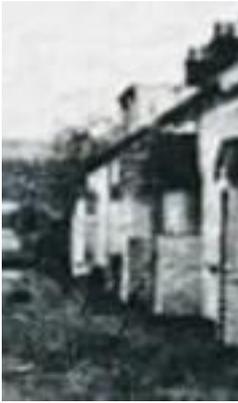
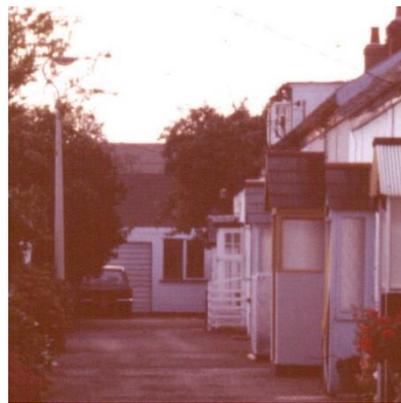
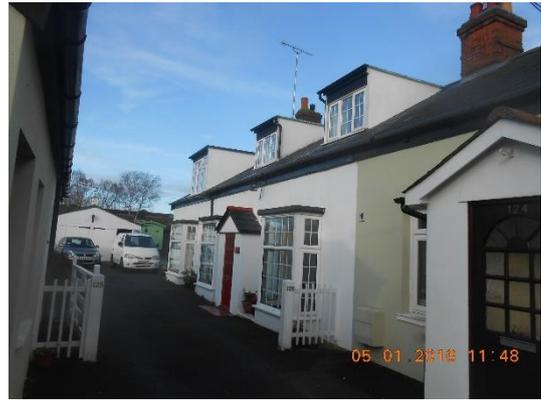
NO. 125

History	<p>In 1911 the residents of this cottage were Frederick Bacon (Painter of Agricultural Implements), his wife Alice and their four children. In 1939 the property was lived in by Ernest Sach (an Iron Moulder) and one other.</p> <p>Consent was granted to extend this cottage to the side in 1991 (91/00485/LBC) and to extend it again in 2000 (00/00293/LBC).</p>
State of preservation	<p>This is the most altered house at Woodfield Cottages. In 1971 it already had flat-roofed dormer windows and flat-roofed bay windows. All the windows were noted as being plastic in 1991.</p>
Opportunities for enhancement	<ul style="list-style-type: none"> • Replacement of plastic windows with better detailed white-painted-timber windows

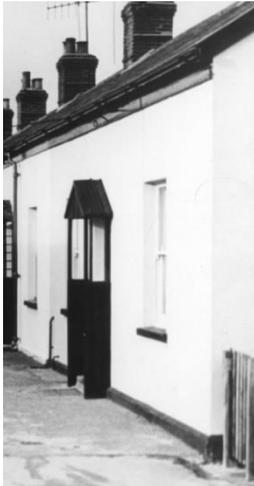
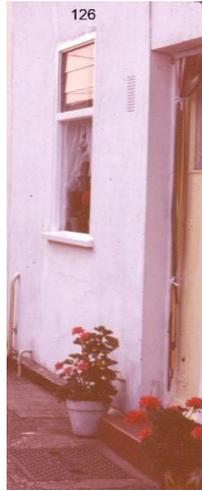
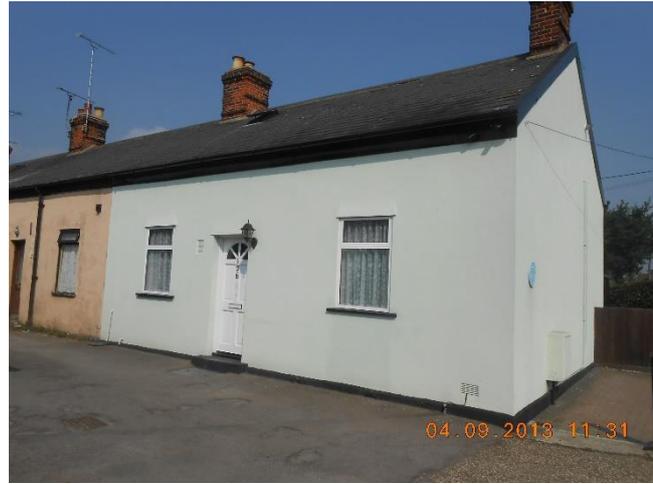
NO. 126

History	<p>In 1911 the residents of this cottage were John Rogers (Moulder) and Eliza Rogers.</p> <p>In 1998 listed building consent was refused to retain recently installed plastic guttering (98/00415/LBC), and consent was subsequently granted for aluminium rainwater goods (99/00969/LBC).</p> <p>In 2001 consent was granted to install three conservation rooflights (01/00859/LBC).</p>
State of preservation	<p>The original sash windows are depicted in a 1970 photograph. A 1979 photograph shows timber windows with glass louvres. By 1992 the current aluminium windows had been installed.</p> <p>The current front door is of a stable-door design with a stained-wood finish (installed between 2013 and 2016). There were at least two replacement doors prior to this neither of which reflected the original design.</p>
Opportunities for enhancement	<ul style="list-style-type: none"> • Installation of white-painted-timber sash windows and a painted-timber front door to reflect the original design

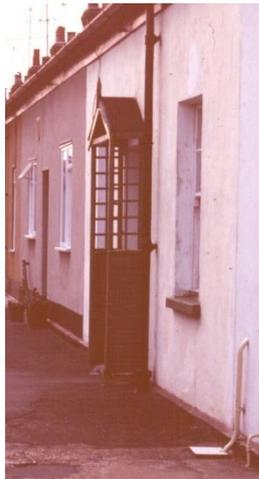
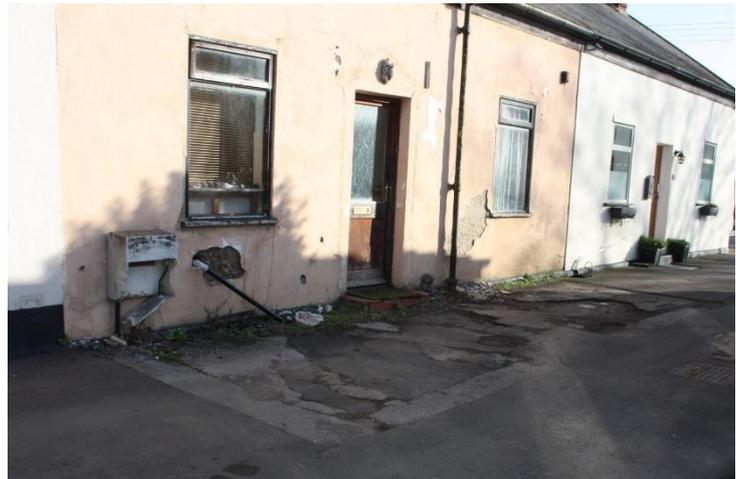
NO. 127

History	<p>In 1911 the residents of this cottage were George Moore (Foundry Labourer), his wife Alice and three children. In 1939 the property was lived in by George, Clifford and Ronald Moore. Clifford and Ronald were Cowmen.</p> <p>There are no known past planning permissions or listed building consents for this property.</p>
State of preservation	<p>The original front sash windows were replaced between 1979 and 1992. The current windows are timber with fanlights.</p> <p>The house, the outbuilding and the section of the shared driveway directly outside the house are all in an extremely dilapidated condition and the garden is increasingly overgrown</p>
Opportunities for enhancement	<ul style="list-style-type: none"> • General refurbishment, repair of render and redecoration • Installation of white-painted-timber sash windows and a painted-timber front door to reflect the original design • Resurfacing of the section of driveway directly in front of the house. • Clearance of brambles and rubbish from the garden.

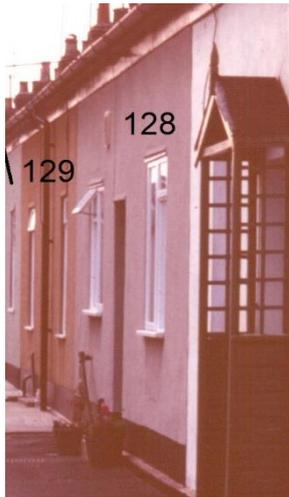
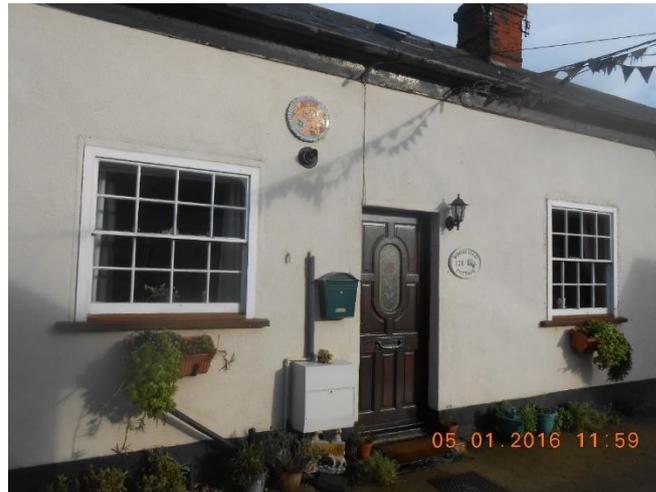
NO. 128

History	<p>In 1911 the residents of this cottage were William Smith (Moulder), his wife Lizzie, and their two children. In 1939 the property was lived in by Frederick Taylor (the caretaker at Maldon Grammar School) and Eva Taylor.</p> <p>In 2007 consent was granted to retain recently installed sliding sash windows (07/00655/LBC).</p>
State of preservation	<p>In 2007 modern plastic casement windows were replaced with the present painted-timber sliding sash windows. The windows differ from the original design in terms of their shape, the number of panes, and the fact they are not recessed.</p> <p>The present, mock-Georgian, stained-wood front door was installed between 1992 and 2005.</p> <p>Between 1993 and 2007 the loft was converted, involving the installation of a rooflight, apparently without permission.</p>
Opportunities for enhancement	<ul style="list-style-type: none"> • Installation of white-painted-timber sash windows and a painted-timber front door to reflect the original design

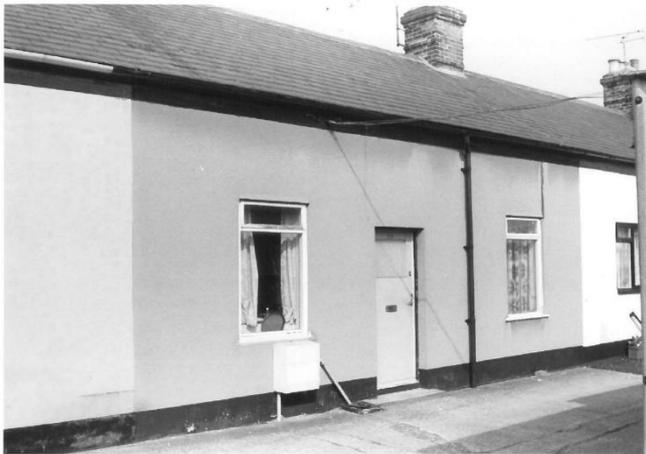
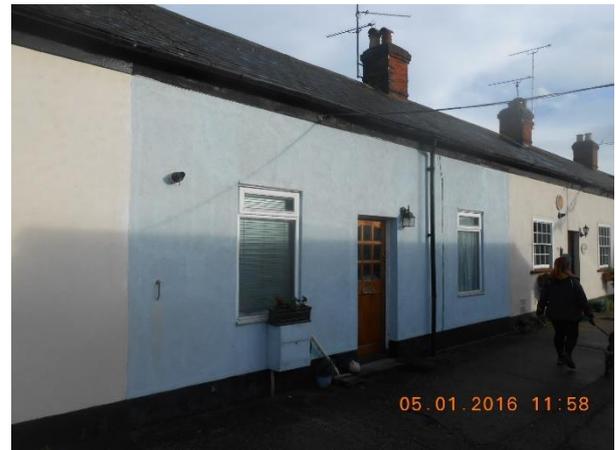
NO. 129

History	<p>In 1911 the residents of this cottage were Frederick Clark (Moulder), Eliza Clark and their family. In 1939 the property was lived in by Frederick Clark (a retired Moulder), Ernie Mansfield (a Wood Machinist), Joan Mansfield (Hardware Shop Assistant), and Ruby Mansfield.</p> <p>There are no known past planning permissions or listed building consents for this property.</p>
State of preservation	<p>Modern painted-timber windows with fanlights had been installed by 1970. The present front door is a stable-style door with a stained wood finish.</p>
Opportunities for enhancement	<ul style="list-style-type: none"> • Installation of white-painted-timber sash windows and a painted-timber front door to reflect the original design

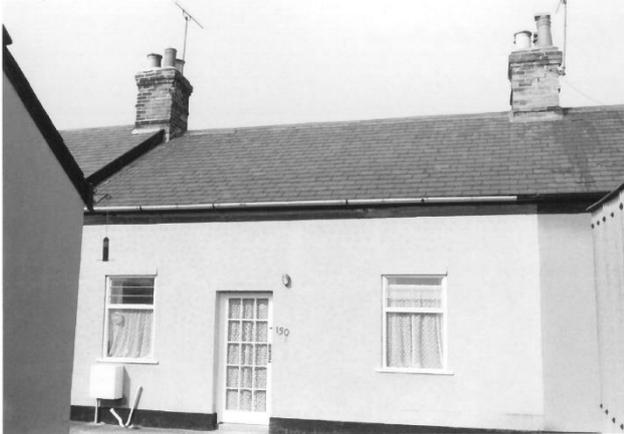
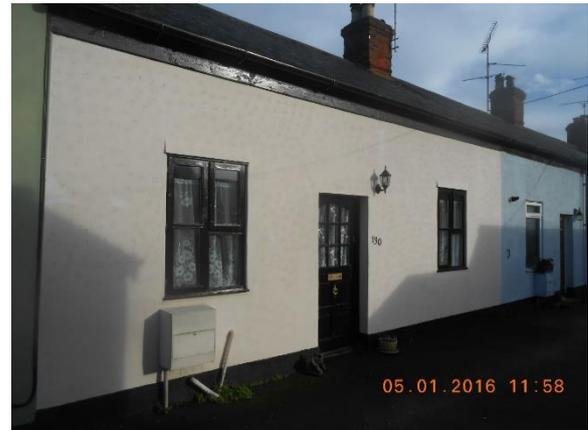
NO. 130

History	<p>In 1939 the property was lived in by Herbert Hardy-King (a Shaper for aircraft / Engineering Work), Ellen Hardy-King (a Laundress), and Dorothy Hardy-King (incapacitated).</p> <p>There are no known past planning permissions or listed building consents for this property.</p>
State of preservation	<p>The front windows and door are modern. The present windows replaced ones with louvred glass (depicted in 1992 photograph) of the same design as at No. 126 (which can be dated to the 1970s).</p>
Opportunities for enhancement	<ul style="list-style-type: none"> • Installation of white-painted-timber sash windows and a painted-timber front door to reflect the original design

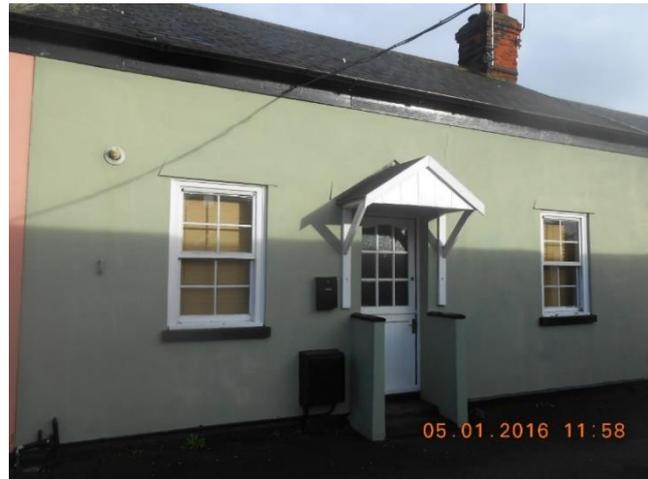
NO. 131

<p>History</p>	<p>In 1911 the residents of this cottage were William Barbrook (Carman), Catherine Barbrook, and five children. In 1939 the property was lived in by Alexander Woodcraft (a Centre Lathe Engineer), Laura Woodcraft, Phyllis Woodcraft (a Packer at a flour mill), William Woodcraft (Tailoring First Salesman), Olive Woodcraft and two unnamed others.</p> <p>There are no known records of planning permissions or listed building consents relating to this property.</p>
<p>State of preservation</p>	<p>A front porch had been added to this house by 1970.</p> <p>The present windows are painted-timber sash windows with plastic glazing bars in a different pattern to the original fenestration.</p>
<p>Opportunities for enhancement</p>	<ul style="list-style-type: none"> • Installation of white-painted-timber sash windows and a painted-timber front door to reflect the original design • Removal or replacement of porch

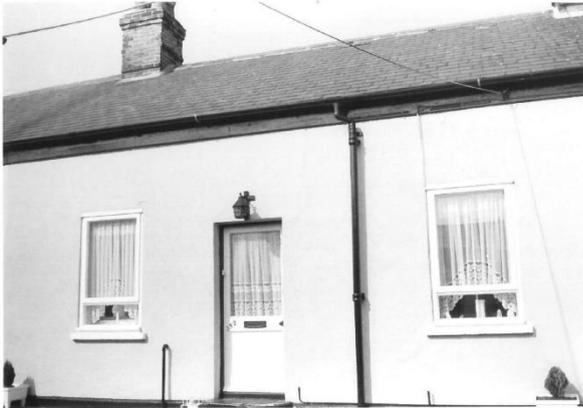
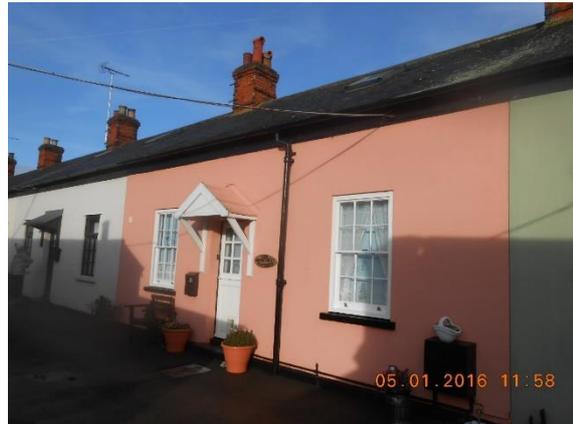
NO. 132

History	<p>In 1911 the residents of this cottage were Frederick Hinton (an 'invalid'), Ellen Hinton, three sons and one granddaughter. In 1939 the property was lived in by Cyril Dickens (a Clothing & Footwear Shop Assistant), Lilian Dickens and one other unnamed person.</p> <p>In 1994 consent was granted to convert the loft, involving the installation of rooflights (94/00397/LBC). In 2006 consent was granted to install sash windows and to renew the render (06/00118/LBC). Later in 2006 consent was granted to widen an internal doorway (06/00341/LBC).</p>
State of preservation	<p>The painted timber sash windows are close to the original design.</p> <p>A porch canopy was installed between 1992 and 2013.</p>
Opportunities for enhancement	<p>This house is close to perfect, but the following works would represent minor enhancements:</p> <ul style="list-style-type: none"> • The removal of the porch canopy • The installation of recessed painted-timber sash windows and a front door which reflects the original design

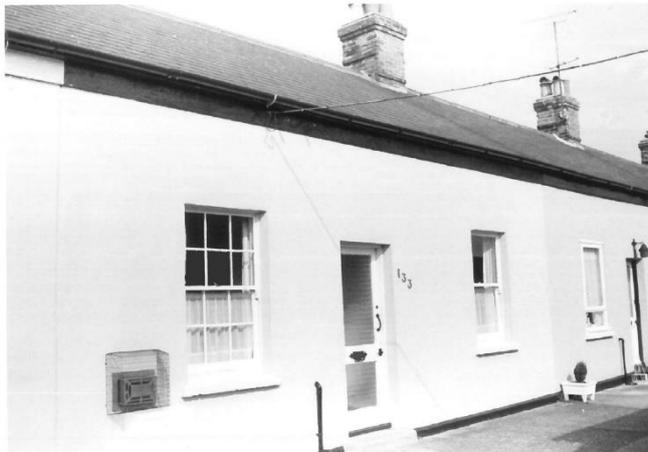
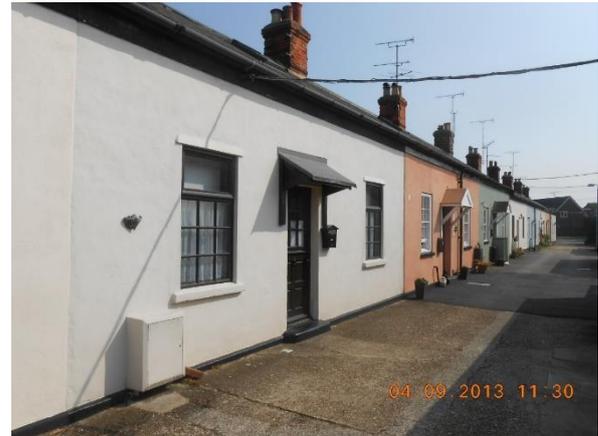
NO. 133

History	<p>In 1911 the residents of this cottage were Alfred Gooch (Agricultural Implement Fitter), Mary Ann Gooch, five children and one visitor. In 1939 the property was lived in by William Pratt (a Farm Worker) and Winifred Pratt.</p> <p>In 1994 consent was granted to convert the loft, involving the insertion of rooflights (94/00397/LBC).</p>
State of preservation	<p>Between 1992 and 2013, Victorian sash windows were replaced by timber windows with top-hung fanlights.</p> <p>The house has a modern stable-style front door and porch canopy covered in mineral felt.</p>
Opportunities for enhancement	<ul style="list-style-type: none"> • Installation of white-painted-timber sash windows and a painted-timber front door to reflect the original design • Removal of the porch canopy

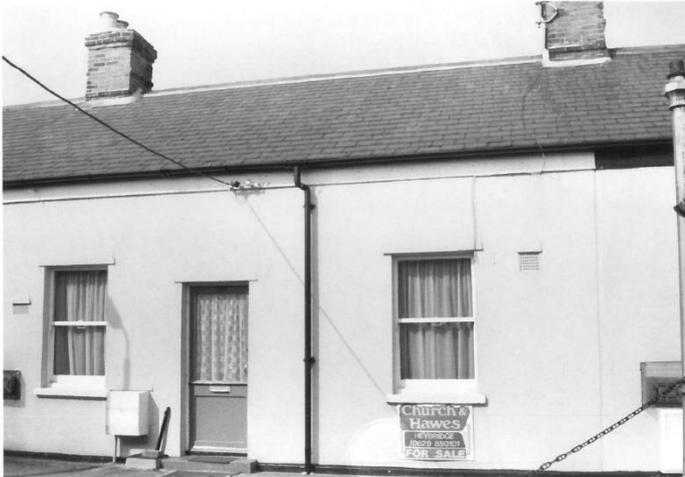
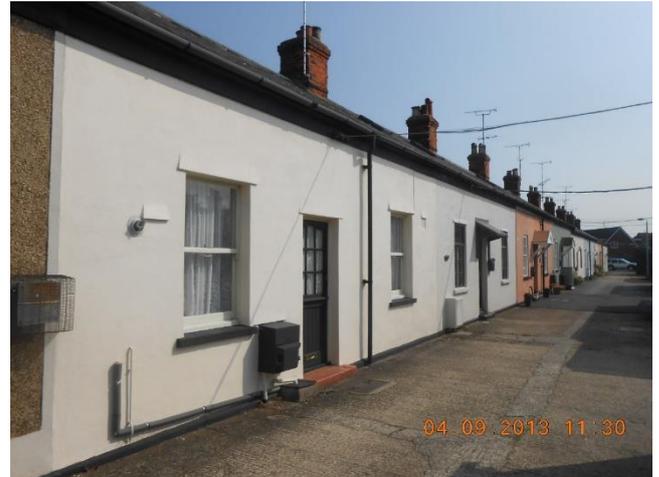
NO. 134

History	In 1911 the residents of this cottage were Alfred Bird (Blacksmith), Alice Bird, and three sons. In 1939 the property was lived in by Terrance Flack (an Engineering Turner), Vera Flack and Tommy Flack (who was under school age).
State of preservation	The plain-glazed timber sash windows date from the 20 th century. A modern front door was replaced with a timber stable door between 1992 and 2013. The garden has been concreted over.
Opportunities for enhancement	<ul style="list-style-type: none"> • Installation of white-painted-timber sash windows and a painted-timber front door to reflect the original design • Break up the concrete in the garden and lay a lawn.

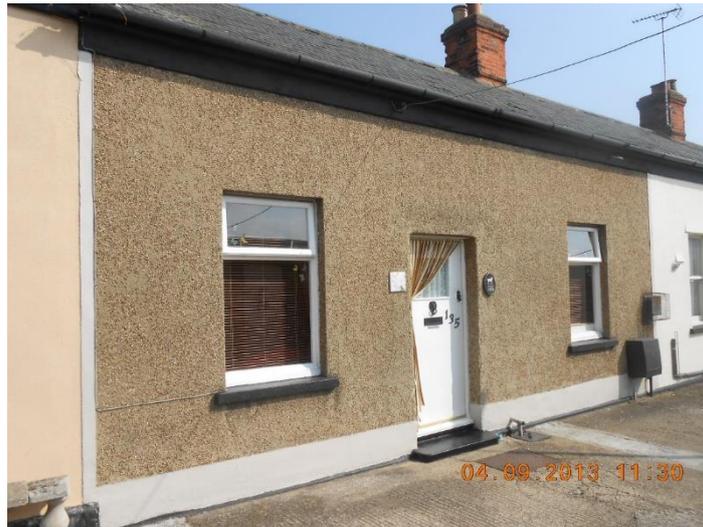
NO. 135

History	<p>In 1911 the residents of this cottage were Mark Fitch (Grinder in Iron), Ellen Fitch and five children. In 1939 the property was lived in by Emily Playle.</p> <p>In 1992 consent was refused to replace the windows with 'uPVC sash effect Georgian-style windows'.</p>
State of preservation	<p>The timber windows and front door date from the third quarter of the 20th century. The windows are plain glazed with top-hung fanlights. The front wall is finished with pebble-dash render.</p>
Opportunities for enhancement	<ul style="list-style-type: none"> • Installation of white-painted-timber sash windows and a painted-timber front door to reflect the original design • Replace pebble-dash render with smooth render.

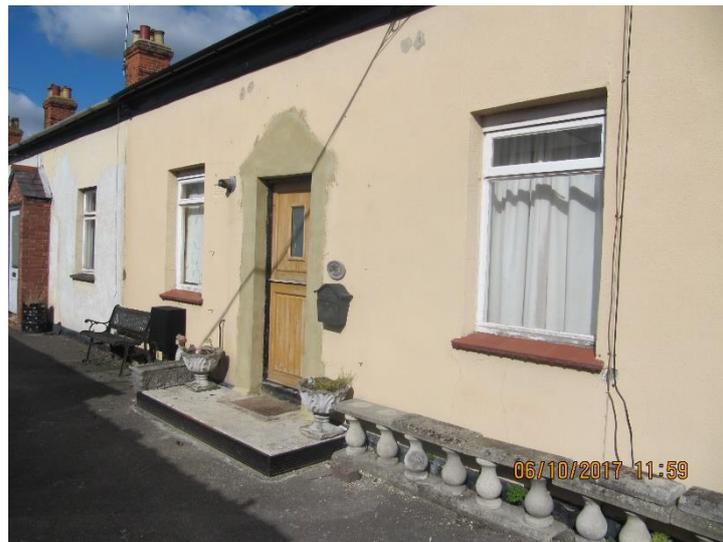
NO. 136

History	<p>In 1911 the residents of this cottage were Henry Key (Gardener), Thirza Key, a grandson, an adopted daughter, and a step daughter. In 1939 the property was lived in by Harriet Turner and one other.</p> <p>In 2002 permission was granted to erect a garage (02/00518/FUL). In 2003 consent was granted to convert the loft of the house, involving the insertion of rooflights (03/00047/LBC). In 2013 consent was refused to retain a recently constructed front porch (13/00645/LBC).</p>
State of preservation	<p>The house has modern timber windows with fanlights and tiled cills. It has a stable-style door with a stained-wood finish.</p> <p>A small porch which existed in 1970 was replaced with a large porch in 2013. This large porch was removed following enforcement action between 2013 and 2017. The concrete base of the unauthorised porch remains in place.</p>
Opportunities for enhancement	<ul style="list-style-type: none"> • Installation of white-painted-timber sash windows and a painted-timber front door to reflect the original design • Removal of the concrete base left over from the unauthorised porch • Painting over the scar left on the front wall by a previous porch

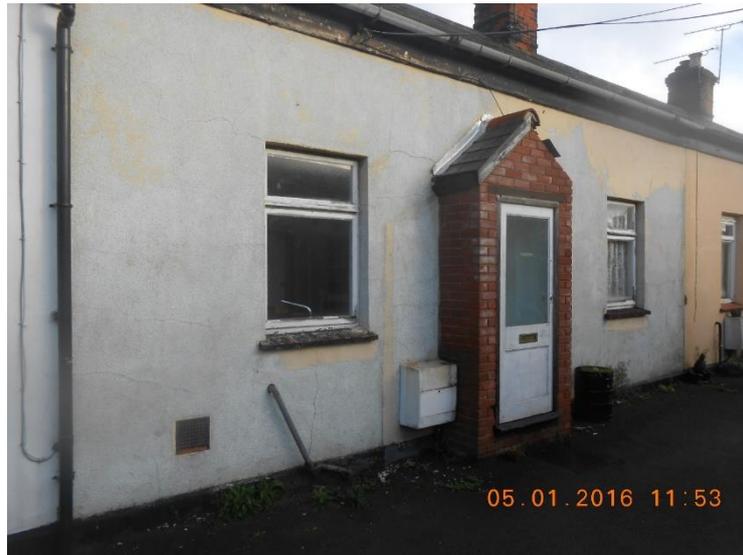
NO. 137

History	<p>In 1911 the residents of this cottage were Edward Gooch (Wood Sawyer), Emily Gooch, two children and two visitors.</p> <p>There are no known past planning permissions or listed building consents for this property.</p>
State of preservation	<p>This house has modern painted timber windows with fanlights and a small brick porch.</p> <p>In 2017 the paint was falling off the front wall.</p>
Opportunities for enhancement	<ul style="list-style-type: none"> • General refurbishment, including repainting of front wall • Installation of white-painted-timber sash windows and a painted-timber front door to reflect the original design • Removal or of front porch, or rendering and painting of front porch to match the rest of the elevation.

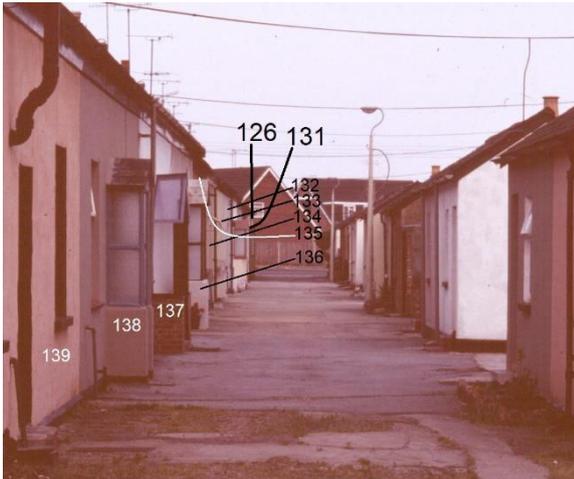
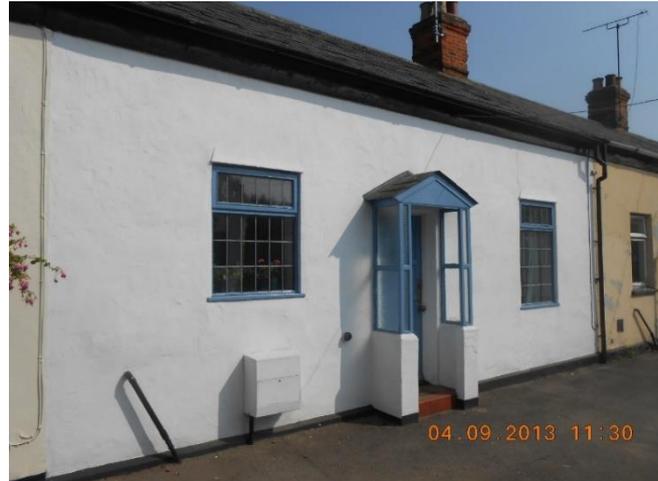
NO. 138

History	<p>In 1911 the residents of this cottage were Anne Sucking and one boarder; John Hurst (Timber Yard Labourer). In 1939 the property was lived in by John Hurst (a Foundry Labourer) and Margaret Hurst.</p> <p>There are no known past planning permissions or listed building consents for this property.</p>
State of preservation	<p>The small porch was in place in 1979.</p> <p>Both the cottage and the outhouse have modern timber windows with top-opening fanlights.</p>
Opportunities for enhancement	<ul style="list-style-type: none"> • Installation of white-painted-timber sash windows and a painted-timber front door to reflect the original design • Removal or replacement of front porch.

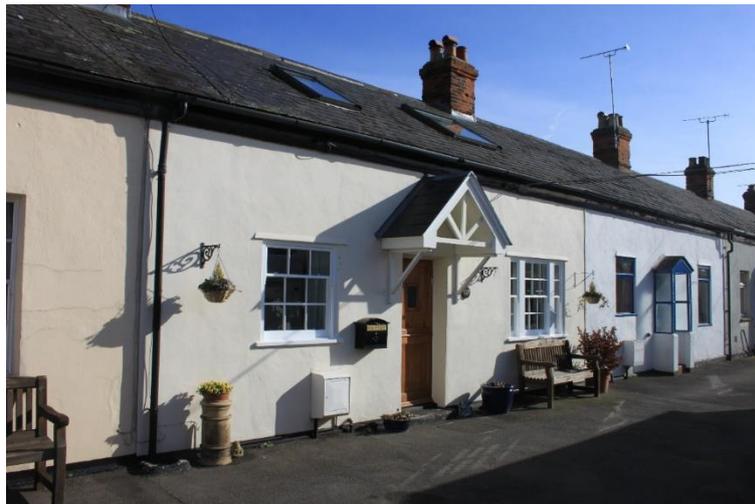
NO. 139

History	<p>In 1911 the residents of this cottage were William Wood (Agricultural Machine Fitter), Kate Wood and two daughters. In 1939 the property was lived in by William Wood (a Packers despatcher) and Kate Wood.</p> <p>In 1985 consent was granted to convert the loft using rooflights, install a porch canopy, demolish the outhouse and construct a garage at the end of the garden. In 2013 consent was refused to retain unauthorised uPVC windows (13/00478/LBC).</p>
State of preservation	<p>Between 1979 and 1985 the front windows were replaced with windows that had top-opening fanlights. The shape of the window opening was altered and the concrete cills were removed. Between 1985 and 2008 the front windows were replaced with multi-paned timber sash windows. A gabled front door canopy was installed and a stained-wood stable door.</p> <p>In 2013 uPVC windows were installed in all five external window openings. These were of a similar style to the previous timber sash windows. In 2018 the uPVC windows were replaced with painted-timber sash windows with slim double glazing. The windows have good detailing, but they do not reflect the original design.</p>

Opportunities for enhancement	<ul style="list-style-type: none"> • Removal of porch canopy • Installation of white-painted-timber sash windows and a painted-timber front door to reflect the original design

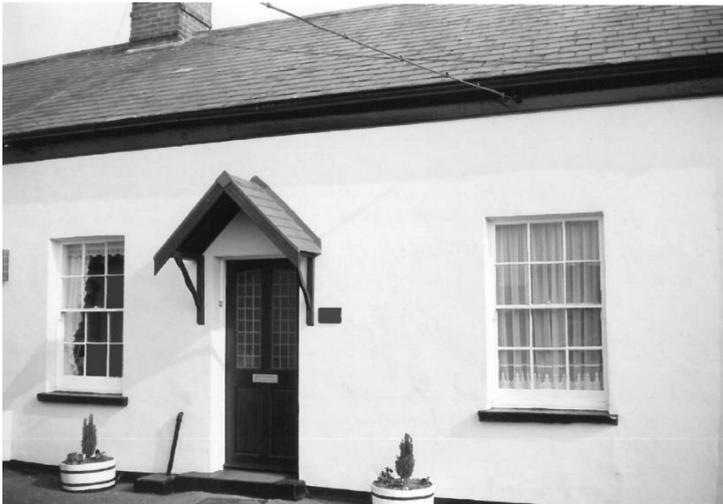
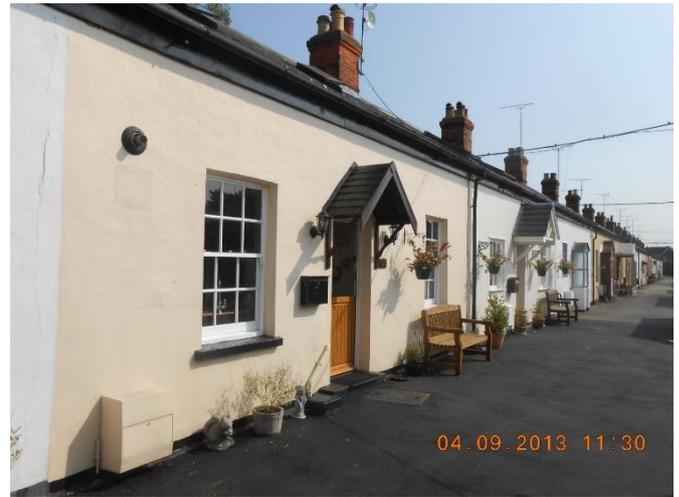
NO. 140

History	<p>In 1911 the residents of this cottage were Alfred Bacon (Stockman), Lydia Bacon, two sons, a granddaughter, and one boarder. In 1939 the property was lived in by Walter Phillips (a Painter & House Decorator) and Elaine Phillips.</p> <p>In 1994 consent was granted to convert the loft, involving the installation of rooflights.</p>
State of preservation	<p>This is one of the only houses to retain original sash windows on the front elevation. The gabled door canopy was installed between 1979 and 1992.</p> <p>A stained-wood stable-style front door was installed in 2013.</p>
Opportunities for enhancement	<ul style="list-style-type: none"> • Replacement of the stained wood stable-style front door with a more traditional painted timber front door • Removal of the porch canopy

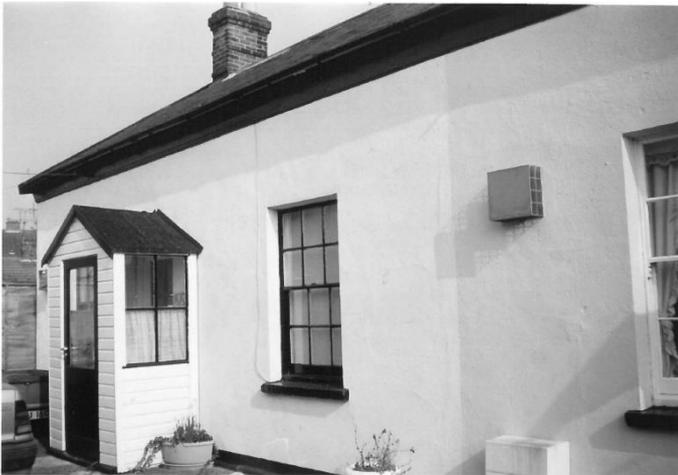
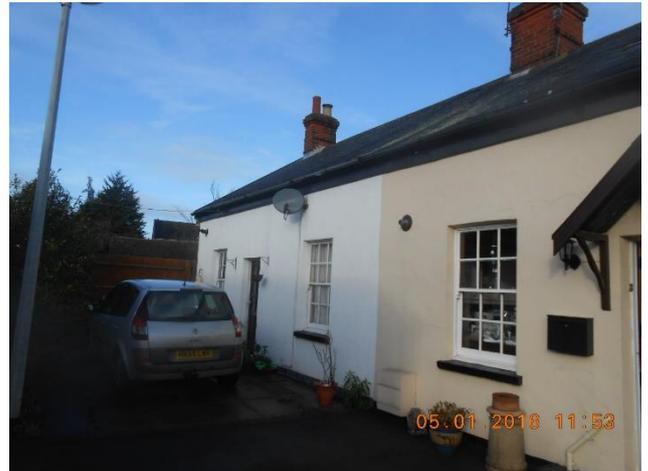
NO. 141

History	<p>In 1911 the residents of this cottage were Golden Lewis (Iron Foundry Labourer), Elizabeth Lewis and four children.</p> <p>According to her great grandson, Harriet Elizabeth Lewis (1865–1955) moved into No. 141 when she married aged 21. In 1939 the property was lived in by Annie Twinn, Harriet Lewis and two unnamed others. Annie Twinn (nee Lewis) was the daughter of Harriet Elizabeth Lewis. Annie purchased the house from Bentalls in the 1930s and lived there until her death in 1987 (source: Richard Twinn, pers.comm.).</p> <p>There are no known past planning permissions or listed building consents for this property.</p>
State of preservation	<p>This is one of the only houses to retain original sash windows on the front elevation. A satellite dish was installed on the front elevation between 1992 and 2005.</p>
Opportunities for enhancement	<ul style="list-style-type: none"> • Replacement of the modern front door with a more traditional-style painted-timber front door • Removal of the satellite dish or its relocation to the rear (north) elevation.

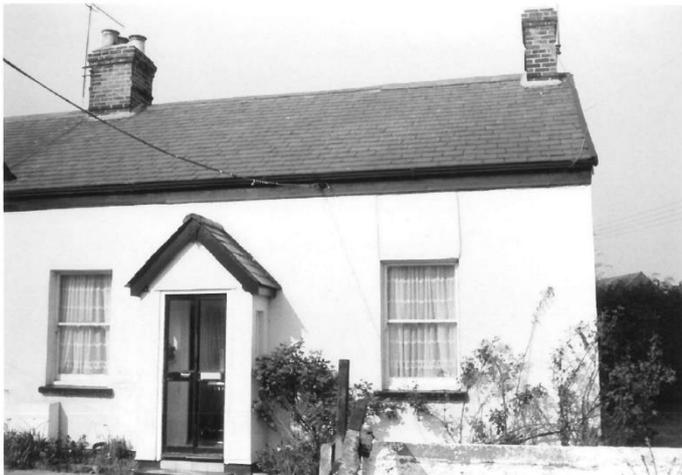
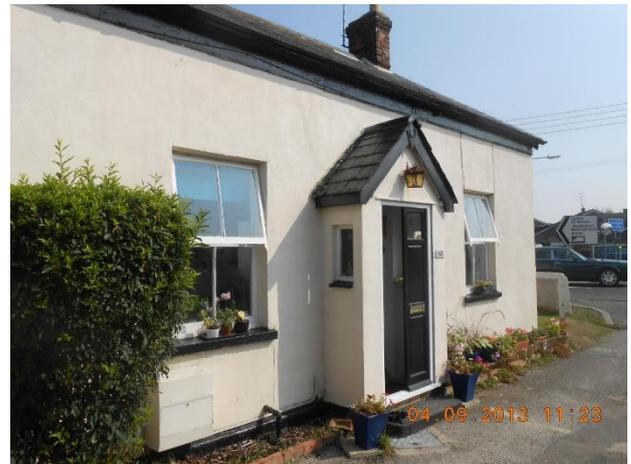
NO. 142

<p>History</p>	<p>In 1939 this cottage was lived in by Herbert Wager (Iron Moulder), another Wager, and Sarah Cook.</p> <p>In 2005 consent was granted to replace 20th-century plain-glazed sliding sash windows with painted-timber tilt-opening sash-style windows (05/00202/LBC).</p>
<p>State of preservation</p>	<p>The small rendered porch was in place by 1992. The porch is compatible with the scale, finishes and detailing of the cottage. The windows are better than uPVC windows but not as sympathetic as the original fenestration.</p>
<p>Opportunities for enhancement</p>	<ul style="list-style-type: none"> • Installation of white-painted-timber sliding sash windows which reflect the original design

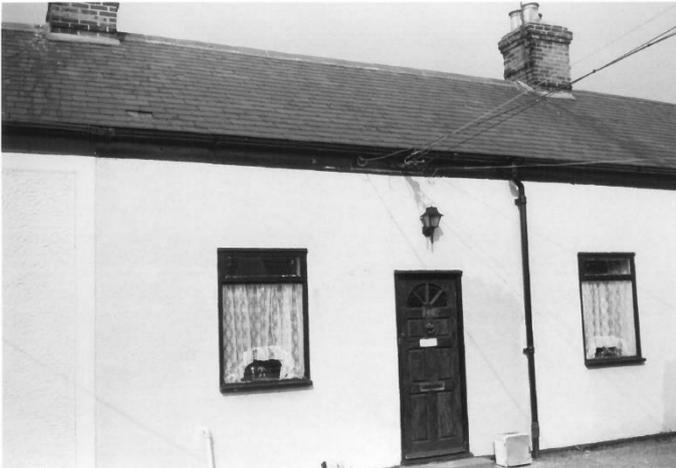
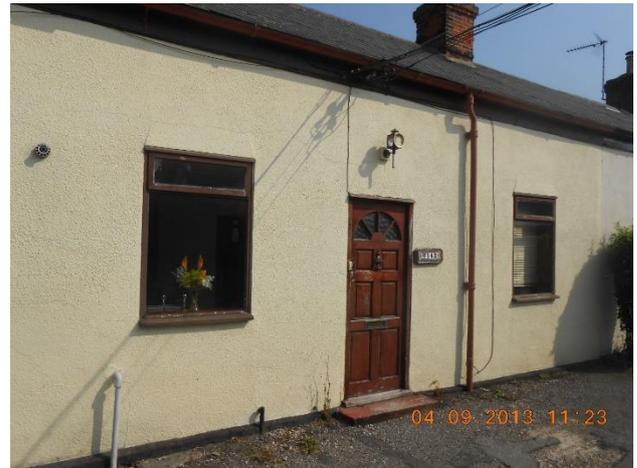
NO. 143

History	<p>In 1911 the residents of this cottage were Henry Cook (a retired Iron Moulder) and Sara Jane Cook. In 1939 the property was lived in by George Sach (an Electrical Contractor) and Annie Sach.</p> <p>In 2006 listed building consent was granted to install a satellite dish on the outhouse (06/01115/LBC).</p>
State of preservation	<p>The painted-timber plain-glazed windows with fanlights and mock-Georgian front door were in place by 1992.</p>
Opportunities for enhancement	<ul style="list-style-type: none"> • Installation of white-painted-timber sash windows and a painted-timber front door to reflect the original design

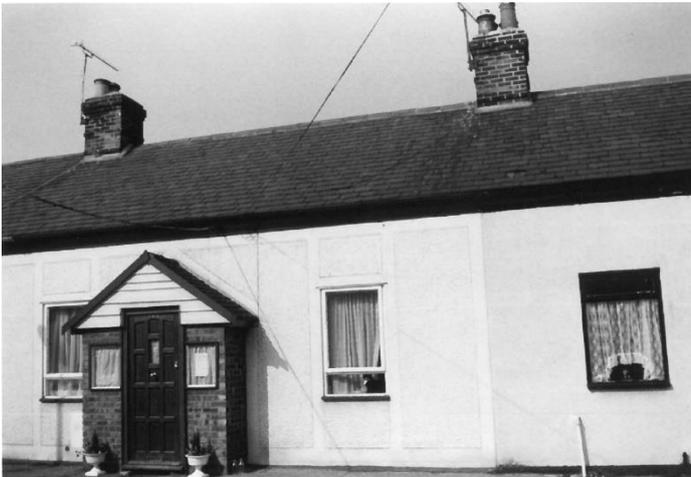
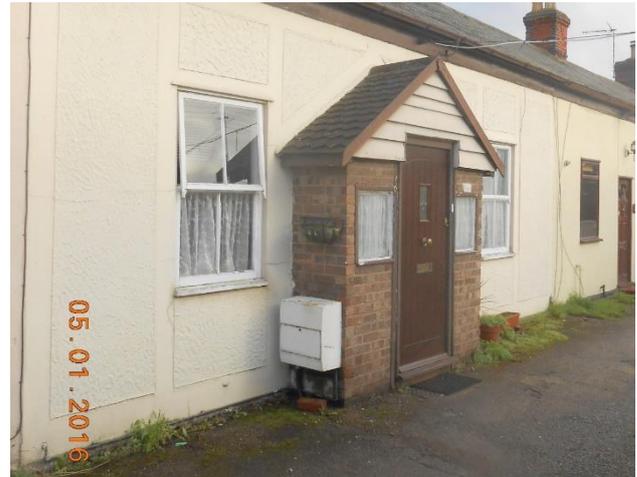
NO. 144

History	<p>In 1911 the residents of this cottage were Herbert Cook (Iron Foundry Moulder), Georgina Cook and two children. In 1939 the property was lived in by Annie Normal, Mary Moles, and two others.</p> <p>In 1998 a listed building consent application to retain unauthorised uPVC windows was refused then dismissed at appeal (98/00444/LBC). In 2003 consent was granted to install painted-timber tilt-opening sash-style windows (03/01156/LBC).</p>
State of preservation	<p>The sash-style windows are better than uPVC windows but not as sympathetic as the original fenestration. The pargetted render and excessively wide porch were in place by 1992.</p>
Opportunities for enhancement	<ul style="list-style-type: none"> • Installation of white-painted-timber sliding sash windows which reflect the original design • The removal or replacement of the current porch • Replacement of the pargetted render with smooth render.

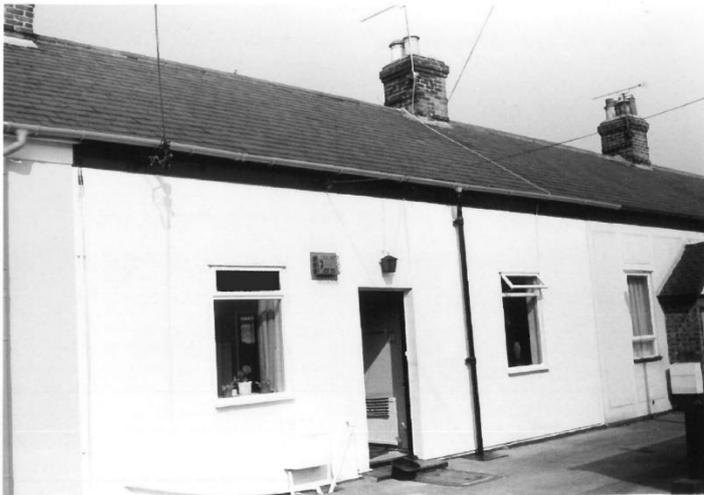
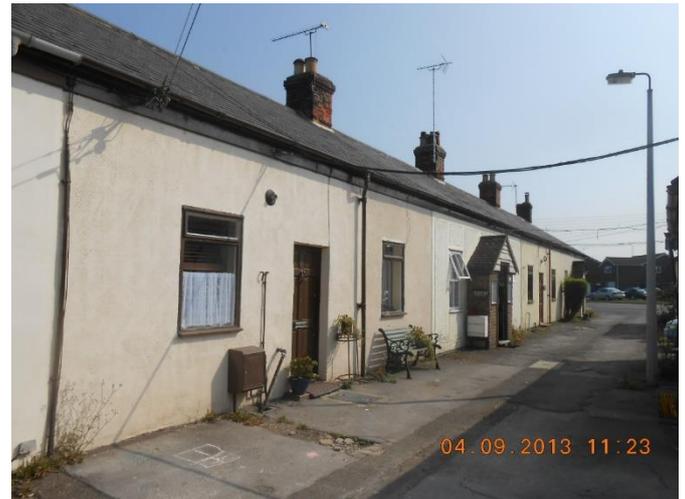
NO. 145

History	<p>In 1911 the residents of this cottage were Eliza Bevers, two sons and one boarder. In 1939 the property was lived in by James Staples (a retired Metal Turner) and Eleanor Staples.</p> <p>There are no known past planning permissions or listed building consents for this property.</p>
State of preservation	<p>The house has painted-timber plain-glazed windows with top-hung fanlights and a mock-Georgian-style front door which were in place by 1992.</p> <p>2018 sale photographs show that one of the rooms in the house retains an original cast-iron grate.</p> <p>The original roof slates on the outbuilding have been replaced by concrete tiles</p>
Opportunities for enhancement	<ul style="list-style-type: none"> • Installation of white-painted-timber sliding sash windows and a painted-timber front door which reflect the original design • Replacement of the concrete tiles on the outbuilding with natural slates
