WOODFIELD COTTAGES, HEYBRIDGE

CONSERVATION AREA CHARACTER STATEMENT

This document was produced by Maldon District Council.

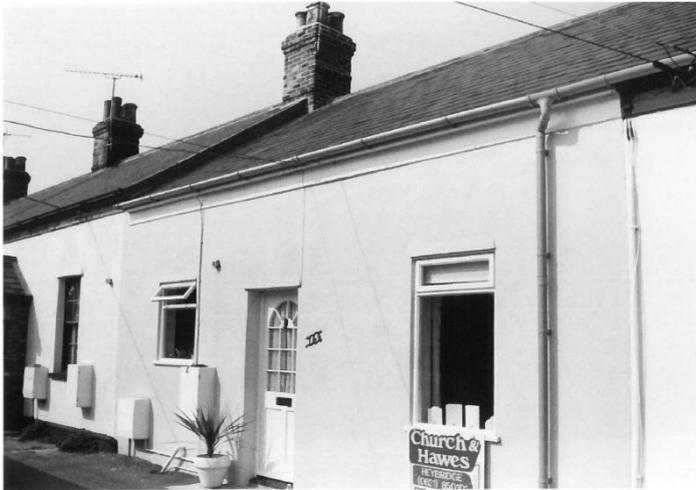
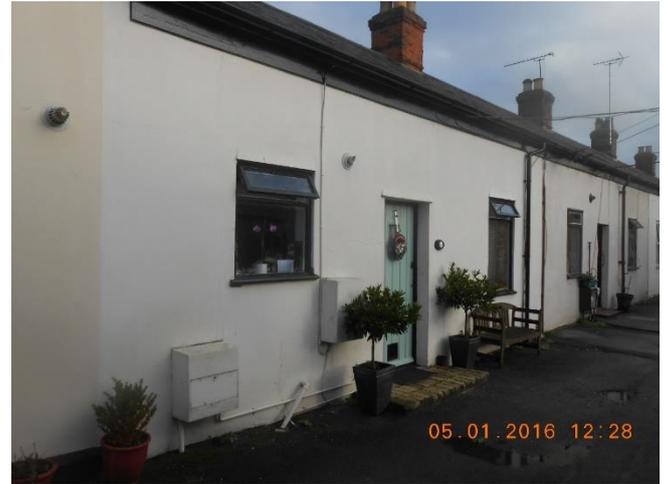
NO. 146

History	<p>In 1911 the residents of this cottage were Henry Taylor (a Horseman on a farm) and two daughters. In 1939 the property was lived in by Albert Taylor (a Lathe Machinist) and Sarah Taylor.</p> <p>There are no known past planning permissions or listed building consents for this property.</p>
State of preservation	<p>The current painted-timber plain-glazed windows with top-hung fanlights were in place in 1992.</p> <p>Between 1992 and 2013, the mock-Georgian front door was replaced by a vertically-boarded painted-timber door with a small rectangular window.</p> <p>Curiously, there appear to be two electricity cabinets on the front wall.</p> <p>The property has a small garage set back in the garden to one side of the outhouse.</p>
Opportunities for enhancement	<ul style="list-style-type: none"> • Installation of white-painted-timber sliding-sash windows in the cottage which reflect the original design • Remove one of the electricity cabinets if no longer required.

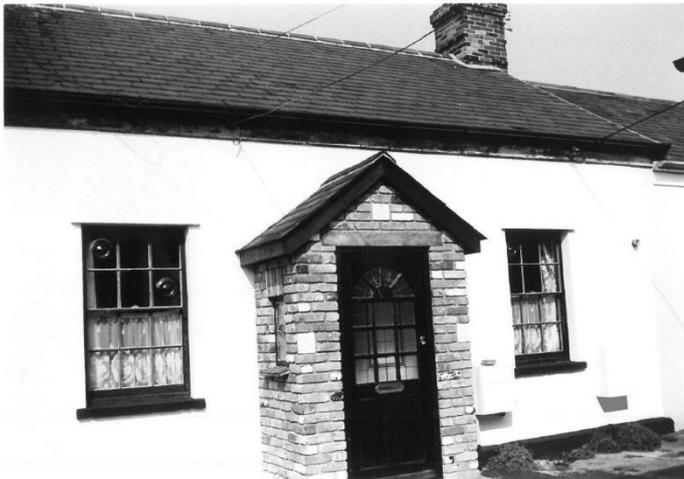
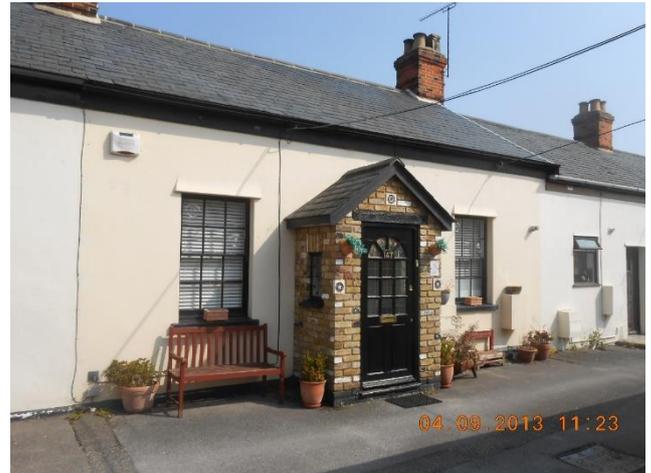
NO. 147

<p>History</p>	<p>In 1911 the residents of this cottage were Sarah Ann Boer and three sons. One of the sons – Frank – was employed as a Turner at an Iron Foundry. In 1939 the property was lived in by James Taylor (a retired Horseman on Farm), Harry Taylor (a Master Boot Repairer), Mary Taylor and John Taylor (a Railway Porter).</p> <p>There are no known past planning permissions or listed building consents for this property.</p>
<p>State of preservation</p>	<p>The windows on the front elevation of this cottage reflect the original design but incorporate modern bulls-eye-effect glass.</p> <p>The rather oversized brick porch was already in place in 1992.</p> <p>Curiously, there appear to be two electricity cabinets on the front wall.</p> <p>The loft has been converted, involving the installation of three rooflights on the rear slope.</p>
<p>Opportunities for enhancement</p>	<ul style="list-style-type: none"> • Removal / smooth rendering / replacement of current brick porch • The replacement of the current mock-Georgian-style front door with painted-timber front door which reflects the original design. • Remove one of the electricity cabinets if no longer required.

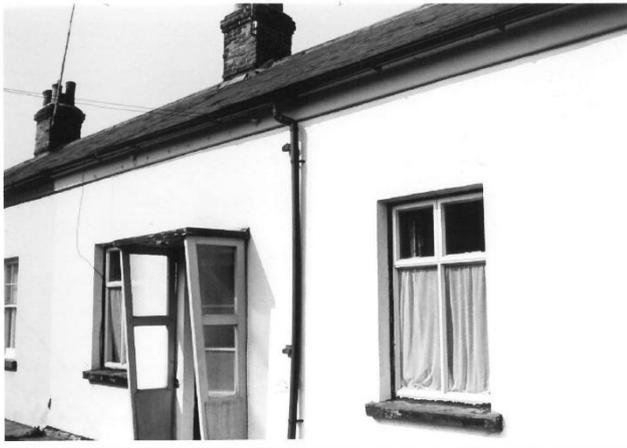
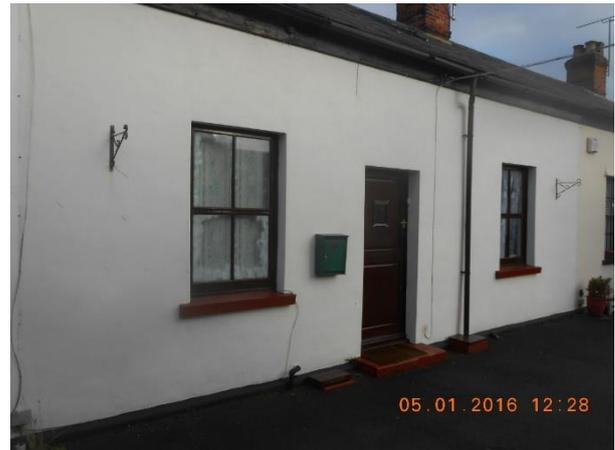
NO. 148

<p>History</p>	<p>In 1911 the residents of this cottage were Frederick Fisher (a Turner), Elizabeth Fisher and three children; Cliff, Tom and Les. In 1939 the property was lived in by Elizabeth Fisher and Edwin Fisher (a Junior Clerk). The Fishers lived at No. 148 until 1952. During the First World War two soldiers were billeted at the cottage (additional information and photographs below kindly supplied by Barbara Chinnery).</p> <p>In 1998 consent was granted to convert the loft, involving the installation of two rooflights (98/00910/LBC)</p>
<p>State of preservation</p>	<p>Tilt-opening sash-style timber windows replaced modern casement windows between 1993 and 2013.</p> <p>The house has a modern stable-style front door.</p>
<p>Opportunities for enhancement</p>	<ul style="list-style-type: none"> • Installation of white-painted-timber sliding-sash windows and a painted-timber front door which reflect the original design

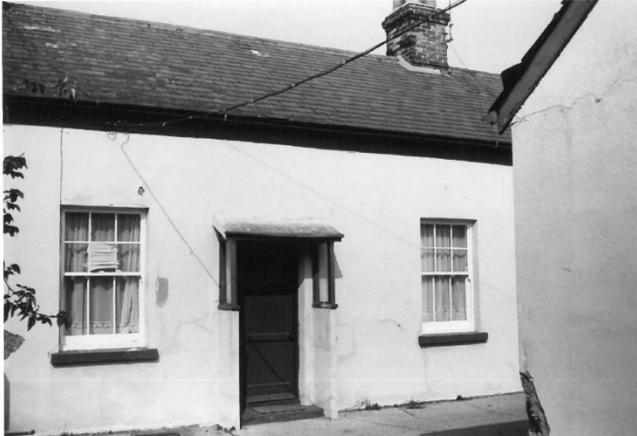
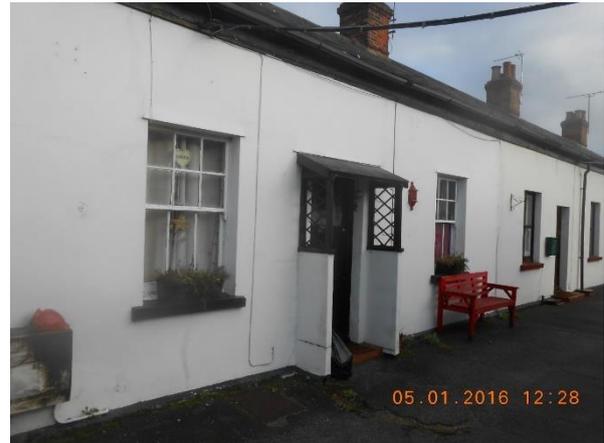
NO. 149

History	<p>In 1911 the residents of this cottage were Thomas Ruggles (Iron Moulder), Rebecca Ruggles, three sons and one boarder. In 1939 the property was lived in by Emily Harvey and Catherine Mulrennan ('Incapacitated').</p> <p>In 2020 consent was granted to convert the loft, involving the installation of rooflights (HOUSE/MAL/20/00969 & LBC/MAL/20/01030).</p>
State of preservation	<p>This house retains original sash windows although most of the bottom casements have been altered and re-glazed to create three elongated panes. The small front porch was in place by 1992.</p>
Opportunities for enhancement	<ul style="list-style-type: none"> • Installation of white-painted-timber sliding-sash windows and a painted-timber front door which reflect the original design • The removal or replacement of the current porch

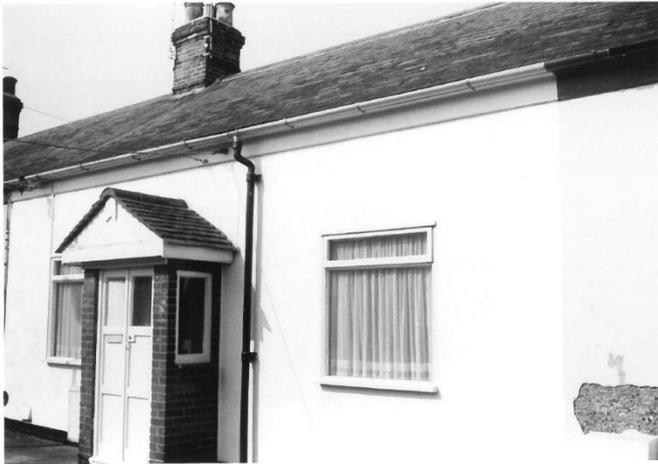
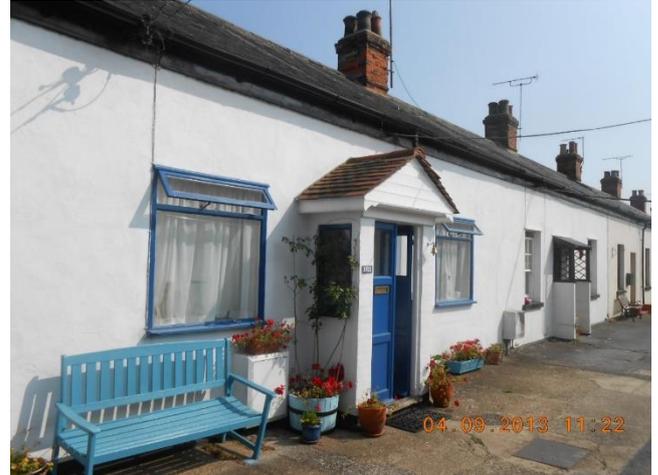
NO. 150

History	<p>In 1911 the residents of this cottage were James Page (Furnaceman at an Iron Foundry), Alice Page and two children. In 1939 the property was lived in by James Page (a retired Iron Foundry Foreman), Ann Page, Ailsa Stevens and one other person.</p> <p>In 2021 listed building consent was granted to install painted-timber sliding-sash windows which reflect the original design (ref. 21/00015/LBC)</p>
State of preservation	The plain-glazed painted-timber windows and porch were in place by 1992.
Opportunities for enhancement	<ul style="list-style-type: none"> • Installation of painted-timber sliding-sash windows and a painted-timber front door which reflect the original design • The removal or replacement of the current porch

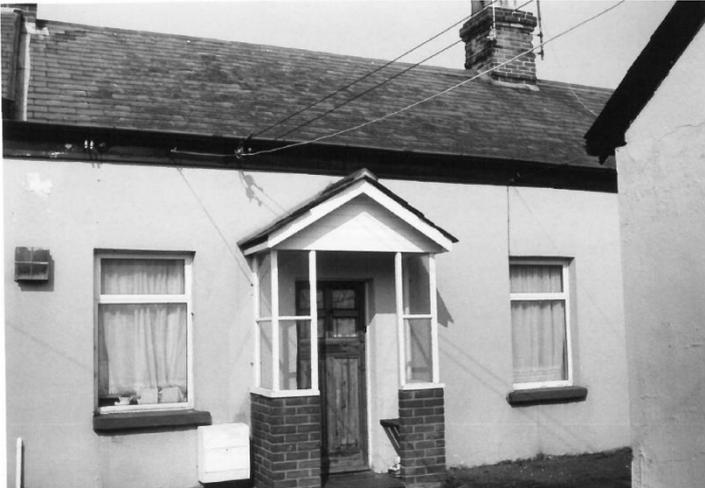
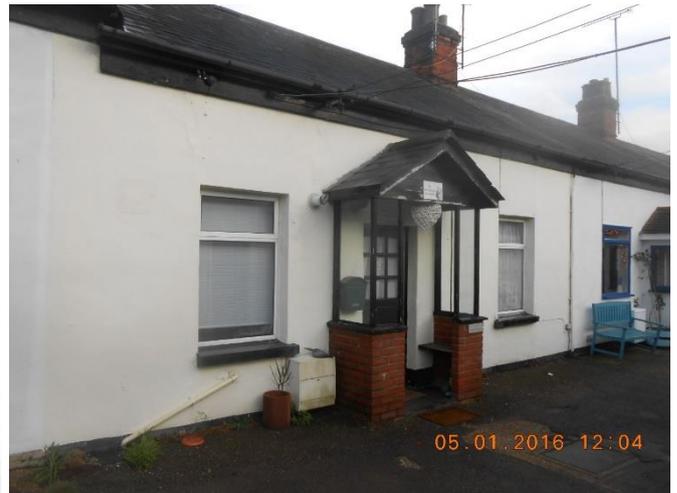
NO. 151

History	<p>In 1911 the residents of this cottage were Charles Howlett (Moulder), Eliza Howlett and six children. In 1939 the property was lived in by Charles Howlett (a retired Iron Moulder), Ethel Howlett, Frederick Howlett (Brick Layer), Albert Howlett (Land Worker), Gladys Howlett (Laundry Hand) and Wilfred Howlett (Wood Machinist).</p> <p>There are no known past planning permissions or listed building consents for this property.</p>
State of preservation	<p>The current porch and aluminium windows were in place by 1992. The front window openings retain their original shape and concrete cills. The front door is a painted-timber stable-style door.</p>
Opportunities for enhancement	<ul style="list-style-type: none"> • Installation of white-painted-timber sliding-sash windows and a painted-timber front door which reflect the original design • The removal or replacement of the current porch

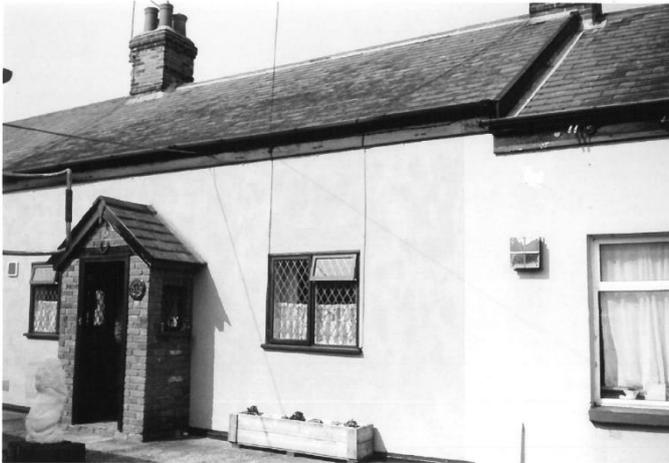
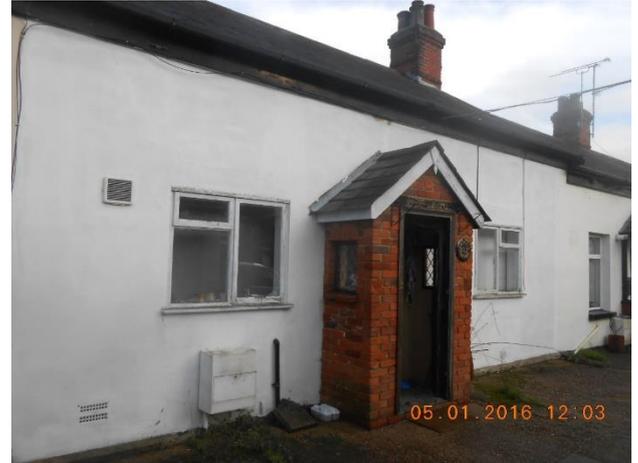
NO. 152

History	<p>In 1911 the residents of this cottage were Joseph Wenden (Wood Sawyer at an Agricultural Implements Manufacturer), and Mary Ann Wenden. In 1939 the property was lived in by Bertie Saltmarsh (an Agricultural Machine Fitter) and Elizabeth Saltmarsh.</p> <p>There are no known past planning permissions or listed building consents for this property.</p>
State of preservation	<p>This house has a modern front door, brick porch and plain-glazed timber windows.</p>
Opportunities for enhancement	<ul style="list-style-type: none"> • Installation of white-painted-timber sliding-sash windows and a painted-timber front door which reflect the original design • Removal of the porch or smooth rendering over the brickwork of the porch walls (see Fig. 45 and p. 26)

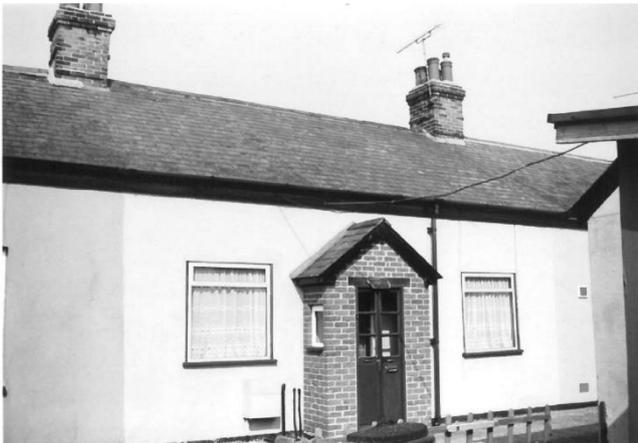
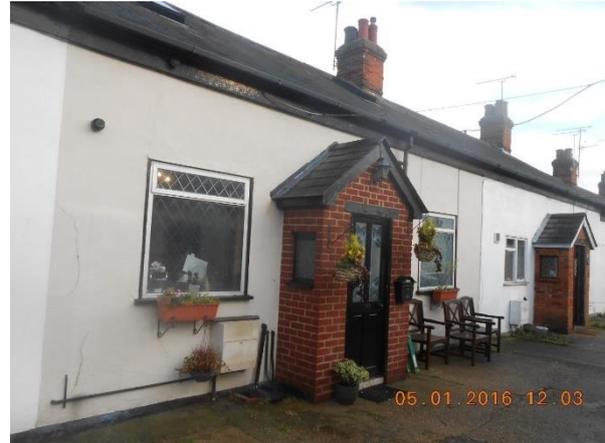
NO. 153

<p>History</p>	<p>In 1911 the residents of this cottage were R. Miller (a Machine Strap Mender), Eliza Miller, and three children. In 1939 the property was lived in by Alfred Smith (an Agricultural Engineer), Florence Smith, ?Basil Smith, and Joyce Smith (who was at school).</p> <p>In 1998 consent was granted to convert the loft, involving the installation of rooflights (98/00023/LBC)</p>
<p>State of preservation</p>	<p>This house has a modern front door, porch and aluminium windows.</p>
<p>Opportunities for enhancement</p>	<ul style="list-style-type: none"> • Installation of white-painted-timber sliding-sash windows which reflect the original design • Removal of the porch or smooth rendering over the brickwork of the porch walls (see Fig. 45 and p. 26)

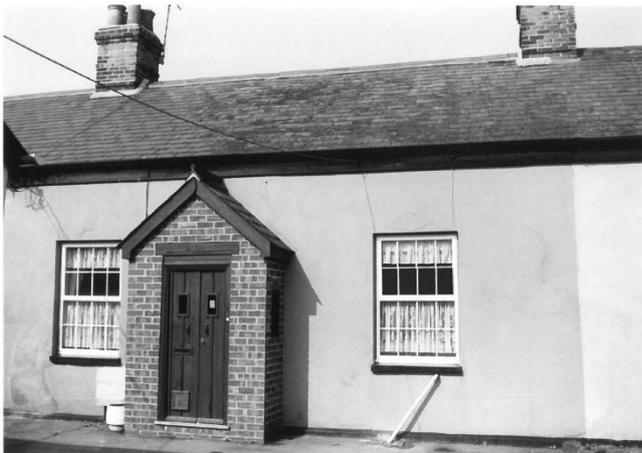
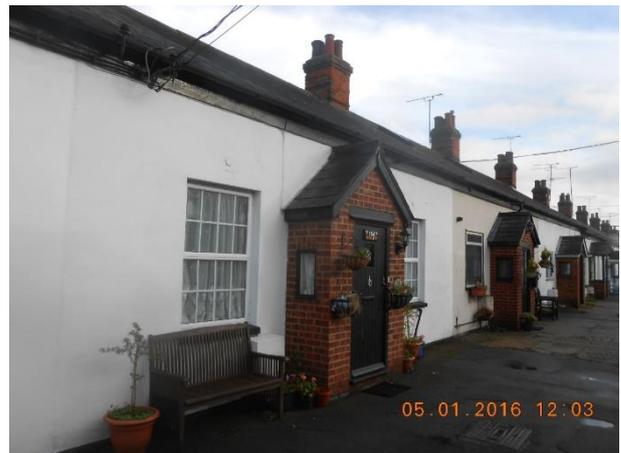
NO. 154

History	<p>In 1911 the residents of this cottage were Charles Fenn (Machine Painter), Florence Fenn, seven children and one other. In 1939 the property was lived in by Charles Fenn (Agricultural Machine Painter), Florence Fenn and Arthur Fenn (Wood Machinist Labourer).</p> <p>There are no known past planning permissions or listed building consents for this property.</p>
State of preservation	<p>This house has a modern front door, brick porch and aluminium windows.</p>
Opportunities for enhancement	<ul style="list-style-type: none"> • Installation of white-painted-timber sliding-sash windows which reflect the original design • Removal of the porch or smooth rendering over the brickwork of the porch walls (see Fig. 45 and p. 26)

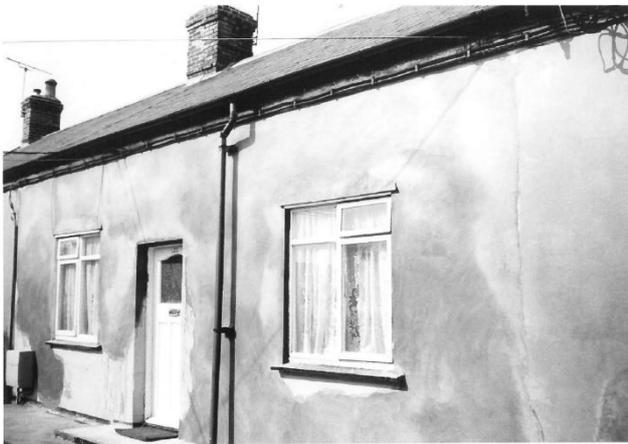
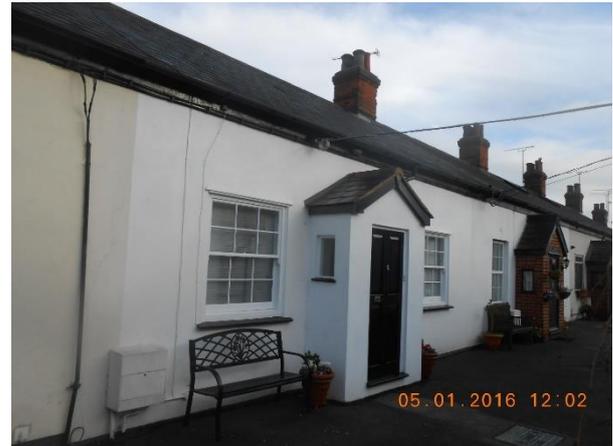
NO. 155

History	<p>In 1911 the residents of this cottage were Samuel Fisher (Carman), Sarah Fisher and two children. In 1939 the property was lived in by Herbert Mortlock (a Wood Machinist) and Winifred Mortlock.</p> <p>In 2014 consent was granted to install painted-timber sliding-sash windows and a porch (14/01075/LBC). In 2020 consent was granted for a loft conversion (20/01175/LBC).</p>
State of preservation	<p>The recent sash windows are a reasonably close reflection of the original window design and the porch is compatible with the scale, finishes and detailing of the cottage.</p>
Opportunities for enhancement	<p>None identified.</p>

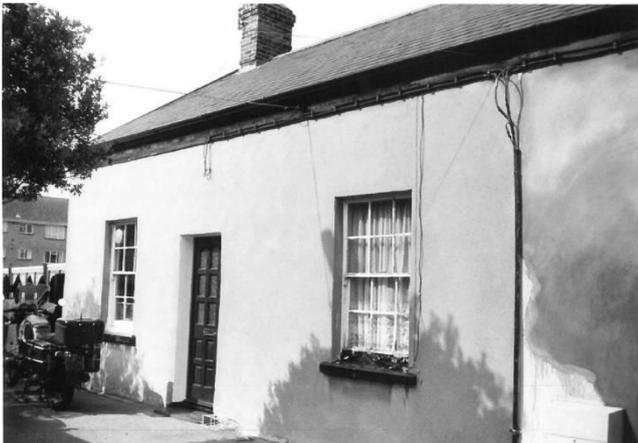
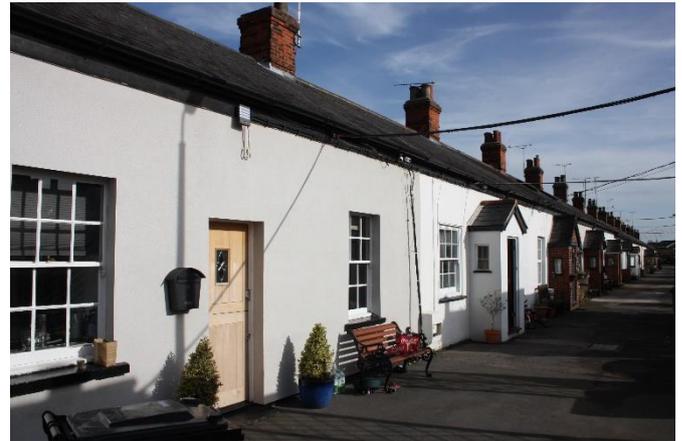
NO. 156

History	In 1911 the residents of this cottage were Alfred Moss (Moulder), Jane Moss and seven children. In 1939 the property was lived in by Frederick Willey (a Shopkeeper), Winifred Willey and one other.
State of preservation	This is one of the few cottages to retain the original sash windows on the front elevation. The current front door is a stained-wood stable-style door. In 2021 permission was granted to convert the loft using rooflights and install a small rendered front porch (refs 21/00347/HOUSE & 21/00348/LBC)
Opportunities for enhancement	<ul style="list-style-type: none"> • Replacement of the front door with a painted-timber four-panel door.
