Memorial Bench Safety Testing Procedure

01 November V1

This procedure is intended for Maldon District Council cemetery staff looking to undertake the memorial bench testing procedure.

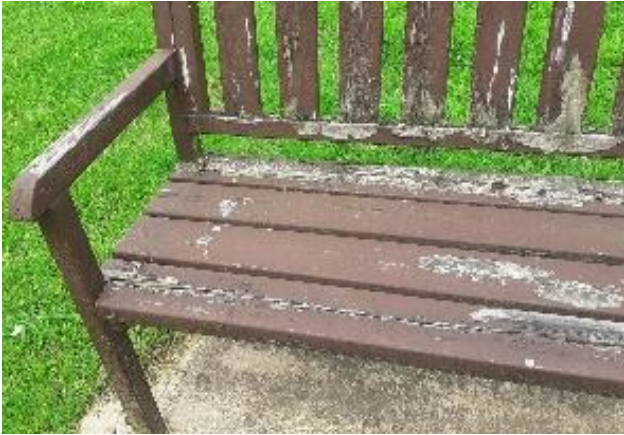
2a. general weathering of bench. This includes peeling paint and exposed timber.

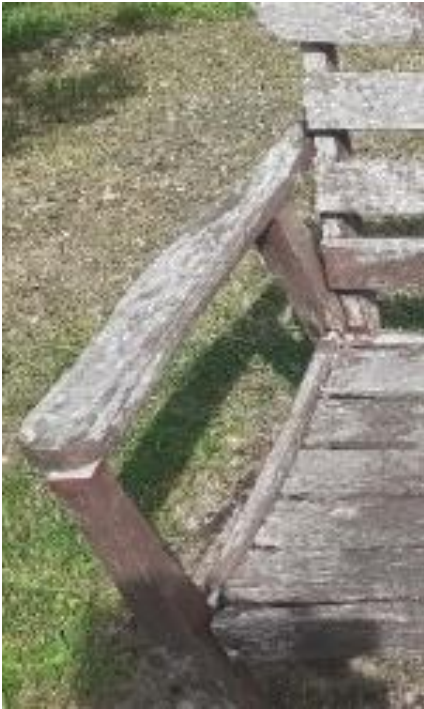
2b. cracking of wood and loose joints within the assembly of the bench.

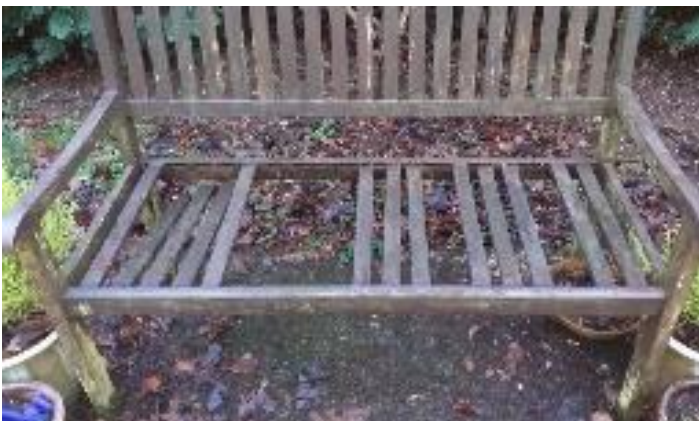
2c. seating slats come loose or removed from bench.
