# Maldon District Heritage at Risk Register 2017

August 2017

Planning Policy

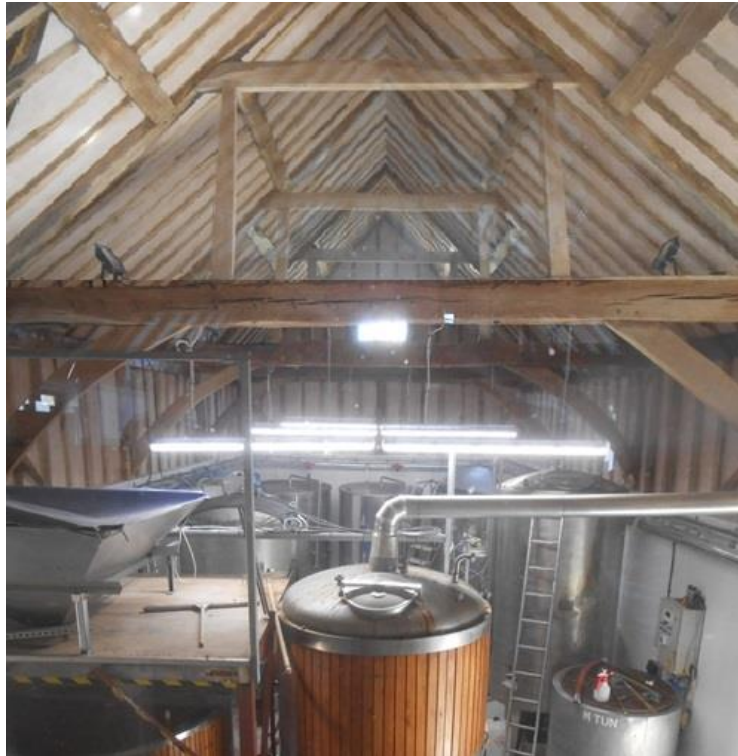
Fig. 3 – Interior of Southminster Hall Barn, restored and converted to a brewery in 2015-16

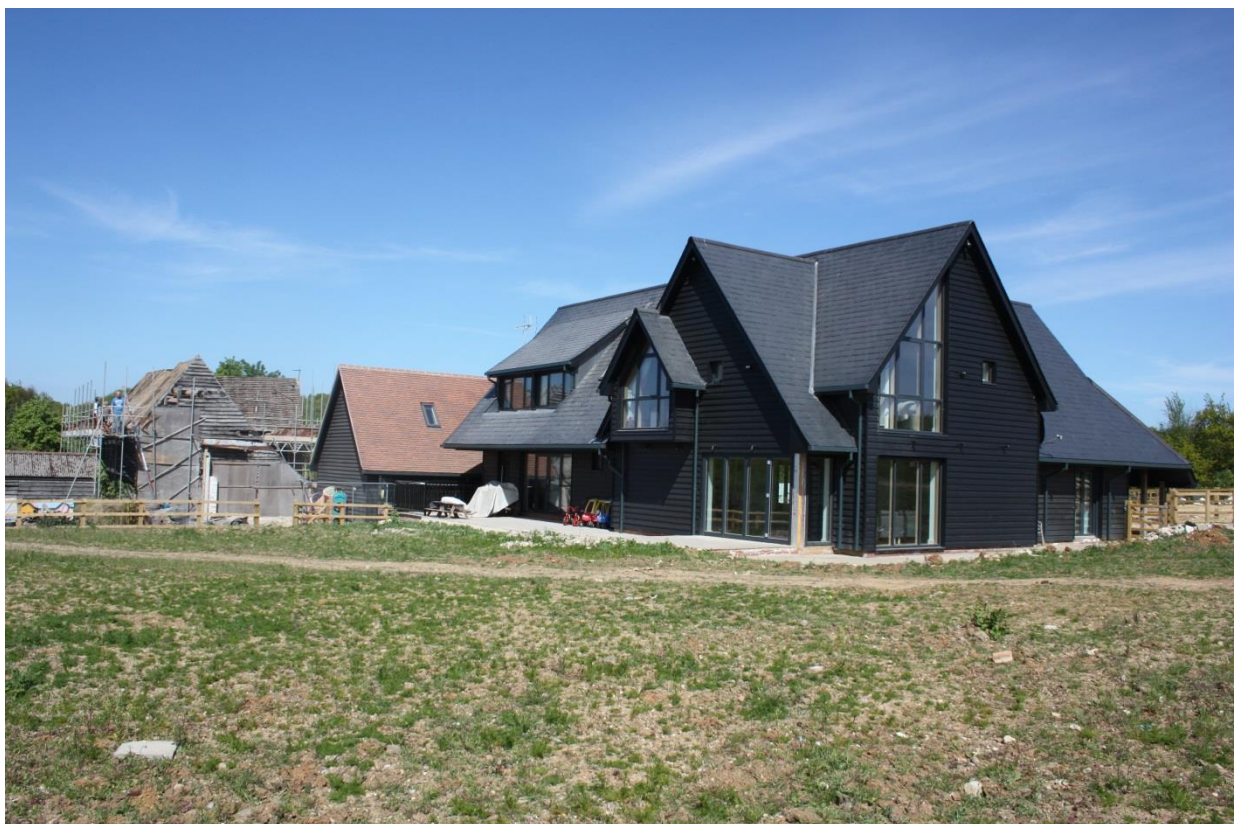
Fig. 4 – a new house at Noaks Cross, Great Braxted. A legal agreement between the owner and the Council requires the repair of the adjacent barn within one year of the completion of the house. The repair of the barn is currently underway.

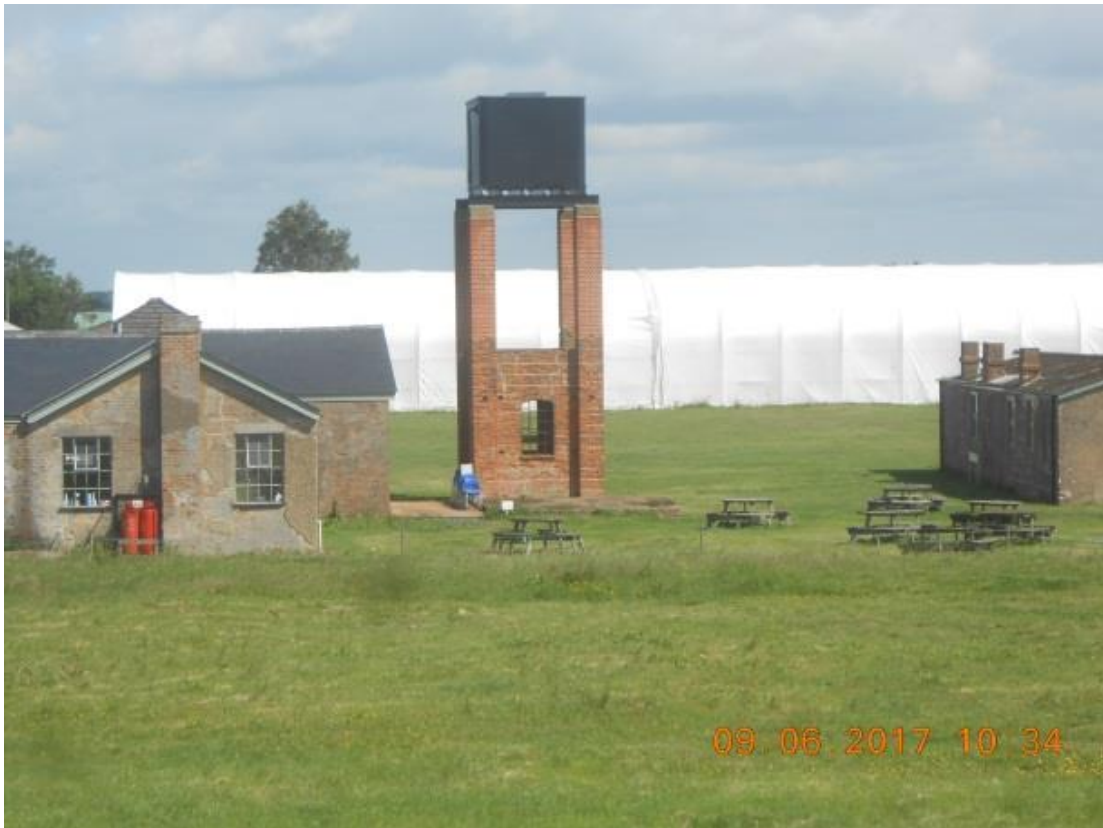
Fig. 5 – The Water Tower at Stow Maries Aerodrome was repaired in 2017

Throughout 2016 and 2017, Stow Maries Great War Aerodrome – one of the District's highest-profile heritage sites – has seen the repair and stabilisation of several of its grade II\* listed buildings. This work has been enabled by grant funding from WREN and Historic England, and has been made easier through a Heritage Partnership Agreement between Maldon District Council and the Trust which manages this site. The Royal Engineers' Workshop, the Motor Transport Shed, the Fuel Store and the iconic Water Tower have all recently been completely repaired and can now be removed from the at-risk register (Fig. 5).

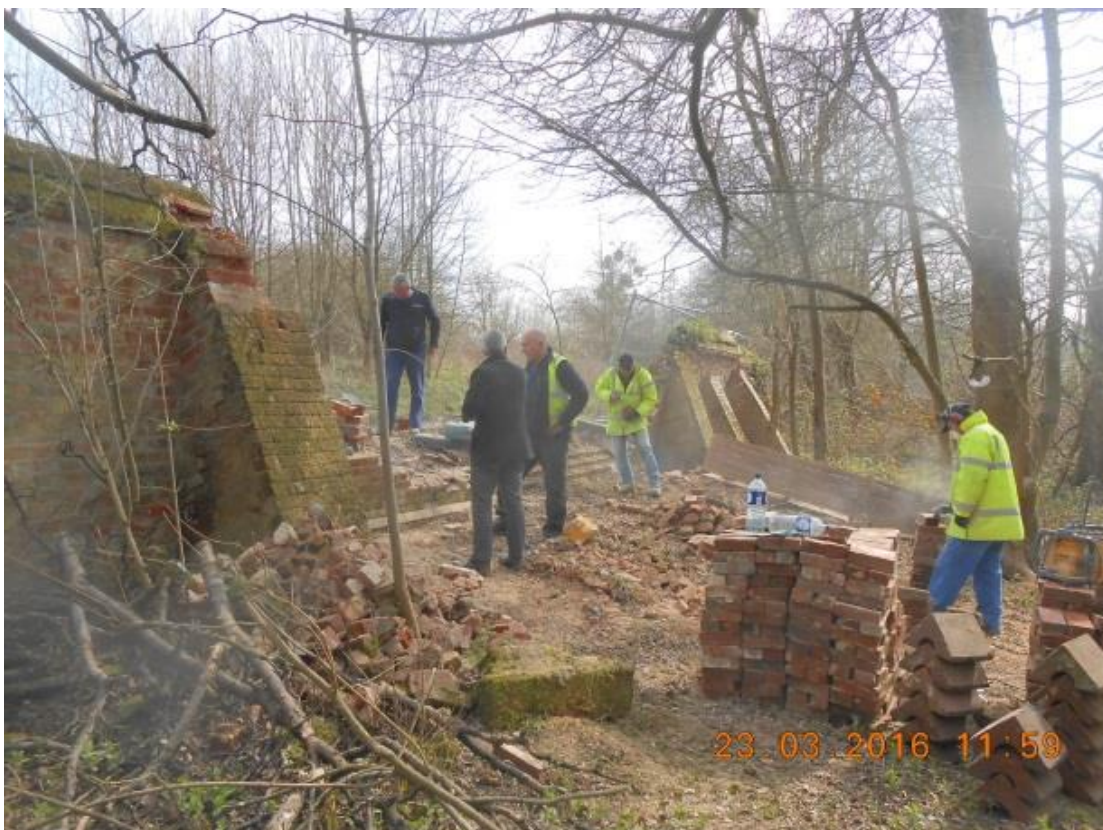
Fig. 6 – The repair of Braxted Park Wall is being funded by enabling development

Unlike Stow Maries Aerodrome, most privately owned buildings are not eligible for grant funding and sometimes alternative, inventive means of financing essential repair are required. The estimated cost of repairing the 4 mile-long, early 19<sup>th</sup>-century wall which surrounds Braxted Park was over a million pounds. Following negotiation with the Council this work is currently being funded by a scheme of enabling development in the form of 14 houses on the edge of the village. Already over a third of the wall's length has been repaired and is set to be completed well ahead of the target date. The repairs carried out so far, using traditional hot-lime techniques, are of an exemplary standard (Fig. 6).

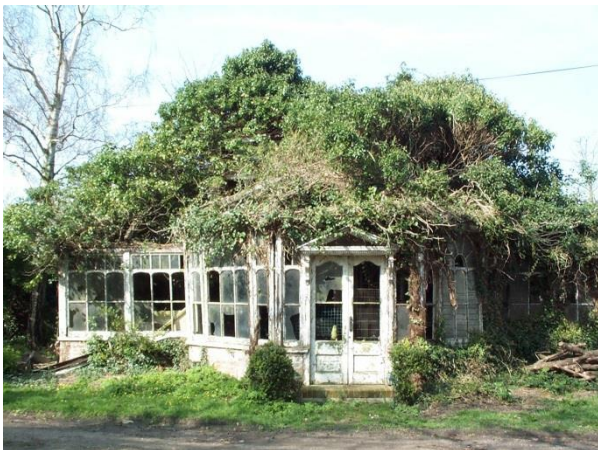
Fig. 7 – Down Hall Conservatory,  
Bradwell-on-Sea, in 2002

Regrettably, there are instances where efforts to rescue historic buildings have not been successful. The detached Victorian conservatory at Down Hall, Bradwell-on-Sea – which had been on the at-risk register since 1991 – has now almost completely collapsed (Figs 7 and 8). This building was in a poor condition when it was first designated a listed building, and despite the efforts of the Mid-Essex Building Preservation Trust a viable new use has never been found for the building. The conservatory is now being considered by Historic England for de-listing. The collapse of one of the Women’s Hostels at Stow Maries Aerodrome during the strong winds of November 2015 was particularly disappointing, although it served to highlight the fragility of these buildings (which, of course, were never intended to last as long as they have) and galvanised the Trust to install structural shoring throughout the site. It is intended to rebuild this collapsed building in replica using the salvaged material as part of the overall restoration of the Aerodrome.

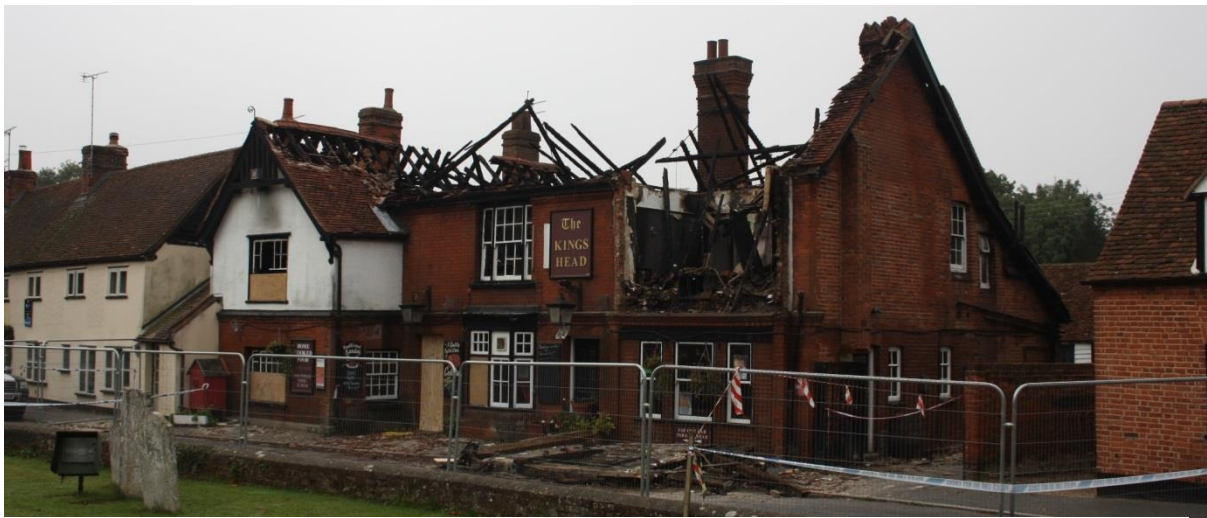
Fig. 9 – The King's Head, Bradwell-on-Sea, in September 2014

There are, however, cases where – against the odds and in spite of the lack of grant availability – owners will go above and beyond to ensure the sympathetic restoration of a building largely because they have been inspired by its importance. A devastating fire in late 2014 revealed that the King’s Head in Bradwell-on-Sea is much older than previously thought. Although it is not listed, the new owner has

restored this medieval building to an exceptionally high standard. This is a building which could so easily have been lost and it is thanks to the commitment of the owner that so much of its ancient fabric has been saved (Figs 9 and 10).

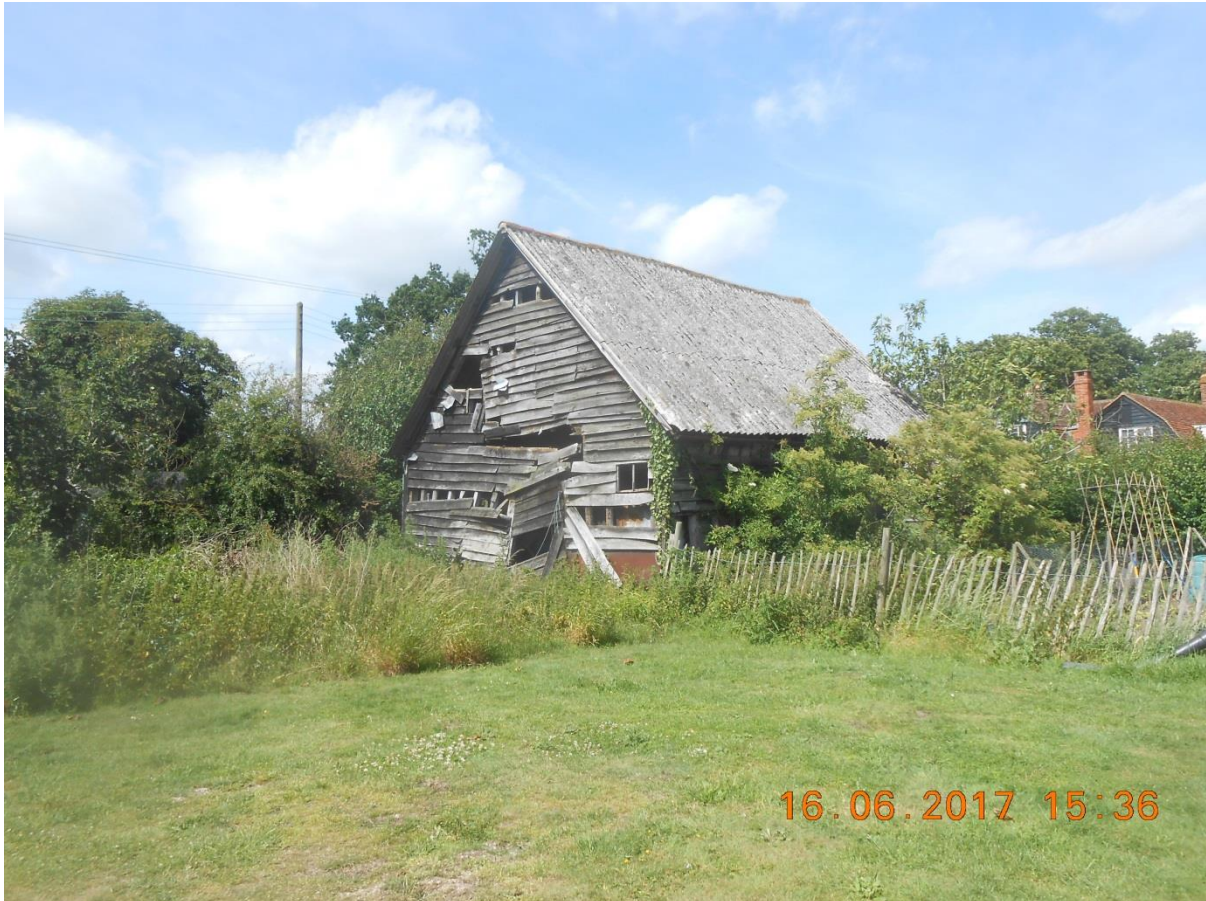
### Bacons Barn, Bacons Chase

Designation:	Grade II listed
Priority:	<b>A</b> - Immediate risk of further rapid deterioration. No solution agreed.
Condition:	<b>Very bad</b> – An adjoining cartlodge has collapsed. The gable-end tie beam has become so decayed that it has snapped in two. Areas of missing cladding mean that it is not satisfactorily weathertight.
Date registered:	2004
Ownership:	Private
For Sale:	No
Summary:	Redundant Georgian farm building. There have been discussions and written correspondence in 2017 between the owner and the conservation officer on how to best secure the future of the barn.

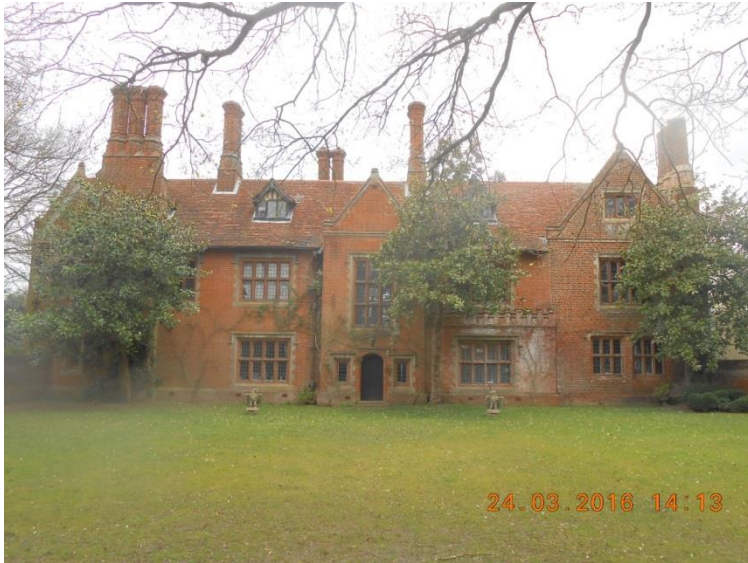
### Creeksea Place

Priority: **E** - This substantial house was derelict for many years, resulting in long-term deterioration of the building's structure. Localised leaks caused parts of the Tudor roof structure to decay. Following grant aid from English Heritage (now Historic England) the roof structure was supported by a system of timber shores and props which remain in place on each floor.

Condition: **Poor** – The building is weathertight. But internally, historic panelling and plaster finishes remain in a decayed and vulnerable condition.

Summary: This building incorporates the remains of an important 16<sup>th</sup>-century brick mansion. For the past decade the current owners have used the Victorian part of the building as a wedding venue with the aim of funding repair works to the Tudor ranges. This has enabled ongoing maintenance of the roof to prevent leaks and the restoration of a panelled room on the ground floor in 2008. However, the large cost of repairing the roof has meant that no progress has yet been made in this respect. The owners have now employed a heritage consultant with whom they are developing a strategy to fund the necessary repairs and finally get the building removed from the 'at risk' register. In 2017 positive meetings have taken place with Historic England, the Country Houses Foundation and subsequently with LEADER to assess potential grant funding.

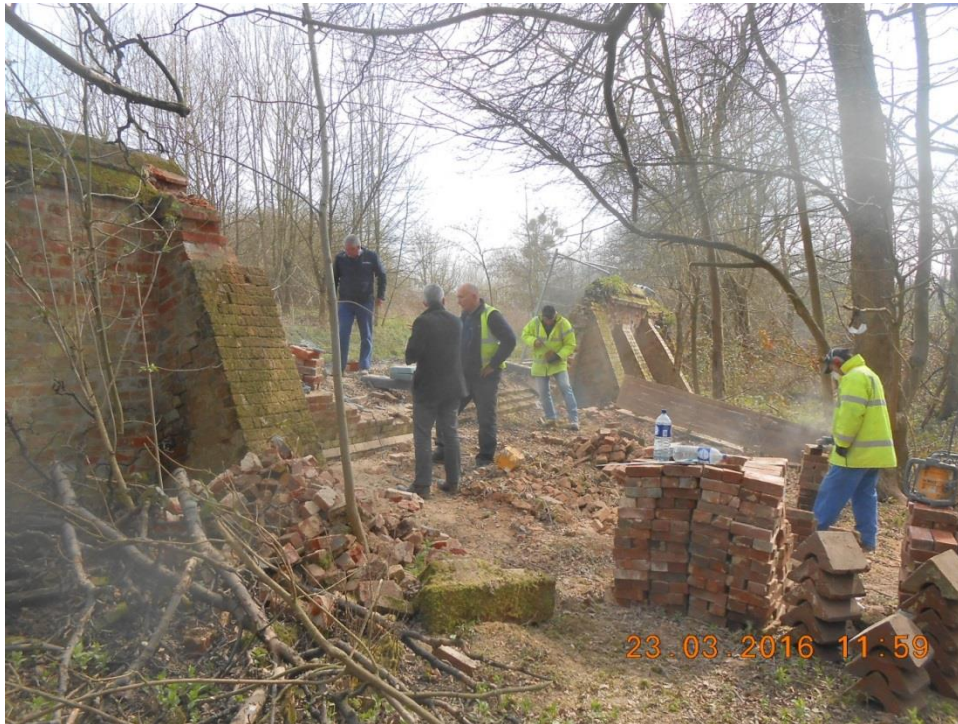
### Wall surrounding the Braxted Park Estate

Designation:	Grade II listed
Priority:	<b>F</b> – Currently undergoing repair
Condition:	<b>Poor</b> - The wall has suffered general deterioration, as well as occasional damage by vehicles on the road-side section.
Date registered:	2011
Ownership:	Private
For Sale:	No
Summary:	Early-19 <sup>th</sup> century wall, approximately four and a half miles long, enclosing the Braxted Park Estate. The cost of repairing the wall (estimated at £1.25m) is being funded by a scheme of enabling development in the form of 14 houses on the edge of the village. The repair work – undertaken by Bakers of Danbury and overseen by Ed Morton – commenced in 2016, with a s.106 agreement requiring completion by 2021. Already over a third of the wall's length has been repaired and is set to be completed well ahead of the target date. The repairs carried out so far, using traditional hot-lime techniques, are of an exemplary standard.

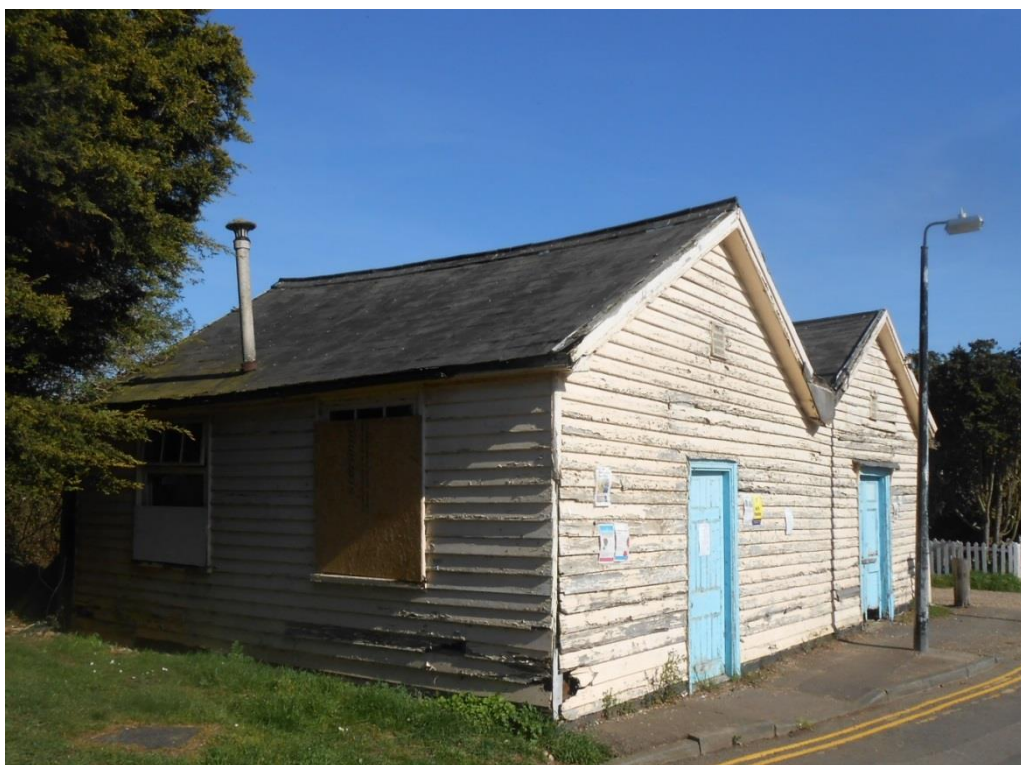
### United Reformed Church, Basin Road

Designation:	Within the Heybridge Basin Conservation Area and on the local list
Priority:	<b>A</b>
Condition:	<b>Very bad</b> - The building has been redundant for many years and is in an increasingly dilapidated state. There are signs that much of the timber-frame structure has become severely decayed.
Date registered:	2010
Ownership:	Private
For Sale:	No
Summary:	Dates from the mid-19 <sup>th</sup> -century expansion of Heybridge Basin, annotated as a Wesleyan Chapel on the 1875 OS map. It is a good example of a vernacular weatherboarded chapel and a significant landmark in an important position within the conservation area. Planning applications in 2008 and 2017 to convert the building to a restaurant have been refused. Maldon District Council commissioned the Mid Essex Historic Buildings Trust to undertake a Condition Survey and Feasibility Study in 2012. The option of residential conversion is complicated by the fact the building is situated in a flood zone.

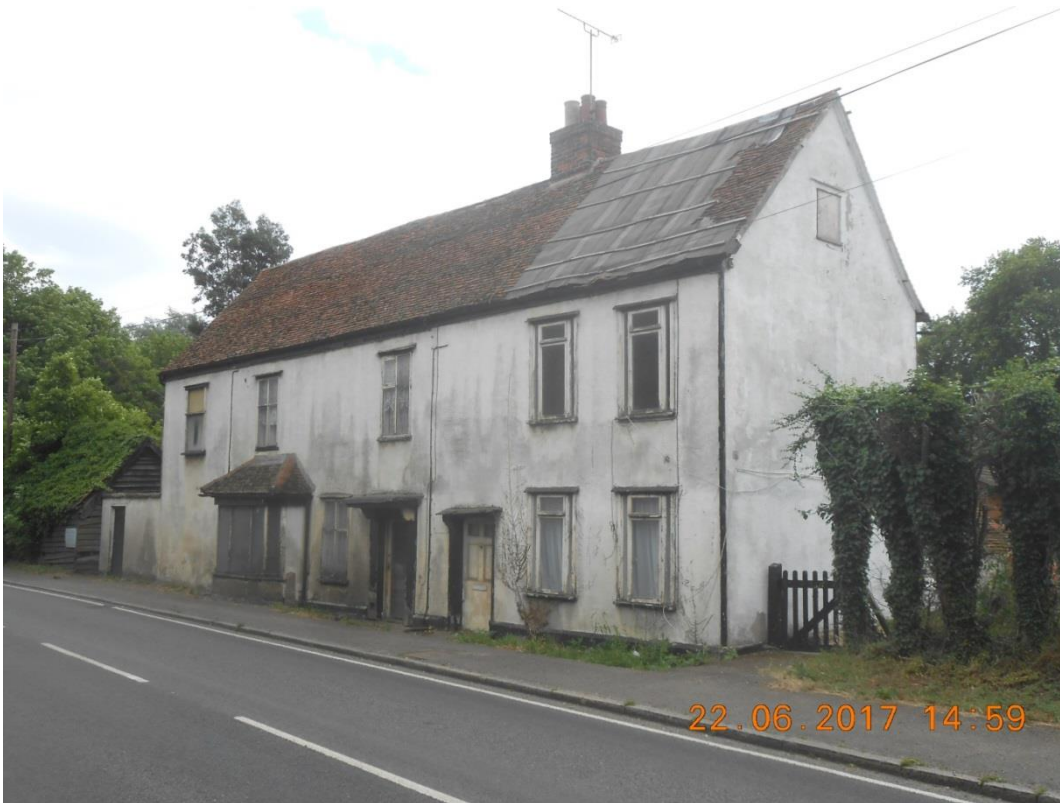
### Homestead, Maldon Road

Designation:	Listed grade II and within the Langford Conservation Area
Priority:	<b>D</b> – Severely decayed windows and doors, temporary repair to roof. Solution agreed but not yet implemented
Condition:	<b>Fair</b> – The building is structurally sound but lacks maintenance and redecoration. The windows are all very rotten. A temporary emergency repair carried out to the roof in 2015 is showing signs of deterioration. The building is an eyesore in the conservation area, but is currently occupied.
Date registered:	2017
Ownership:	Private
For Sale:	No
Summary:	The list description dates the house to the 18 <sup>th</sup> century, but recent investigation has established that it incorporates the remains of a small late-medieval hall house. This means the house is the oldest in the centre of Langford, and of considerable significance. Listed building consent was granted in late 2016 to refurbish the house, including replacement windows and re-tiling the roof. The owner has been in ongoing dialogue with the Council's enforcement team and the conservation officer.

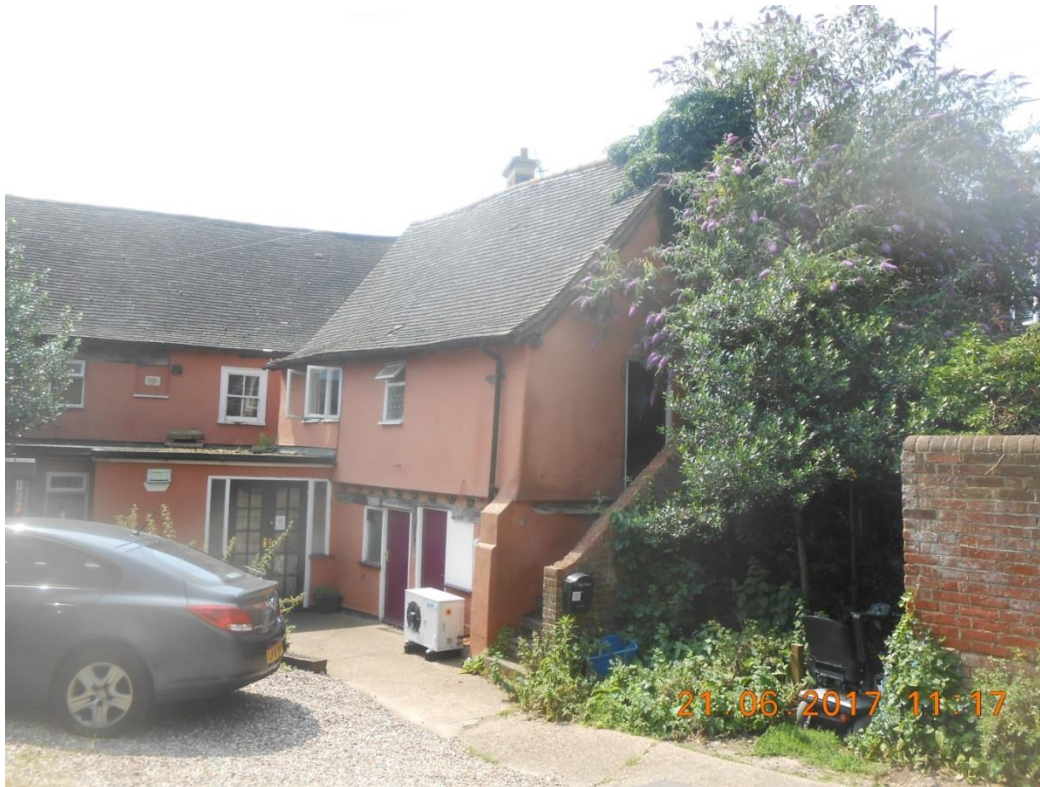
### 1-3 High Street

Designation:	Listed grade II* and within the Maldon Conservation Area
Priority:	<b>D</b> - Slow decay. Solution agreed
Condition:	<b>Fair</b> - Ivy growth to the rear range has become excessive and risks causing this part of the building to deteriorate
Date registered:	2017
Ownership:	Private
For Sale:	No
Summary:	Nos. 1-3 High Street were first built as a hall house in the 14 <sup>th</sup> century, making it the oldest timber-framed building on Maldon High Street. Ivy growth has become excessive on the rear range which dates from the 15 <sup>th</sup> century. The new owner was alerted to the problem in July 2017, and subsequently met the conservation officer on site to discuss removal of the ivy.

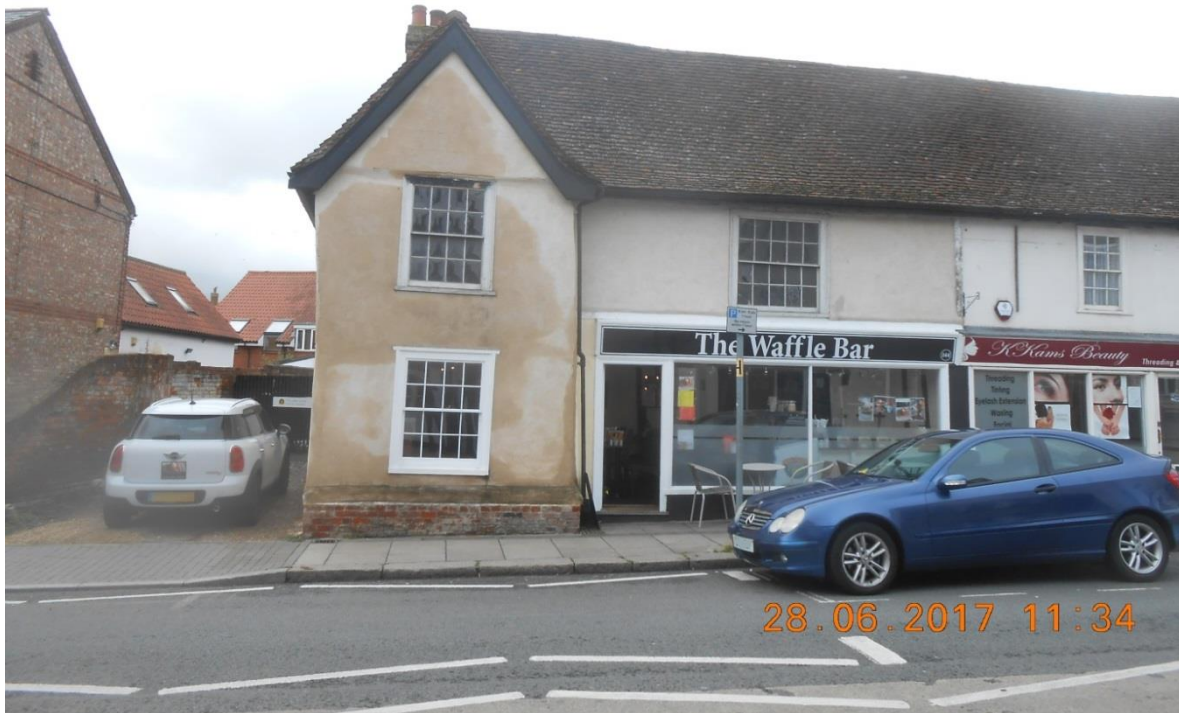
### 1-3 High Street

Designation:	Listed grade II and within the Maldon Conservation Area
Priority:	<b>E</b> – The building is weathertight but the windows, render and parts of the timber-framed structure require repair
Condition:	<b>Poor</b> -
Date registered:	1986
Ownership:	Private
For Sale:	No
Summary:	This is a medieval hall and crosswing, later altered by the heightening of the hall, the application of render and the insertion of sash windows. Most of the ground-floor rooms have been refurbished and are in use, but the first-floor rooms remain derelict and in a poor condition. In 2009 the owners removed the render and windows without consent. In 2011, lime render was re-applied to timber frame and Georgian sash windows were reinstated in accordance with an enforcement notice served by the Council. However, the render has not been applied very well, is cracking in places, and has not been lime-washed.

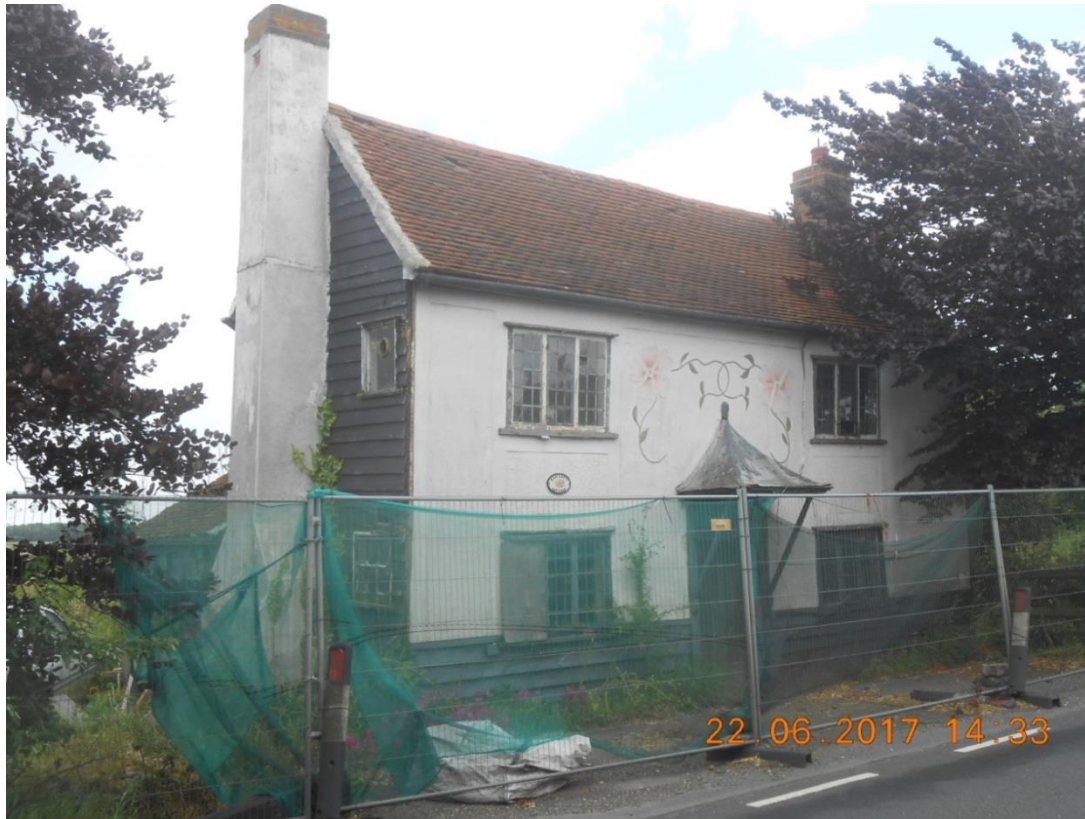
### Eastcroft, Fambridge Road, Purleigh

Designation:	Listed grade II
Priority:	<b>A</b> - Immediate risk of further rapid deterioration. No solution agreed.
Condition:	<b>Very bad</b> – The building is derelict. There are some slipped roof tiles, the rainwater goods are not operating effectively.
Date registered:	2017
Ownership:	Private
For Sale:	Yes, at time of writing
Summary:	A timber-framed cottage, known from documentary evidence to have been built in 1799 on manorial waste. The lead-glazed windows on the front elevation are original and a rare survival. The building became derelict in 2013. It is situated quite close to a busy road. In 2015 the current owner was dissuaded from submitting an application to demolish and rebuild the cottage. Ongoing discussions between the owner and the conservation officer about plans to refurbish and extend the building have become protracted and now the property has been put up for sale. The owner and the Conservation Officer are due to meet in August 2017 to discuss urgent works.

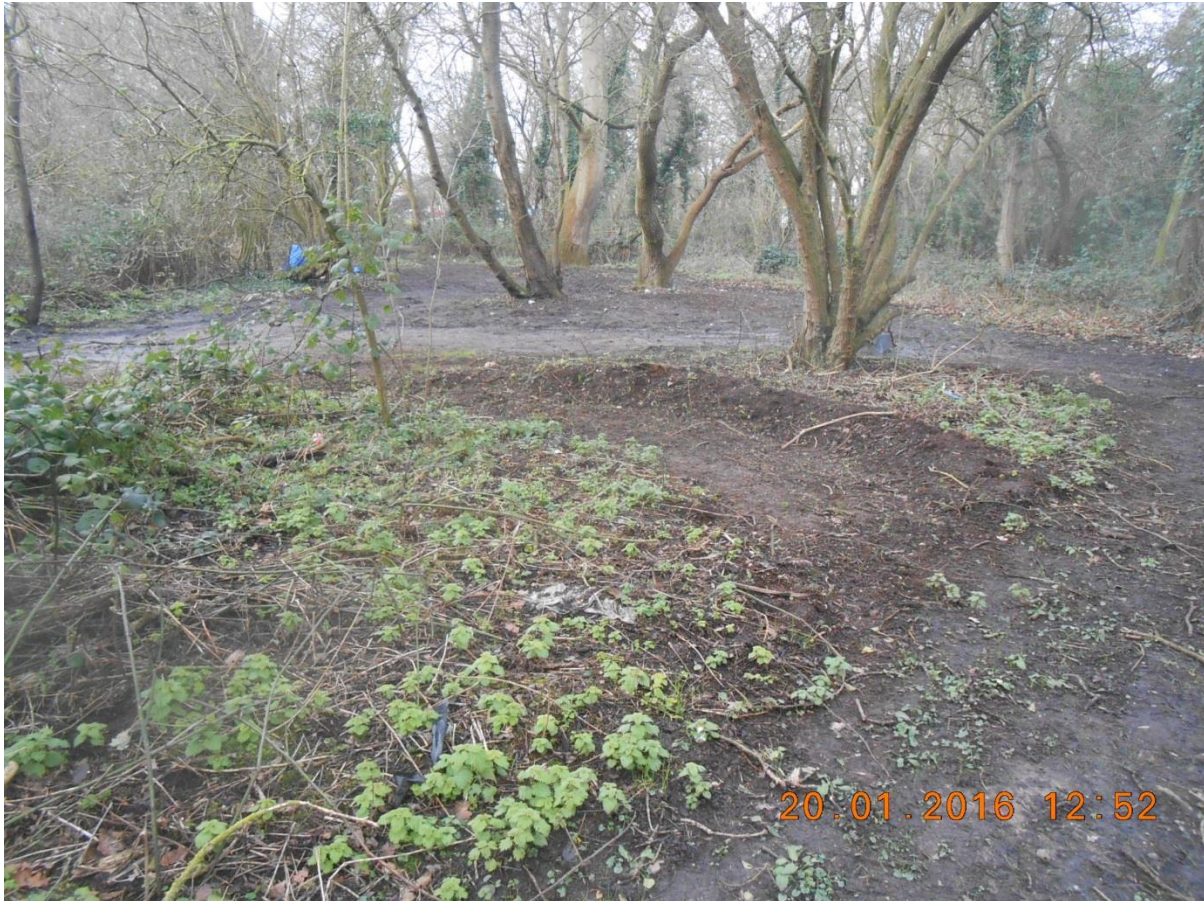
### Pandole Wood

Designation:	Scheduled monument
Priority:	<b>C</b> - Slow decay. No solution agreed.
Condition:	<b>Poor</b> – The monument is being gradually eroded by motorcyclists using the earthworks as a scrambling track.
Date registered:	2017
Ownership:	Private
For Sale:	No
Summary:	This scheduled monument comprises substantial earthworks thought to represent an enclosure of late Iron Age or Roman date. A management plan was developed in dialogue with Historic England and the landowner which would have addressed many of the problems, but was dependent for funding from a nearby housing development which was refused planning permission. The applicants for that development had appealed but have now withdrawn the appeal.

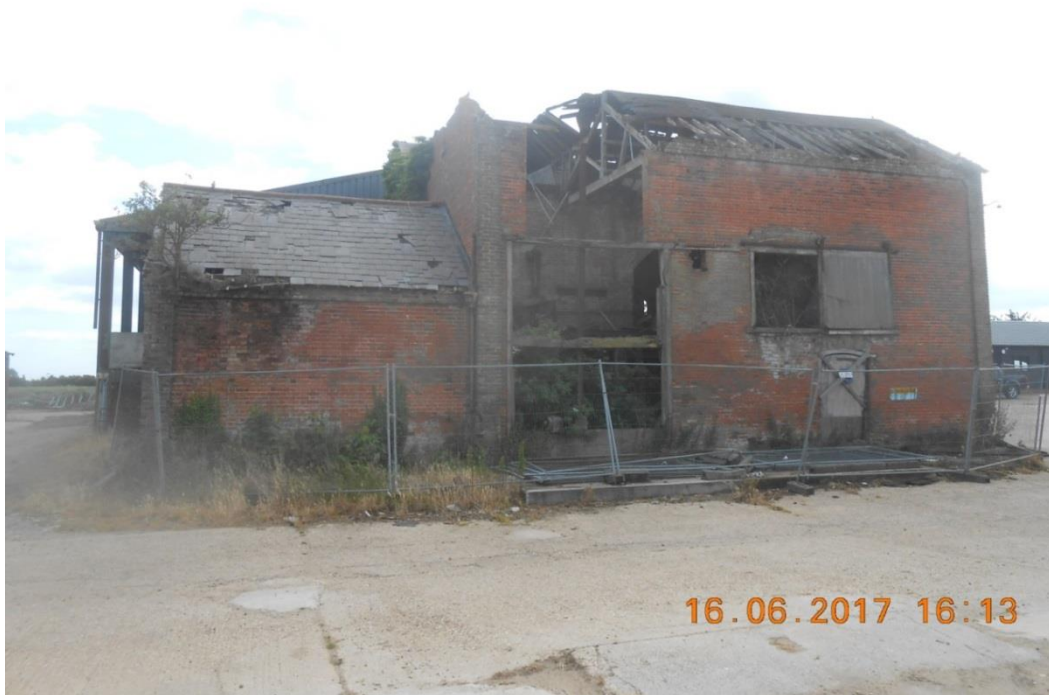
### Former grain-drying unit, Southminster Hall Farm

Designation:	Grade II listed
Priority:	<b>C</b> - Slow decay. No solution agreed.
Condition:	<b>Very bad</b> - Many years ago the main roofs were covered by a form of felt, which quickly failed and led to the deterioration of the timber structure.
Date registered:	2004
Ownership:	Private
For Sale:	No
Summary:	This redundant late-19 <sup>th</sup> -century brick-built grain drying unit is situated in the middle of a working farmyard. Over recent years, there have been various efforts to find a new viable use for this building. A feasibility study was prepared by the Mid Essex Historic Buildings Trust, with financial assistance from Maldon District Council and input from students on the MSc Building Conservation Course at Anglia Ruskin University. A report by the structural engineer Edward Morton in 2013 found that, due to the extensive decay, little if any of the original roof or floor structures would now be salvageable.

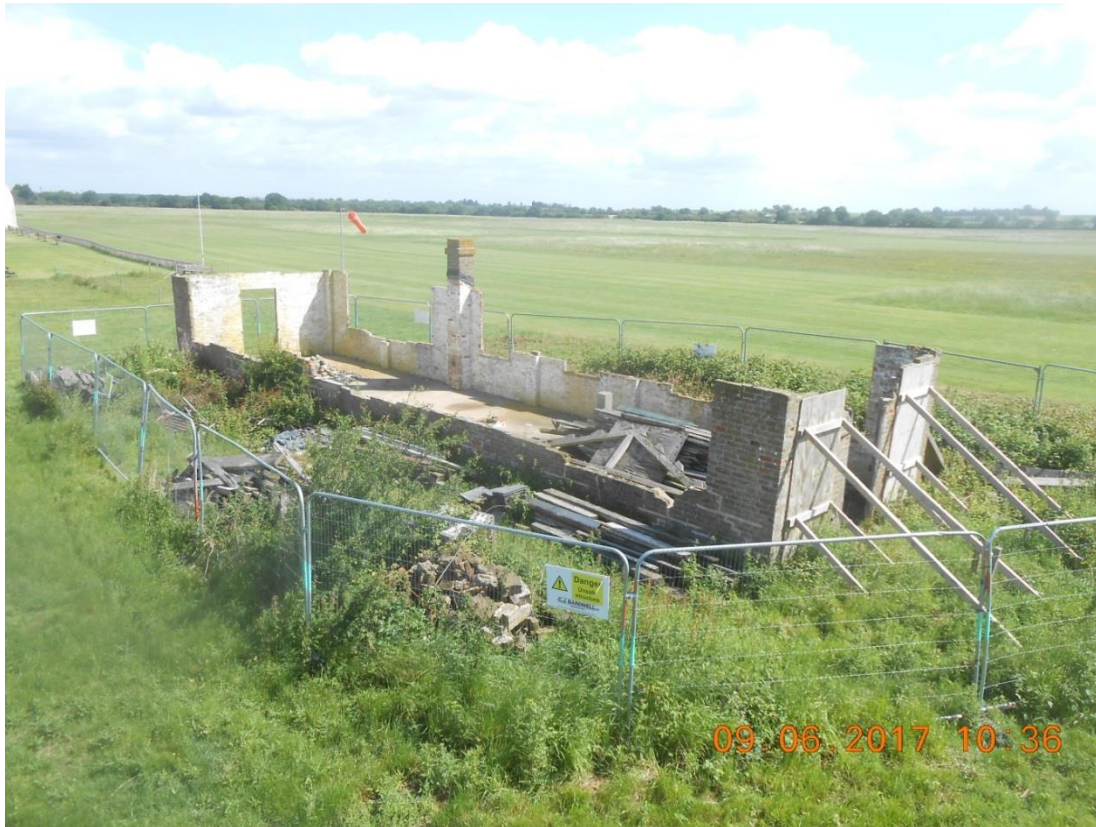
### Night flying store

- Designation: Grade II\* and in the Stow Maries Aerodrome Conservation Area.
- Priority: **C** - Slow decay. No solution agreed.
- Condition: **Very bad** – Following collapse of the roof structure the end walls have been shored up.
- Date registered: 2012
- Ownership: Private
- For Sale: No
- Summary: One of twenty four original buildings remaining at Stow Maries World War One Aerodrome. Following collapse, the materials were recorded and the salvageable timber trusses put into storage. Funding is being sought to reconstruct the building.

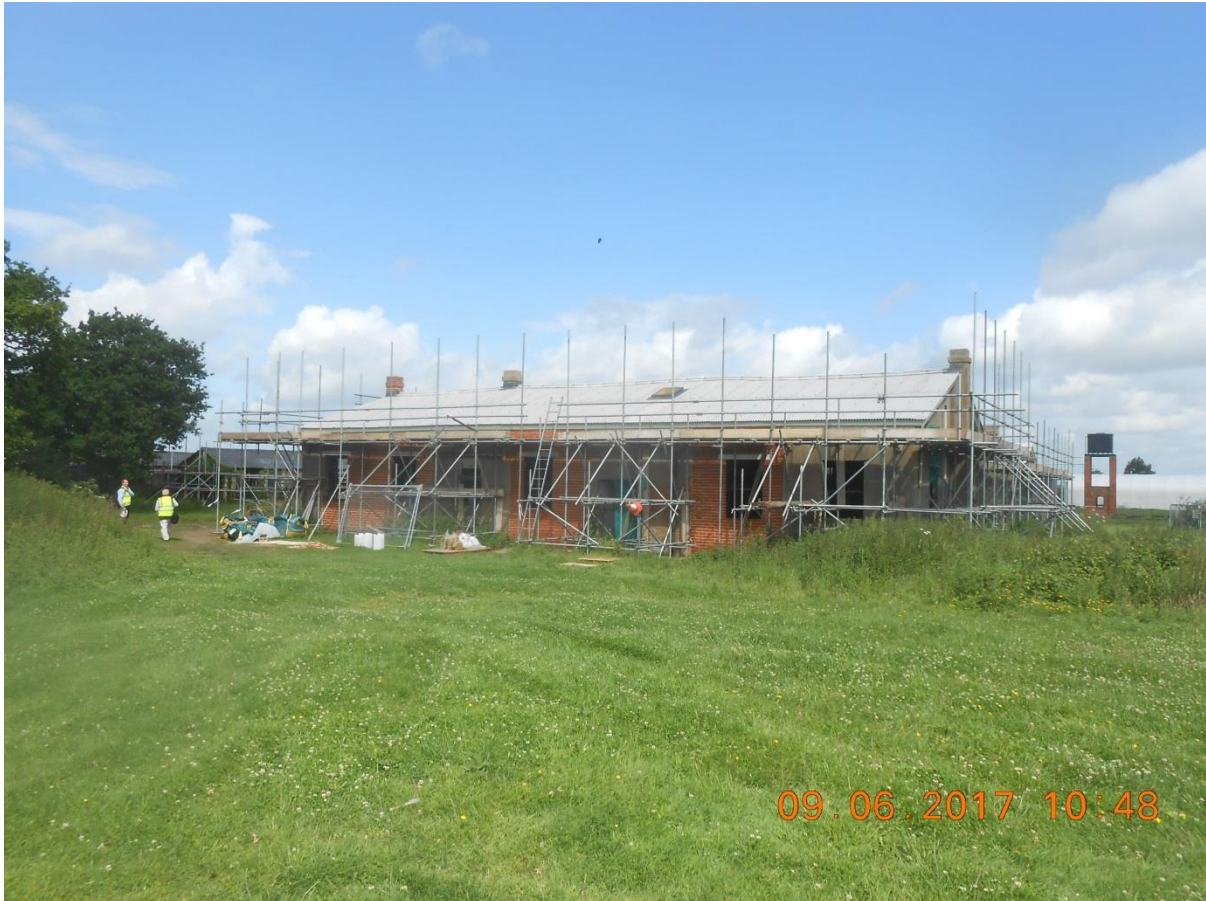
### Officers' Mess

Designation:	Grade II* and in the Stow Maries Aerodrome Conservation Area.
Priority:	F - Repair scheme in progress
Condition:	<b>Fair</b> – Grant funding from Historic England and WREN has recently enabled the repair of the roof.
Date registered:	2012
Ownership:	Private
For Sale:	No
Summary:	This E-shaped complex is the largest original building to survive at Stow Maries World War One Aerodrome. Only two other Royal Flying Corps Offices Messes are listed in this country. The interior is remarkably unaltered with a good survival of internal fixtures and fittings.

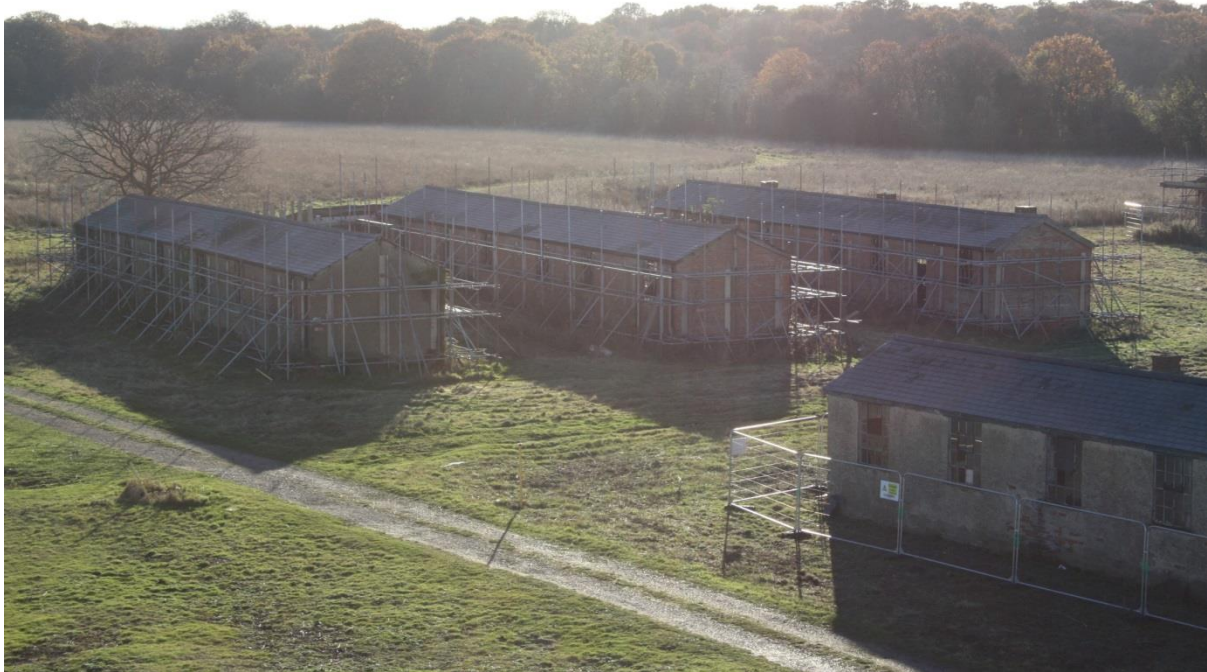
### Officers' Quarters

Designation:	Grade II* and in the Stow Maries Aerodrome Conservation Area.
Priority:	<b>D</b> - The buildings have been stabilised by structural shoring. There are ongoing discussions about the best way to repair the structures
Condition:	<b>Poor</b> -
Date registered:	2012
Ownership:	Private
For Sale:	No
Summary:	Three of the twenty four original buildings remaining at Stow Maries World War One Aerodrome. Each of the three parallel ranges is connected at the southern end by a block for toilets and washroom which has partially collapsed.

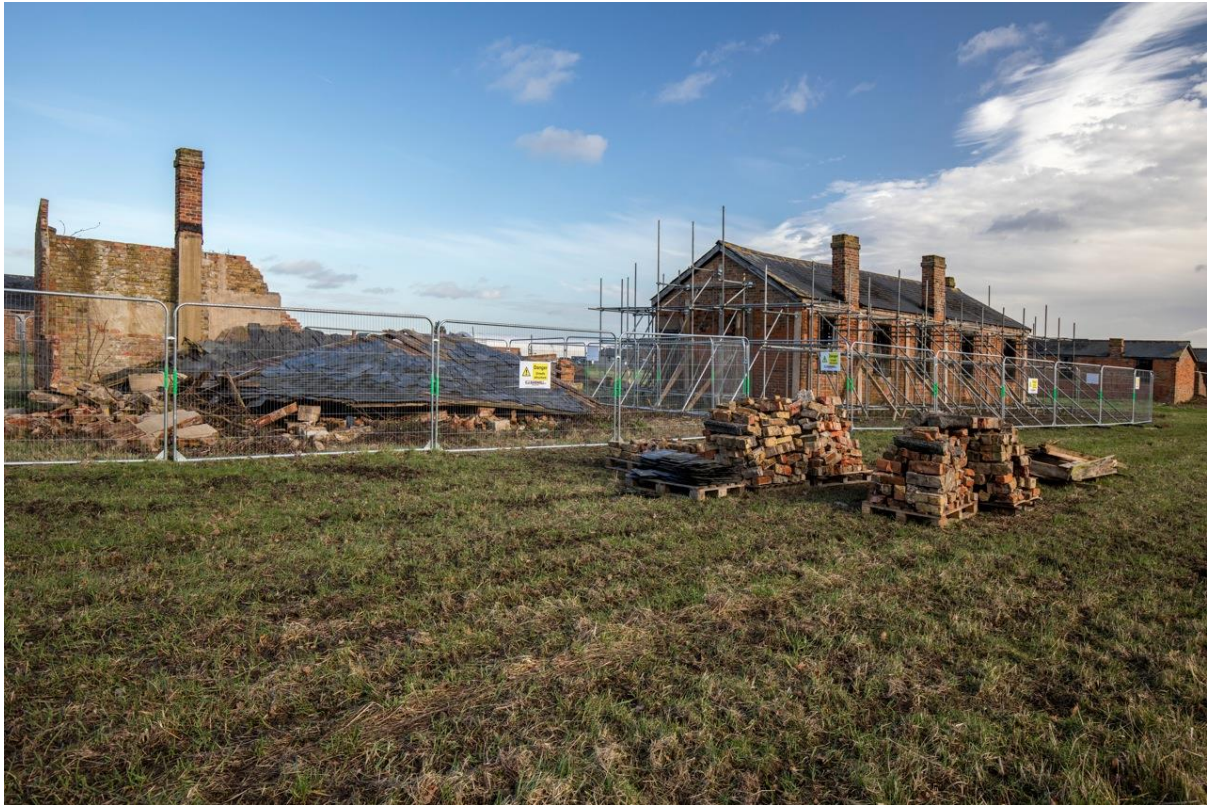
### Women's Hostels

Designation:	Grade II* and in the Stow Maries Aerodrome Conservation Area.
Priority:	<b>D</b> - Slow decay. Solution agreed but not yet implemented.
Condition:	The western building is <b>very bad</b> and the other is <b>poor</b> . The western block collapsed during strong winds in November 2015. This event highlighted the fragility of the buildings on the site and galvanised the Trust to install structural shoring throughout the site.
Date registered:	2012
Ownership:	Private
For Sale:	No
Summary:	Two of the twenty four original buildings remaining at Stow Maries World War One Aerodrome.

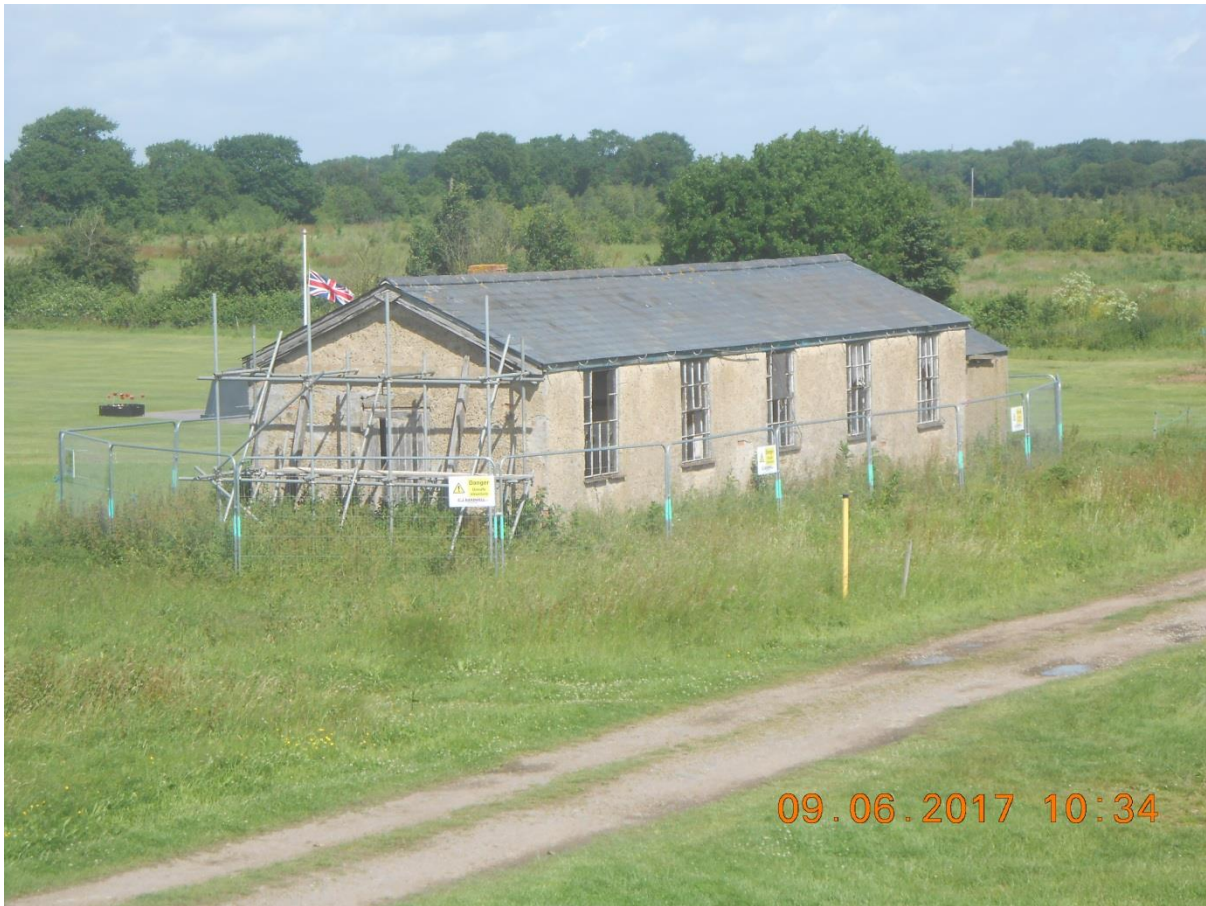
### NCO Accommodation block

Designation:	Grade II* and in the Stow Maries Aerodrome Conservation Area.
Priority:	<b>D</b> - Slow decay. Solution agreed but not yet implemented.
Condition:	<b>Poor</b> – The building is derelict but has been stabilised by structural scaffolding. Minor repairs have recently been undertaken to the roof and guttering is soon to be installed.
Date registered:	2012
Ownership:	Private
For Sale:	No
Summary:	One of the twenty four original buildings remaining at Stow Maries World War One Aerodrome. A single building with a long corridor plan. Used for domestic purposes after the war.
