# Maldon District Heritage at Risk Register 2017

August 2017

Planning Policy

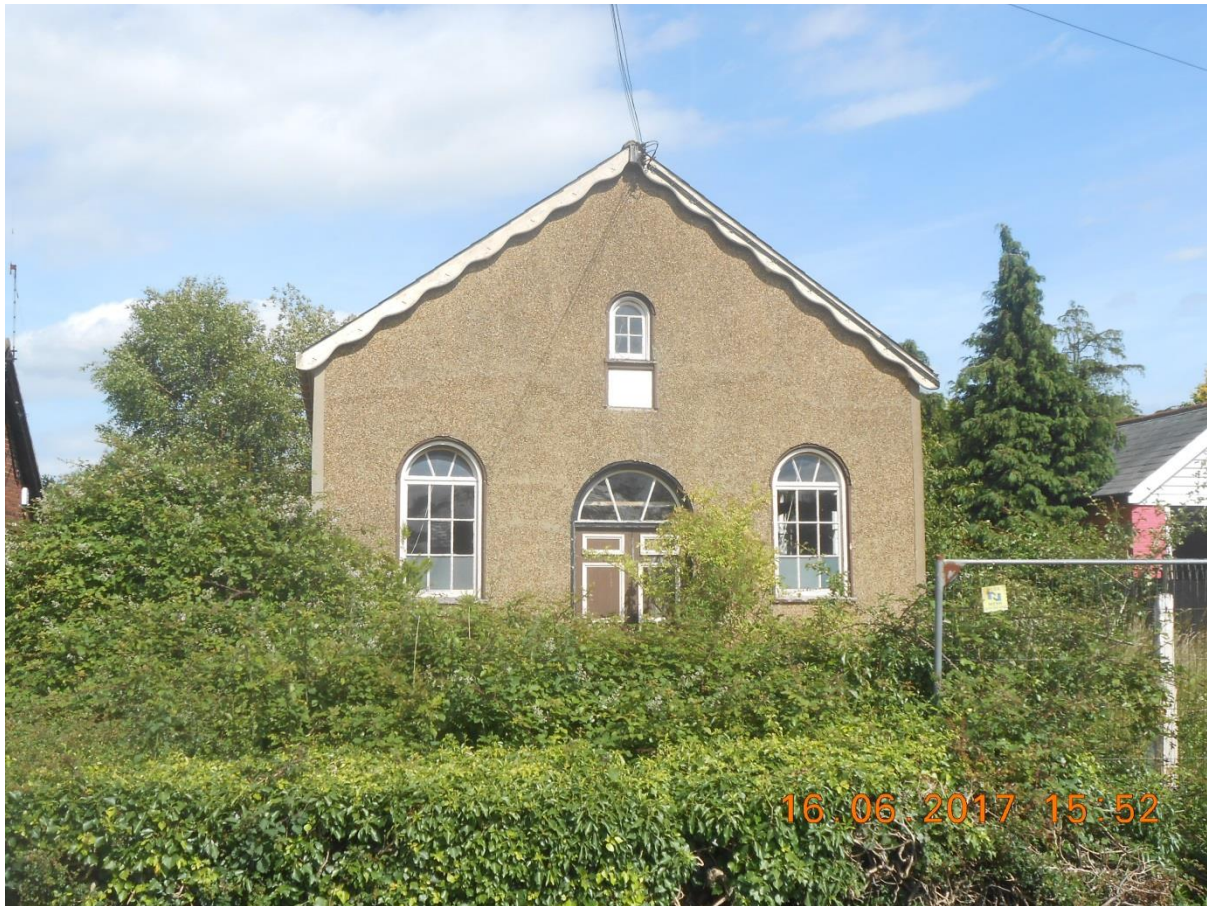
### Peculiar People's Chapel

Designation:	On the local list and within a conservation area
Priority:	D – Derelict and deteriorating. The grounds are becoming overgrown.
Condition:	<b>Poor</b>
Date registered:	2017
Ownership:	Private
For Sale:	No
Summary:	Victorian timber-framed chapel built for the Peculiar People, a particular branch of non-conformity in Essex. Planning permissions were granted in 2010 and 2015 to convert the chapel to a house but these have not been implemented.

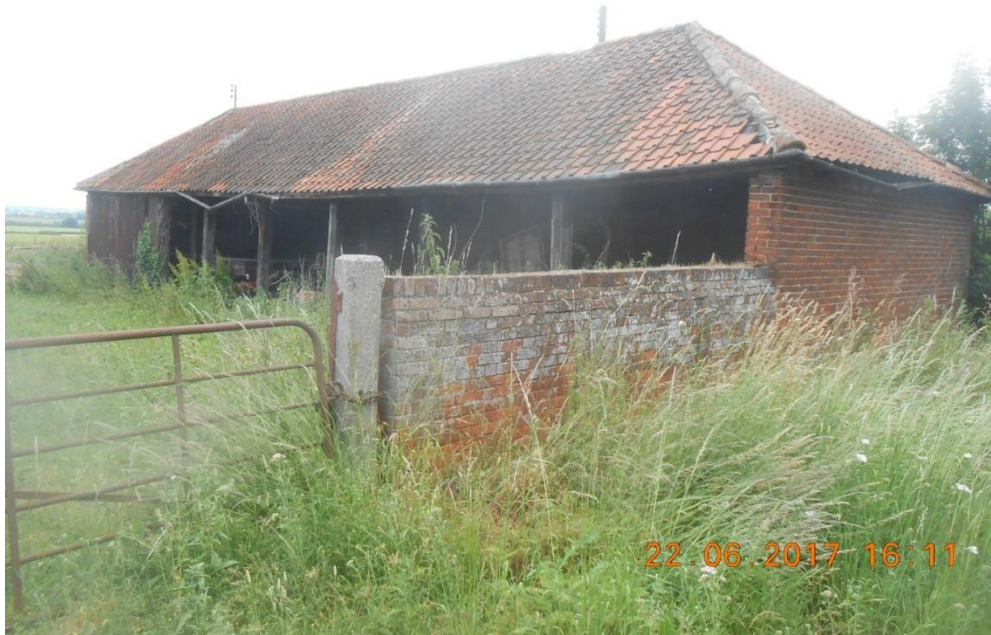
### Bourchier's Barns, Back Road, Tollesbury

Priority: D - Slow decay. Solution only partly implemented

Condition: **Poor**

Summary: The site contains an attached pair of Georgian threshing barns, which are grade II listed, and five Victorian animal shelter buildings which are curtilage listed. The Georgian barns are the most significant structures on the site, but the Victorian buildings are also of considerable significance, as good quality examples of their type, reflecting the increased emphasis upon livestock in the later 19<sup>th</sup> century. Permission was granted in 2013 to refurbish all the historic buildings on the site, but four of the five Victorian buildings remain in need of repair, typically exhibiting slipped roof tiles, failed guttering and areas of decayed brickwork.

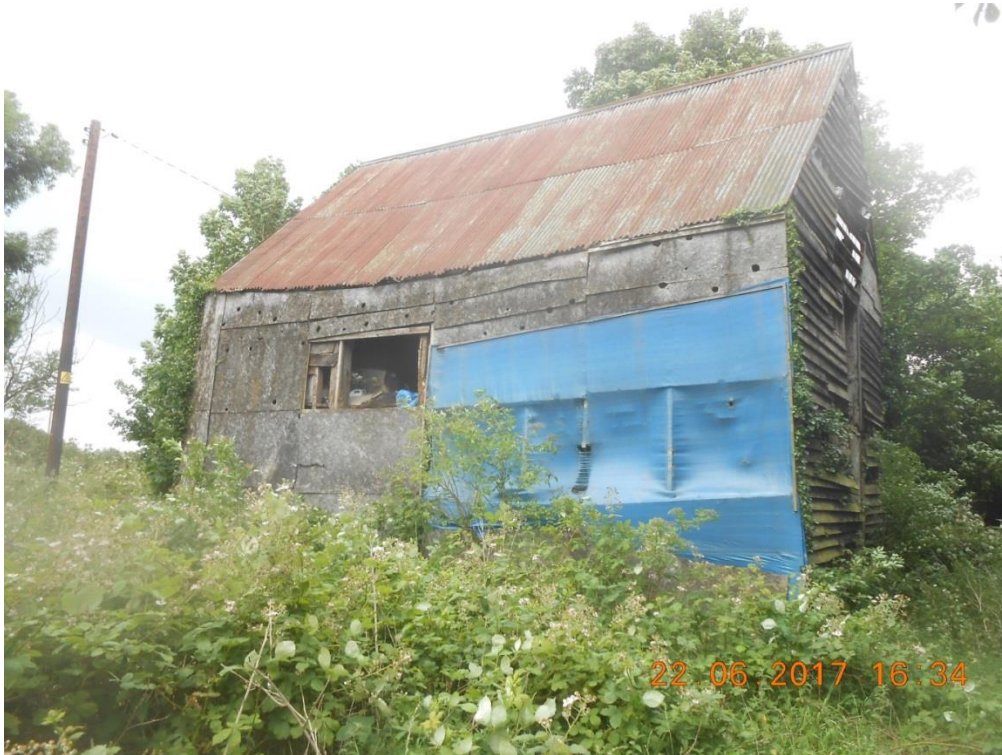
### Byre at Bohuns Hall, Church Street

Designation:	Grade II listed
Priority:	A – Areas of cladding are missing, ivy is beginning to invade the building, and parts of the timber frame are extremely decayed.
Condition:	<b>Very bad</b>
Date registered:	2004
Ownership:	Private
For Sale:	No
Summary:	Redundant Georgian timber-framed byre. A decision to refuse residential conversion was upheld at appeal in 2011. There are ongoing discussions between the owners and the Conservation Officer about the condition of the building.

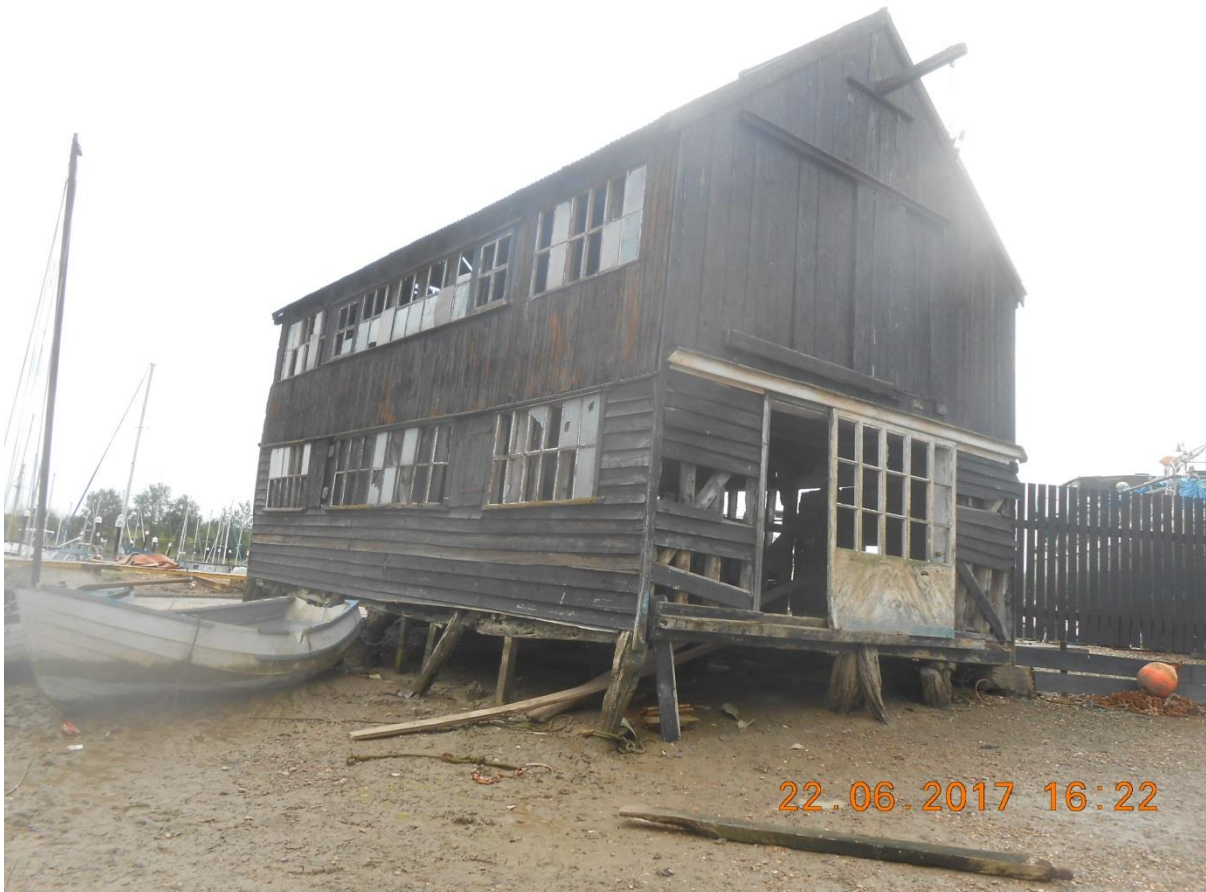
### Granary at Woodrolfe Creek, Tollesbury

Designation:	Grade II listed
Priority:	C - Slow decay. No solution agreed.
Condition:	<b>Poor</b> -
Date registered:	1995
Ownership:	Private
For Sale:	No
Summary:	A 19 <sup>th</sup> -century timber-framed granary / store. In the past, options for reuse of the building have been investigated by the Mid-Essex Building Preservation Trust. It also featured on the third series of BBC's Restoration. Temporary stabilisation works – in the form of internal shoring – were undertaken with grant assistance from Maldon District Council.

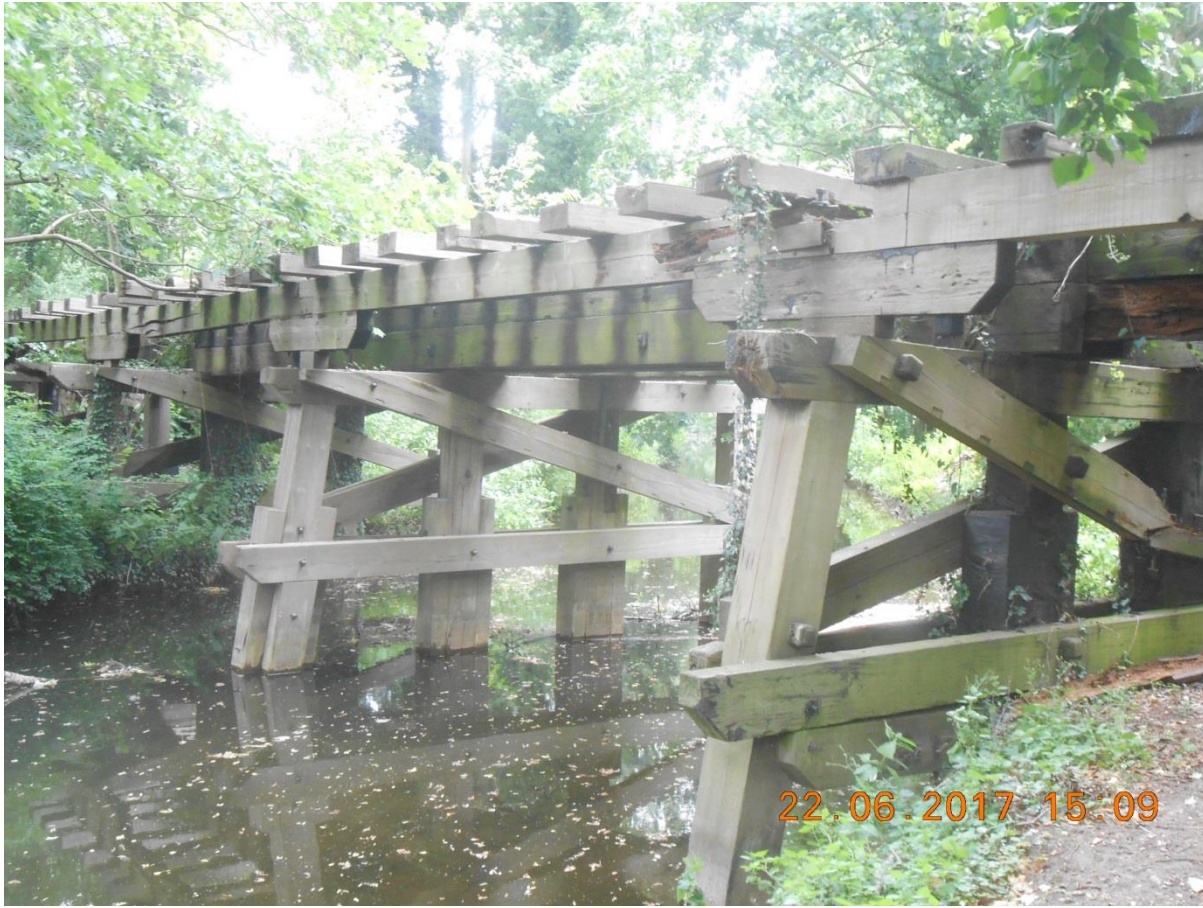
### Timber Trestle Viaduct at Wickham Place

Designation:	Scheduled Monument
Priority:	<b>A</b> - Immediate risk of further rapid deterioration. No solution agreed.
Condition:	<b>Very bad</b> – Extensive decay has led to structural failure of parts of the viaduct.
Date registered:	2007
Ownership:	Essex County Council
For Sale:	No
Summary:	Timber trestle viaduct built in 1847 as part of the now redundant Witham, Maldon and Braintree Railway Line.

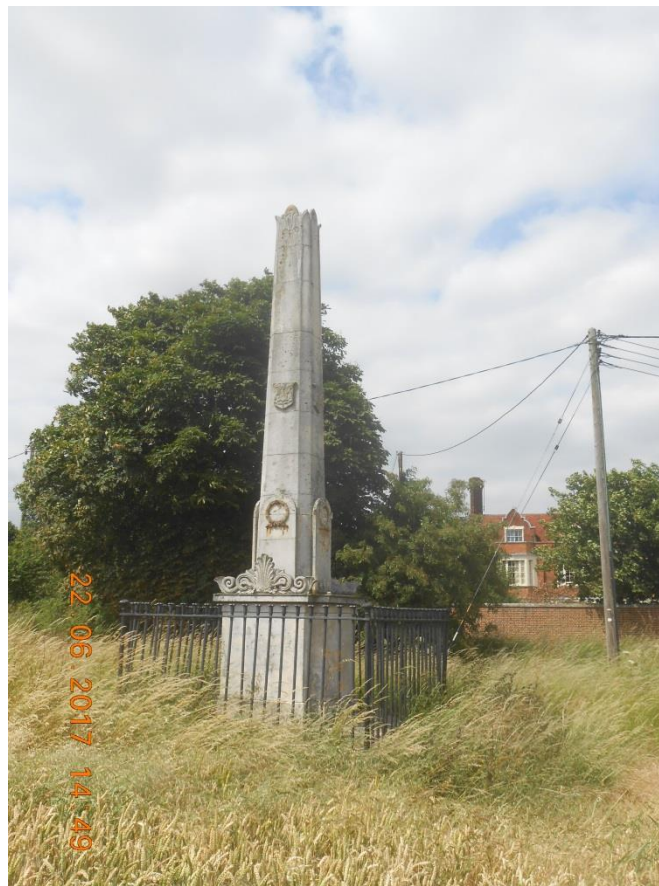
### Obelisk opposite Woodham Mortimer Hall

Priority: C - Slow deterioration. No solution agreed.

Condition: **Poor**

Summary: Erected in 1825 by the Coopers Company to commemorate William Alexander's bequest of his estate at Woodham Mortimer. The monument has suffered from a lack of general maintenance. The railings have rusted at their base and some of the stone plinths have split. The railings also appear to have been knocked and bent. The stone monument would also benefit from general conservation. The Conservation Officer has been in discussion with the land owner and the Coopers Company since 2012, but no solution has been agreed.
